EFFECT OF CONSTRUCTING HIGH-RISE BUILDINGS WITHOUT A GEOPHYSICAL SURVEY

Adagunodo T. A.^{1*}, Sunmonu L. A.¹, and Oladejo O. P.²

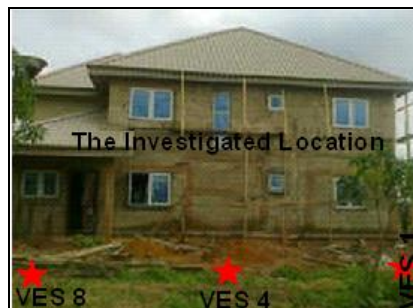
Figure 2b: Location of the VES stations and the patched cracks in the building.

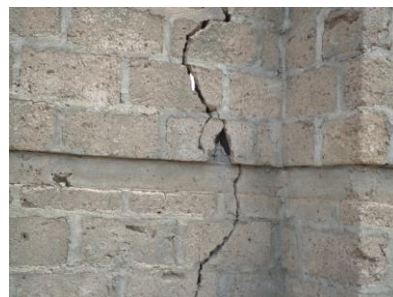
Figure 2c: The cracks notice at the Eastern fence that separates the building from another house.

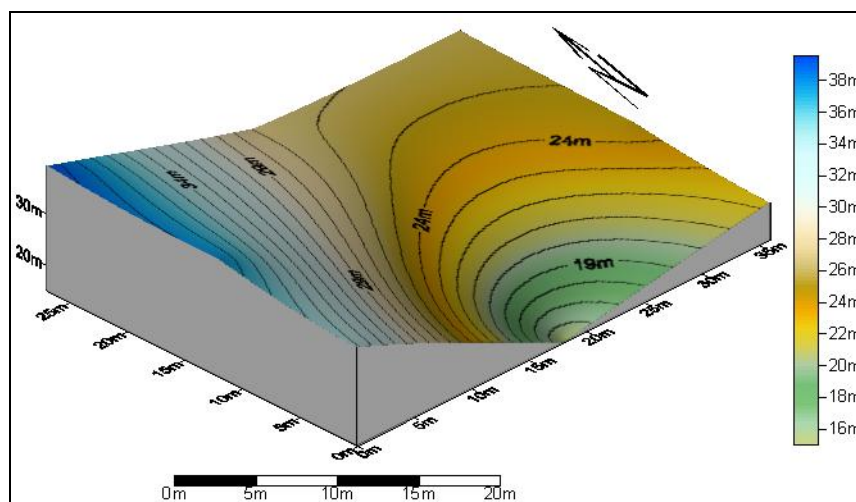
Figure 4: Three-Dimensional plot of overburden thickness in the study area.

Overburden thickness interpretation with respect to subsurface competency for the construction of high-rise building in the study area is as follow: figure 4 shows that only the Southern part of the building is underlain with thin overburden while the remaining parts are relatively thick. According to Sunmonu *et al.* (2012), who rated overburden greater than 15 m (about 50 ft) as thick (table 4), it could be seen from figure 5 that except VES 6 that has the value of 14.9 m (approx. 15 m), other VES stations are greater than 15 m. This overburden is relatively thick for a high-rise building without an artificial basement before the foundation is laid.

The results of the investigation showed that the possible cause of the cracks in the high-rise building constructed along Oda road, Akure is due to building on thick overburden (ranges between 14.9 m and 39.6 m). This overburden is relatively thick for construction of high-rise building without an artificial basement before the foundation is laid. The contractor has his blame because geophysicist should have been invited for geophysical survey before the construction works started. Finally, it was recommended that mega activities like party, playing of heavy acoustic music, manual pounding of yams within the building, use of heavily vibrated machines should be avoided in the building.

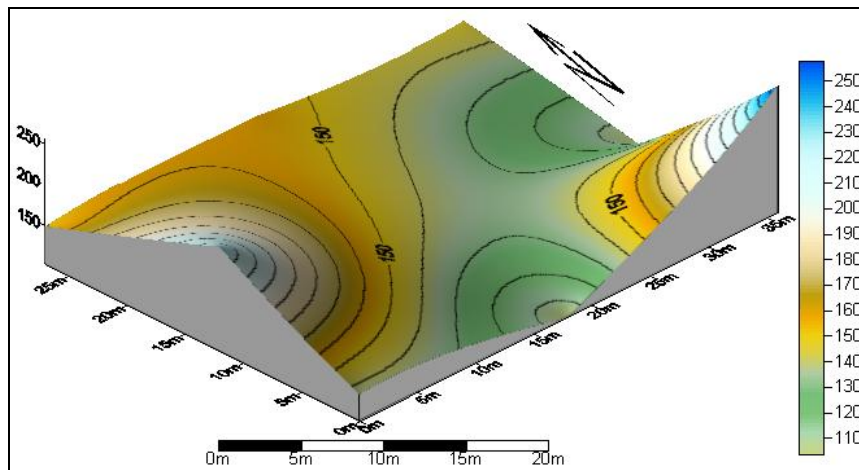
Figure 6: Three-Dimensional plot of weathered layer iso-resistivity in the study area.

However, the weathered layer iso-resistivity interpretation with respect to subsurface competency for the construction of high-rise building in the study area is as follow: the resistivity varied between 102.8 Ωm and 258 Ωm with an average value of 160.4125 Ωm . The 3-D weathered layer iso-resistivity map (figure 6) was produced from the interpreted VES data. Also, the distribution of the weathered layer iso-resistivity was produced in figure 7. From figure 6 and figure 7, none of the weathered layer resistivity falls within the zone of optimum weathering and good groundwater potential i.e. resistivity ranging from 21 Ωm and 100 Ωm . The closest resistivities are that of VES 5 and VES 6 which are 103.4 Ωm and 102.8 Ωm respectively. These 2 VES stations fall under the medium conditions and medium potential for groundwater as reported by Sunmonu *et al.* (2012). This was done in order to know the characteristics of weathered layer in the study area, whether it will permit the transport of water from subsurface to the supporting walls of the building or not. The result showed that the resistivities of the weathered layer's value constitute little and medium weathering processes with poor potential for groundwater (table 5). Therefore, water cannot be transported from the subsurface to the supporting walls of the building.
