AN ANALYTICAL INVESTIGATION OF A FAILED 1120 ALUMINIUM WIRE

C. A. Loto

*Center for Engineering Research
The Research Institute
King Fahd University of Petroleum & Minerals
Dhahran 31261, Saudi Arabia*

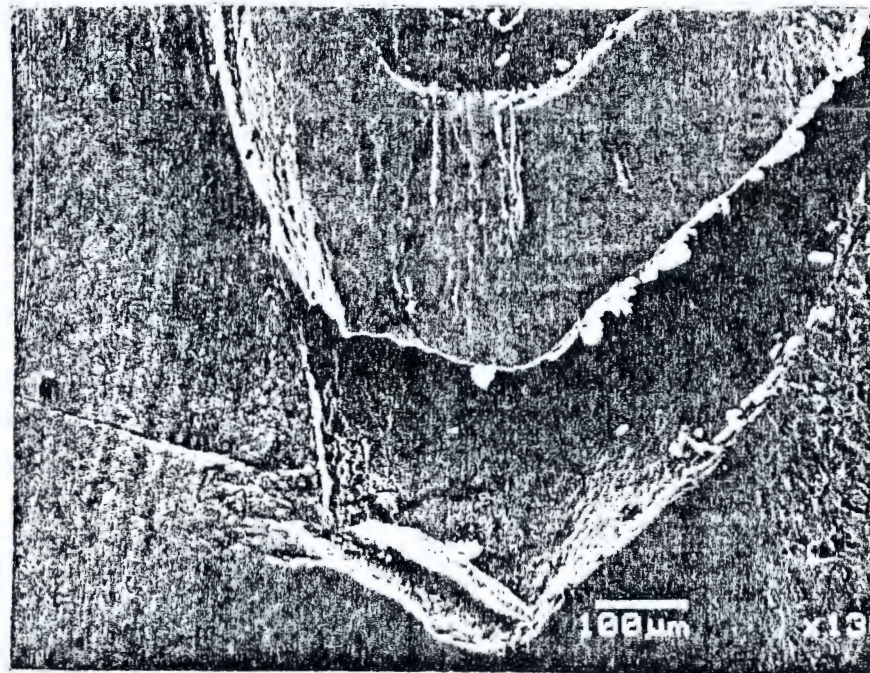
Fig. 1 shows the micrograph made for the largest open microscopic failure. It presents no details for further analysis at that magnification of 130 x. However, at the inside center of the crack failure, Fig. 2, at a magnification of 2000 x, there are located many distinct grains or particles with well-defined grain boundaries. The phenomenal appearance is different from that of the matrix. The mode of failure was apparently that of brittle failure, while the surrounding matrix presents a feature of mixed brittle and ductile failure.

Fig. 1. Failed surface of as-received aluminium wire

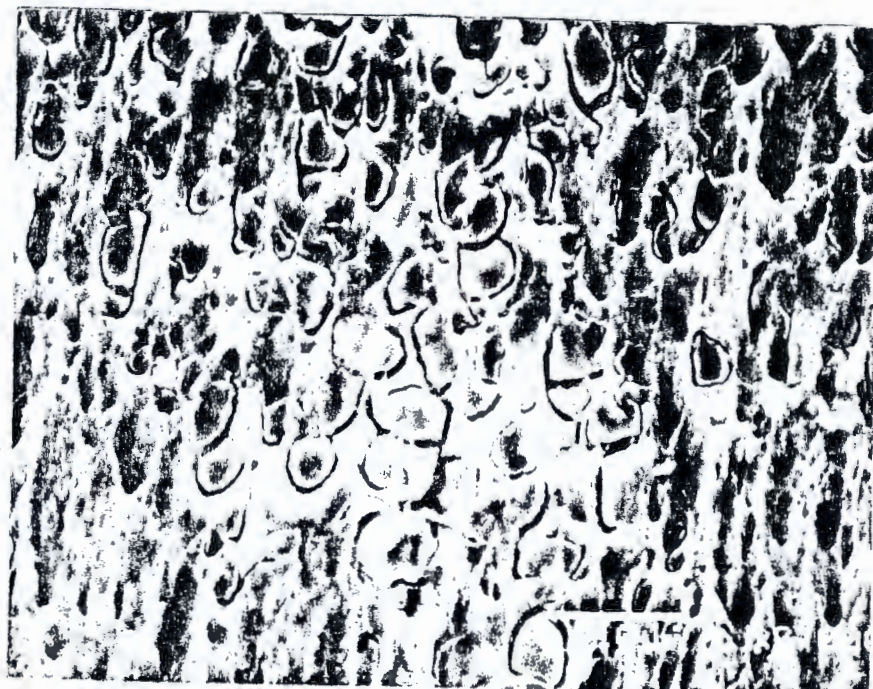
Fig. 2. Inside surface feature of the failed aluminium wire.

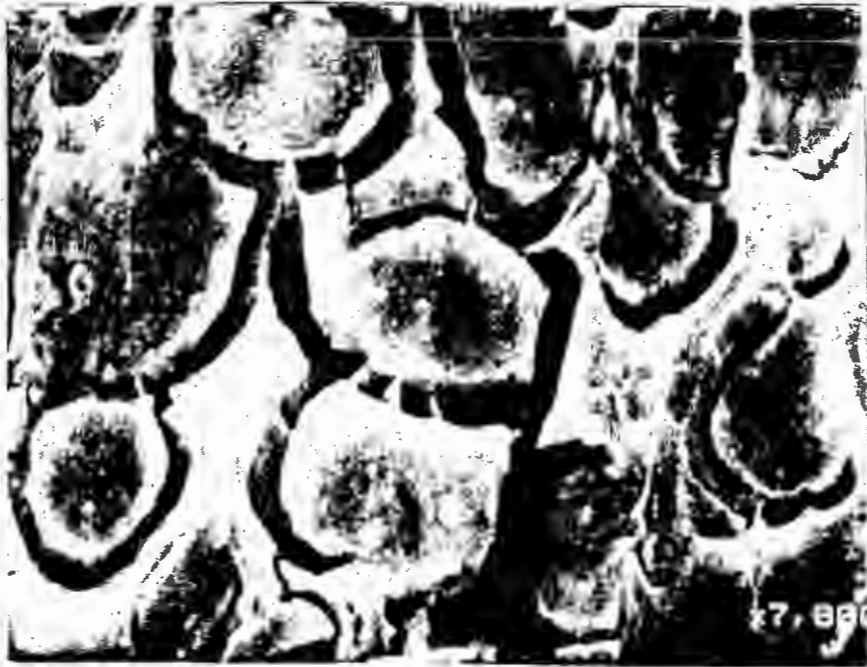
Fig. 3 shows the particles located at the center of the crack described above in Fig. 2, but at a higher magnification of 7000 x. The EDS analysis of the apparent, widely separated particles is presented in Fig. 5. Fig. 4 shows the internal feature of the open crack failure at a magnification of 600 x.

Fig. 3. Second-phase particles inside the failed surface matrix.

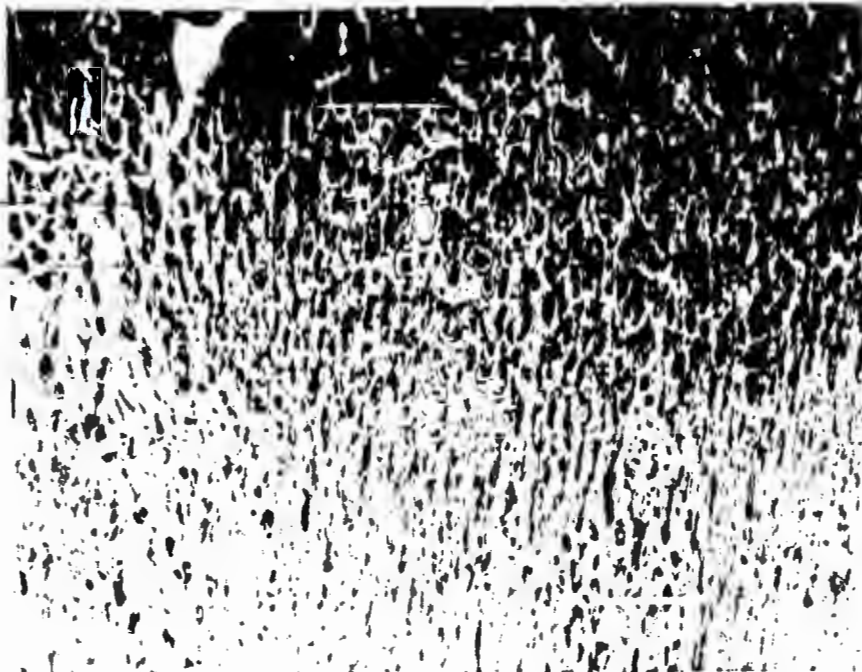
Fig. 4. Failed aluminium surface topography at a lower magnification (600 x)

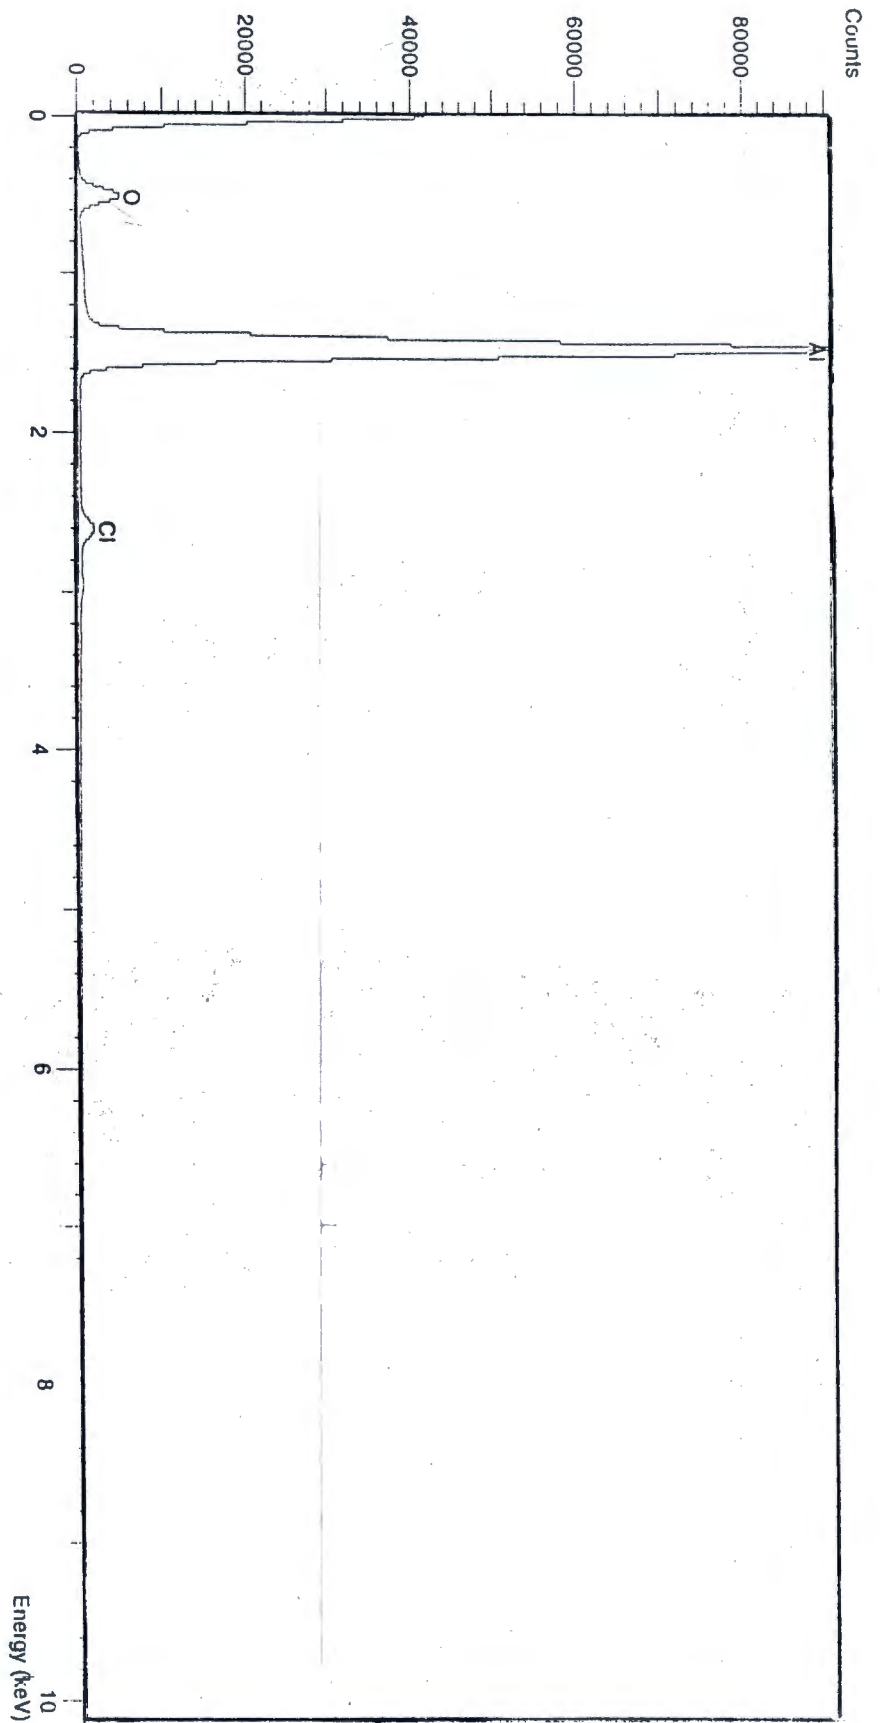
The EDS analysis shows clearly the peak of elemental oxygen in addition to the base aluminium. Also apparent in Fig. 5 is the peak for chlorine (Cl) – an indication of the presence of chloride ions. Oxygen in combination with aluminium inside the matrix is an indication of the presence of alumina (Al_2O_3). This is a deleterious impurity inside the aluminium matrix that weakens the structure. Under

the application of high stress, such as used in testing of the aluminium wire, it will yield embrittlement. The presence of chloride as inclusion of the grain within the matrix is difficult to explain.

Fig. 5. EDS analysis of center grain of failed surface

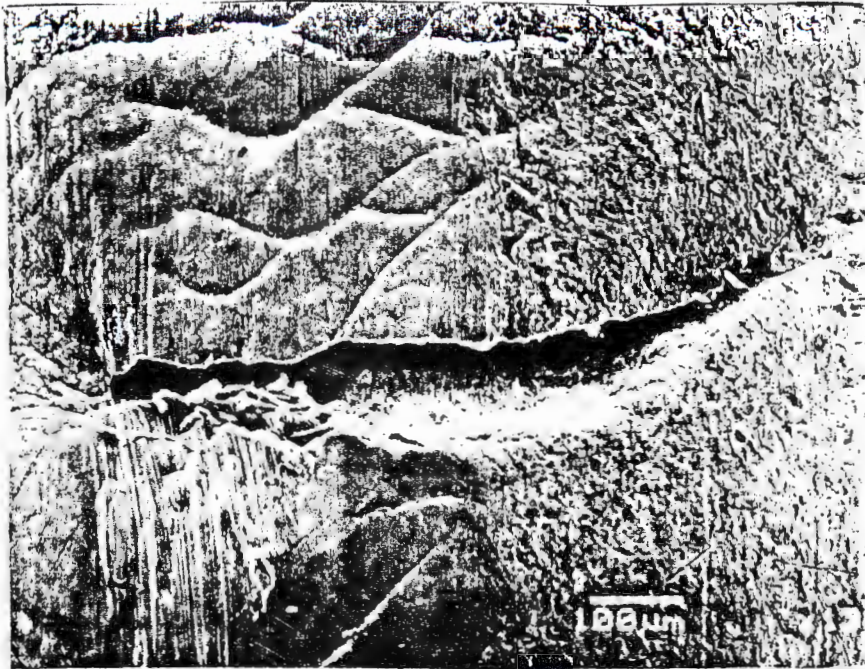
The micrograph of another open crack failure presented in Fig. 6. A magnified feature (2000 x) of its edge failure mode, is shown in Fig. 7. Fig. 8 shows the inside and the edge (near) features of the crack. The upper middle right portion of Fig. 8 is magnified form (4000 x) is presented in Fig. 9. Figs. 6 and 7 show brittle failure appearance at the edge. In Fig. 8, a brittle failure mixed with ductile failure is clearly shown. The feature in Fig. 9 is a further evidence of this phenomenon where the second phase particles are distinctly shown. The grain boundaries are widely separated. Some of the particles could be observed in the micrograph to be fragmented. The failure mode here was that of brittleness. These second-phase particles created a region of weakness and stress within the aluminium matrix. Under applied stress such as used in the test, an unexpected failure could occur. The EDS analysis of the particles in Fig. 10, presented in Fig. 10. The peaks show the presence of copper with the constituent element composition of 19.16%, and oxygen, 5.07% in addition to the base aluminium.

Fig. 6. Failed surface of as-received tested aluminium wire.

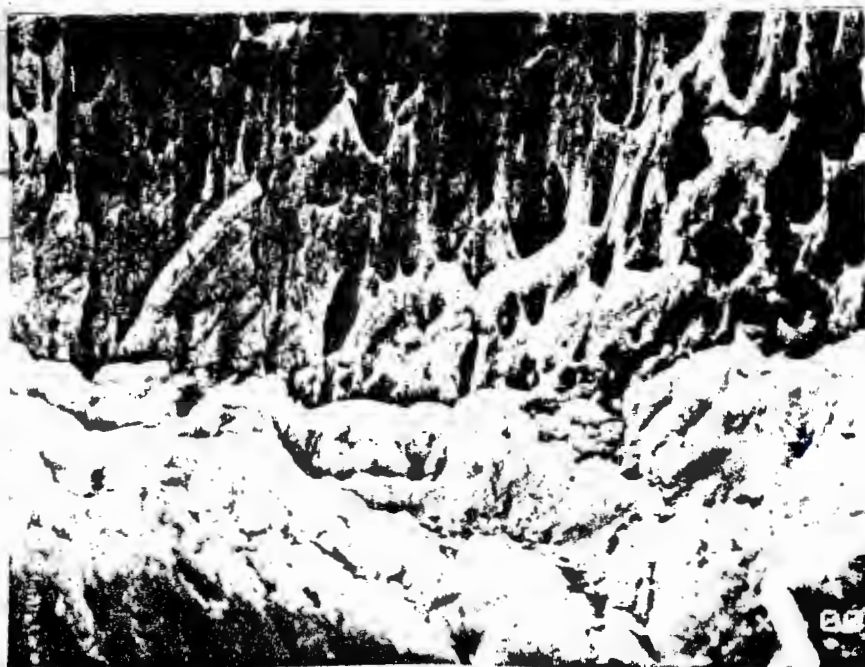
Fig. 7. Edge and near the edge feature of the failed sample (from Fig. 6)

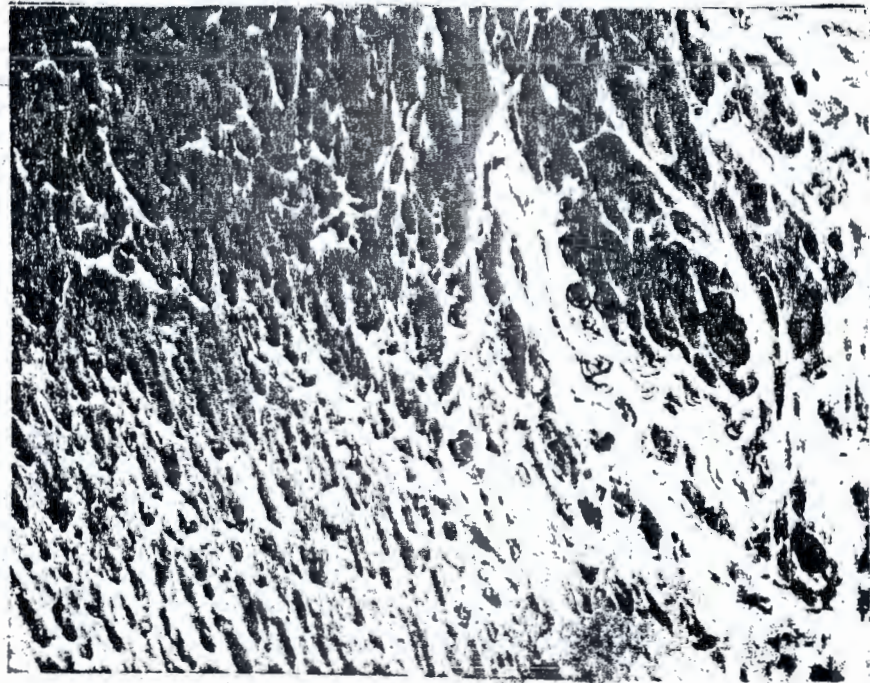
Fig. 8. Failed surface feature inside and near the edge of the open crack.

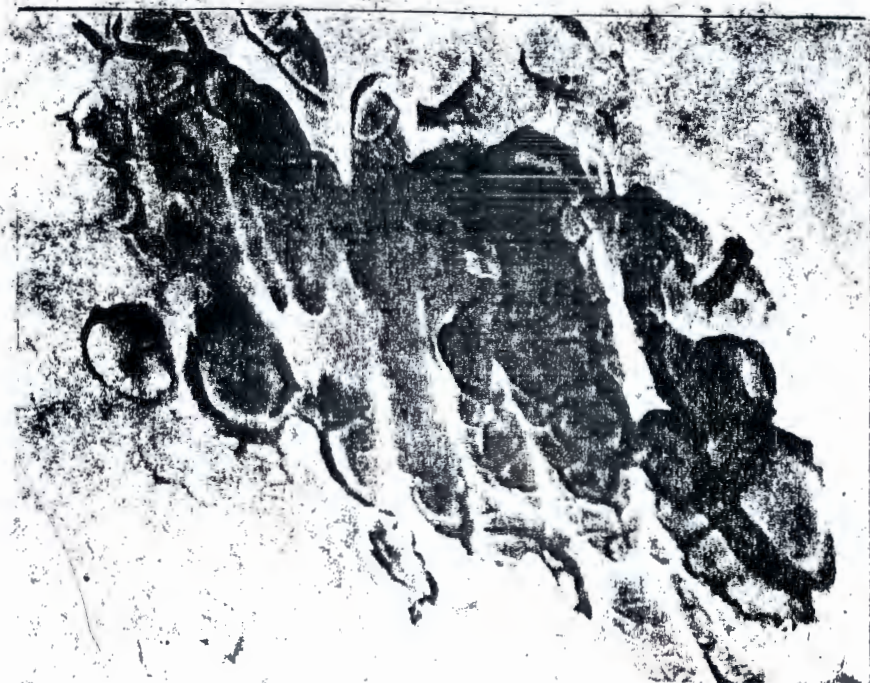
Fig. 9. Second phase particles as in Fig. 8. at higher magnification (4000 x).

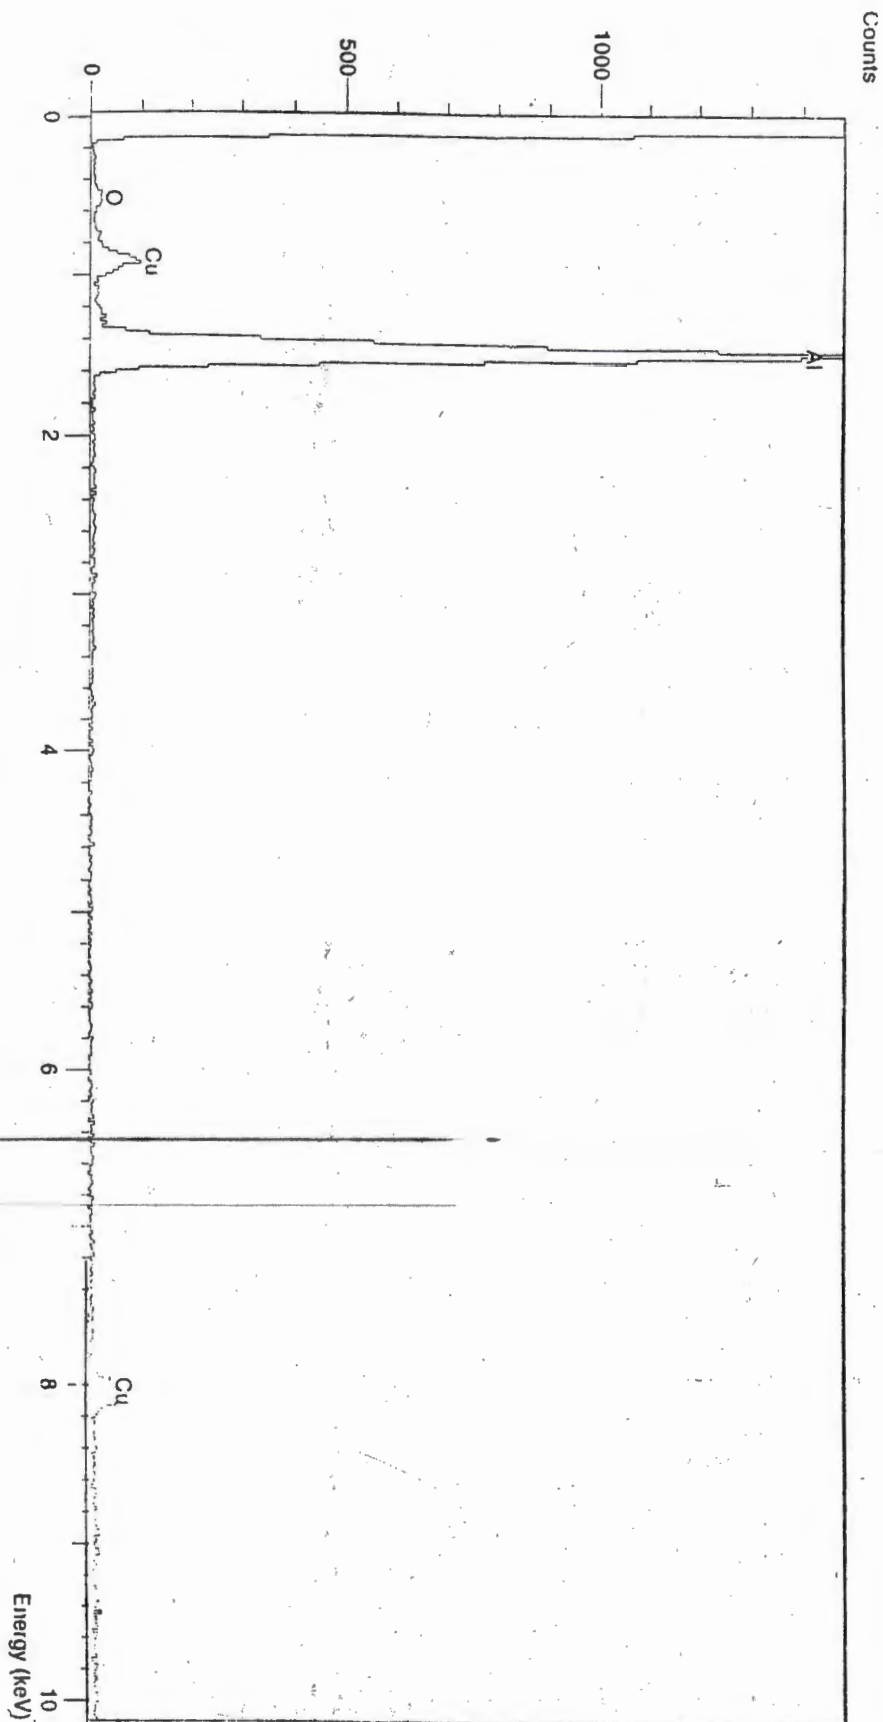
Fig. 10. EDS analysis of second phase particles in Fig. 9

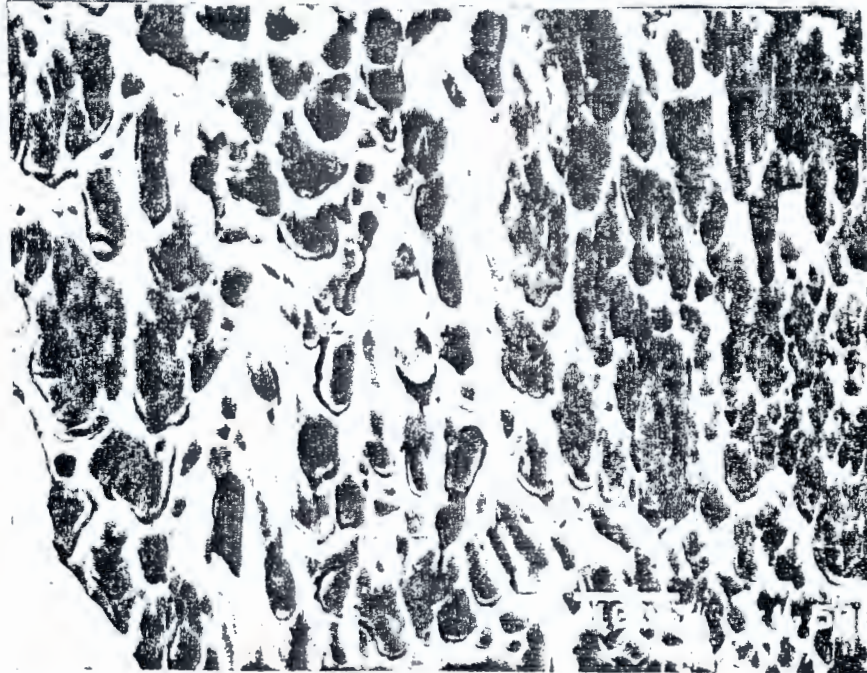
Fig. 11 shows the SEM micrograph mode of failure at the edge of the crack in Fig. 6. A higher magnification of Fig. 11 (4000 x) is presented in Fig. 12. The observed second phase particles here as described earlier. The striking difference, however, is the dark particle within the grains and failure matrix. An analysis of the dark particle, Fig. 13, (2000 x) the EDS, confirms the presence of iron (Fe), the constituent composition which amounts to 1.90%. The presence of oxygen at 7.94% also confirms the grains to be alumina. It can thus be inferred that the aluminium matrix consists of alumina, which also contains iron. The overall effect, therefore, will be that of weakening the aluminium structure, raising a fine stress, and hence rendering it susceptible to the stress cracking failure under test.

Fig. 11. Surface feature of failed samples as in Fig. 6 near the edge of crack.

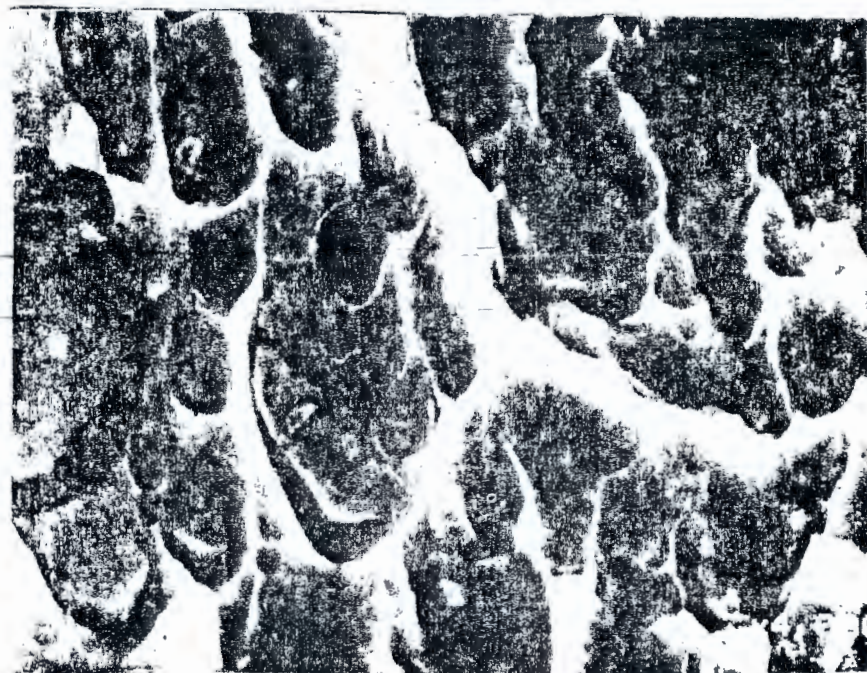
Fig. 12. Surface feature as in Fig. 11 but at a higher magnification showing second phase particles within the matrix.

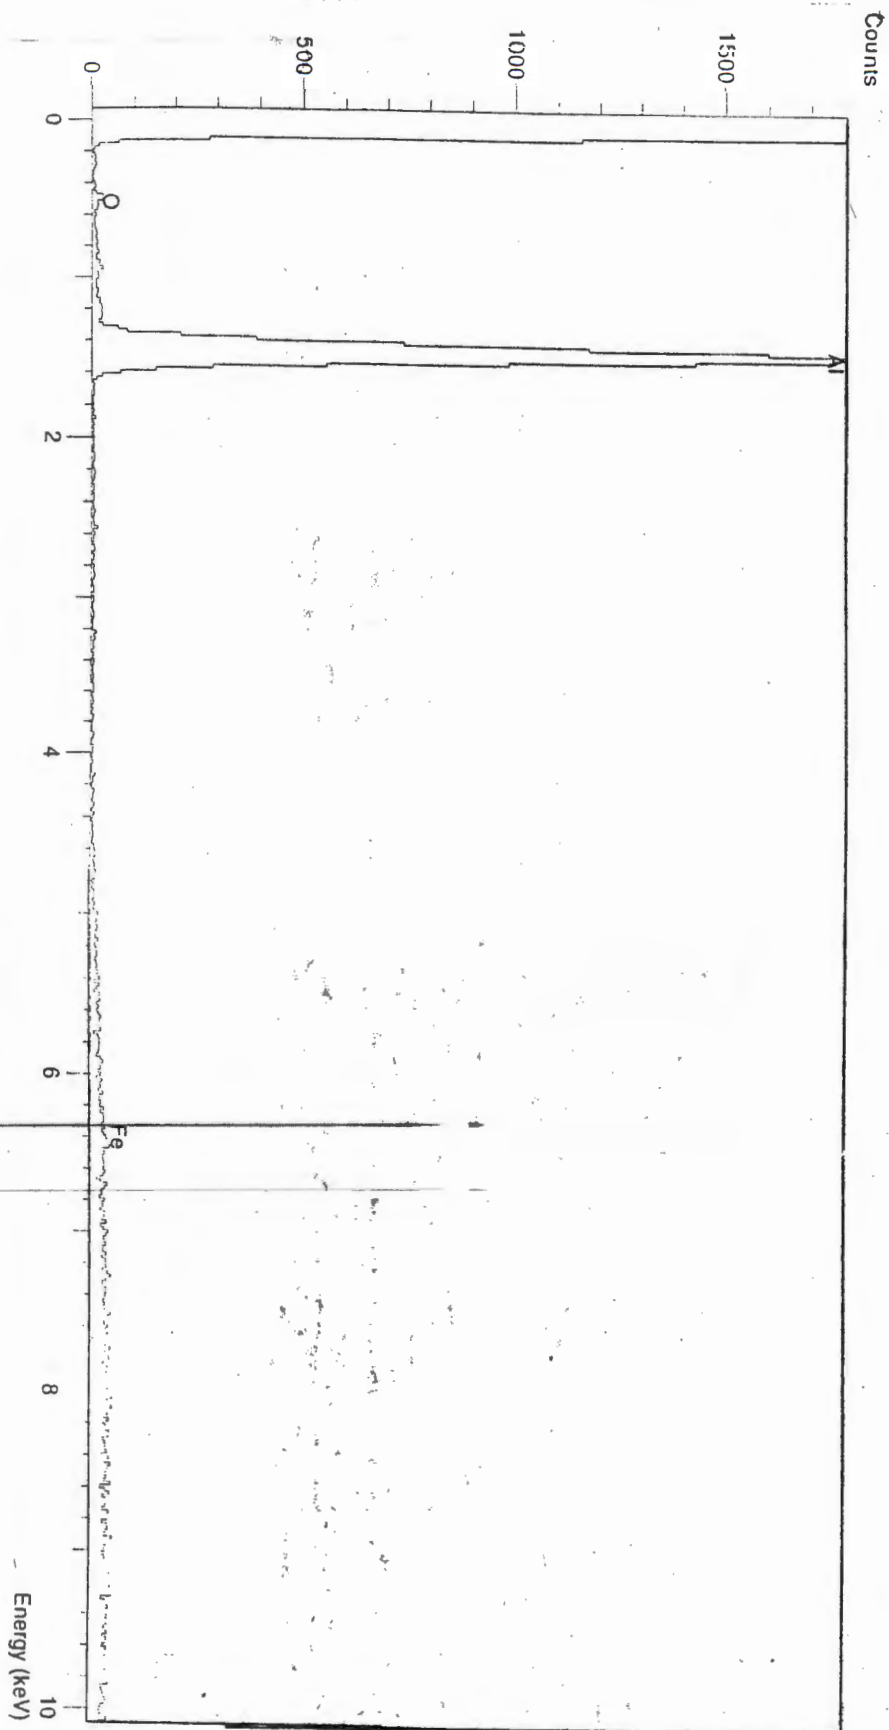
Fig. 13. EDS analysis of dark substance at the center of a large particle in Fig. 12

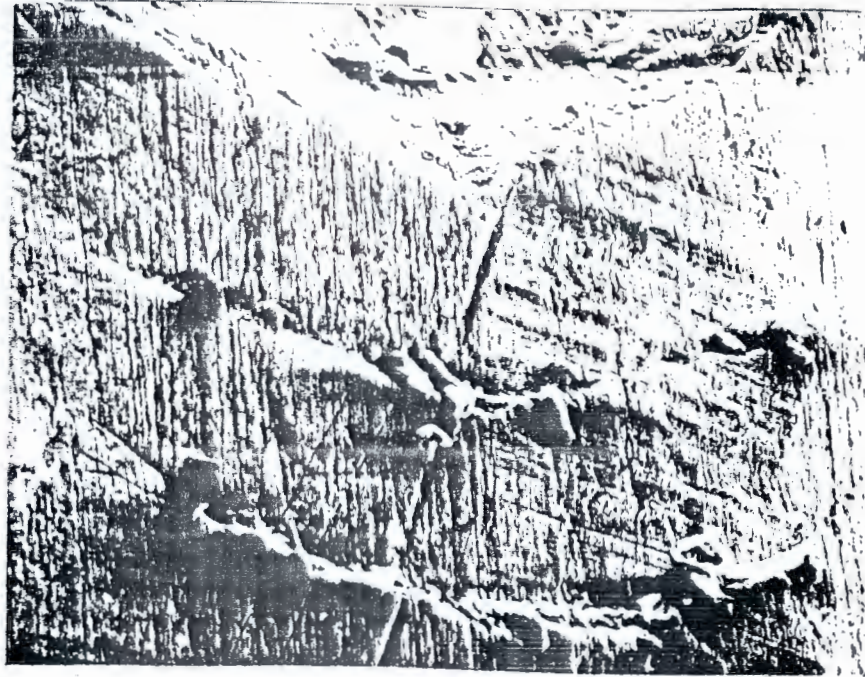
The graph presented in Fig. 14, is the failed surface and the welding crack steps that led to the failure. The only striking things examined are the particles that were located on the crack steps. The EDS analysis of a representative particle is presented in Fig. 16. It consisted of various chemical constituents which include C, O, Cu and Ca. These particles are known to be detrimental to the desired ductility of aluminium particularly when in compound form such as observed in this aluminium wire with the second phase particles.

Fig. 14. Failed surface and crack defect steps leading to failure.

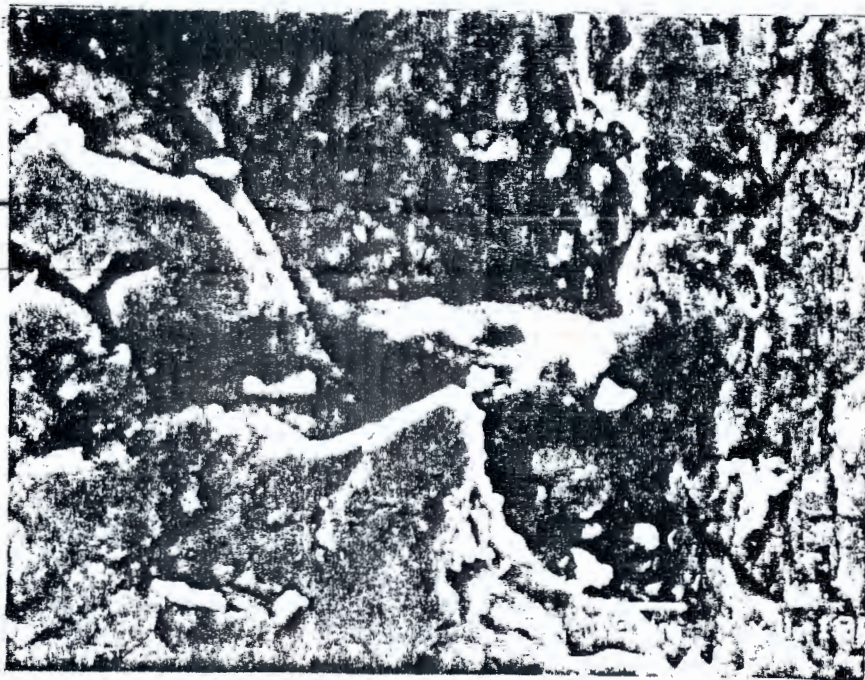
under test is that of an irregular shallow pit-like corrosive degradation in the vicinity of the failed portion. This feature is presented in Fig. 15. The EDS analysis made of the pit confirmed the presence of C, O, Na, Cl, K and Al (Fig. 17). At another site of the pit, Fig. 18, the presence of Si, O, and C are confirmed in addition to Al. This phenomenon is an evidence of corrosive degradation that resulted due to the long-time exposure of the aluminium wire in storage, to the atmosphere laden with sodium chloride contained in the atmospheric moisture. While the presence of chloride ion is recognized here, it is not considered strong enough to be the cause or major cause of the failure of the tested metal. It could, however, make a contribution to the failure, especially in the region that has already been weakened by the second phase particle impurities such as observed in this failure analysis. While the presence of oxygen can be associated with alumina, the high percentage of carbon present can be associated with aluminium carbide. The presence of these elements and Si, are harmful to the mechanical strength of the metal.

Fig. 15. Irregular pit-like formation on the aluminium wire sample of the Failed surface.

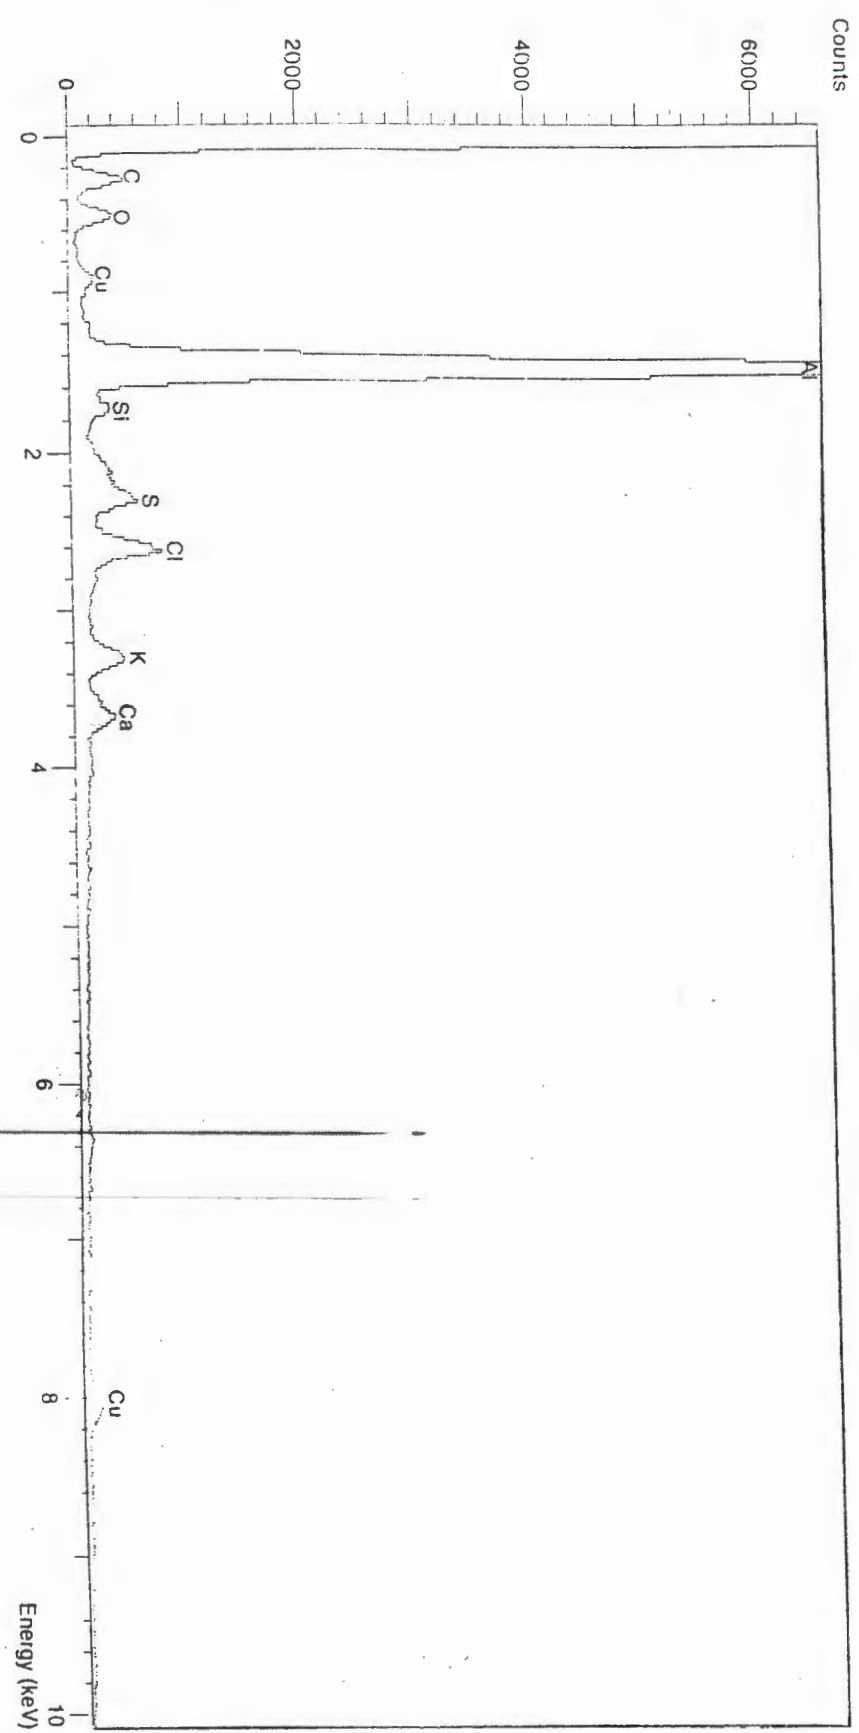
Fig. 16. EDS analysis of a particle on cracked surface defect in Fig. 14

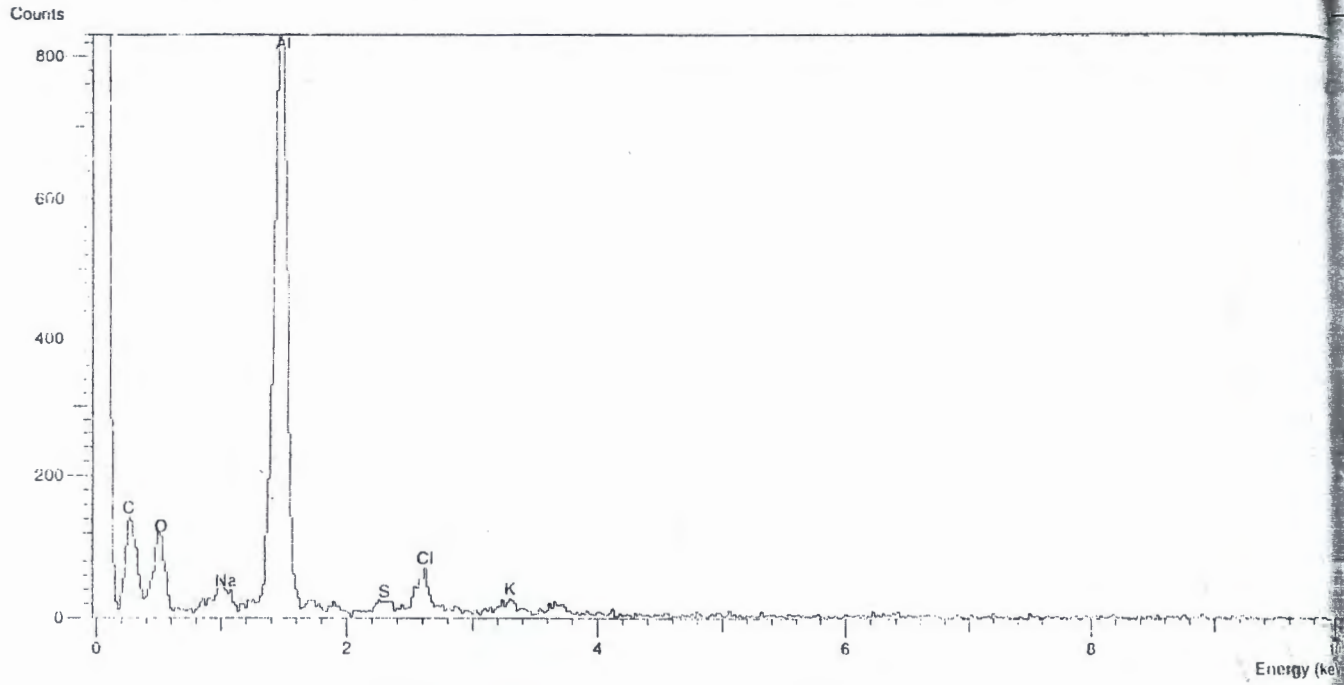
Fig.17. EDS analysis of the corroded pit-like formation in Fig. 15

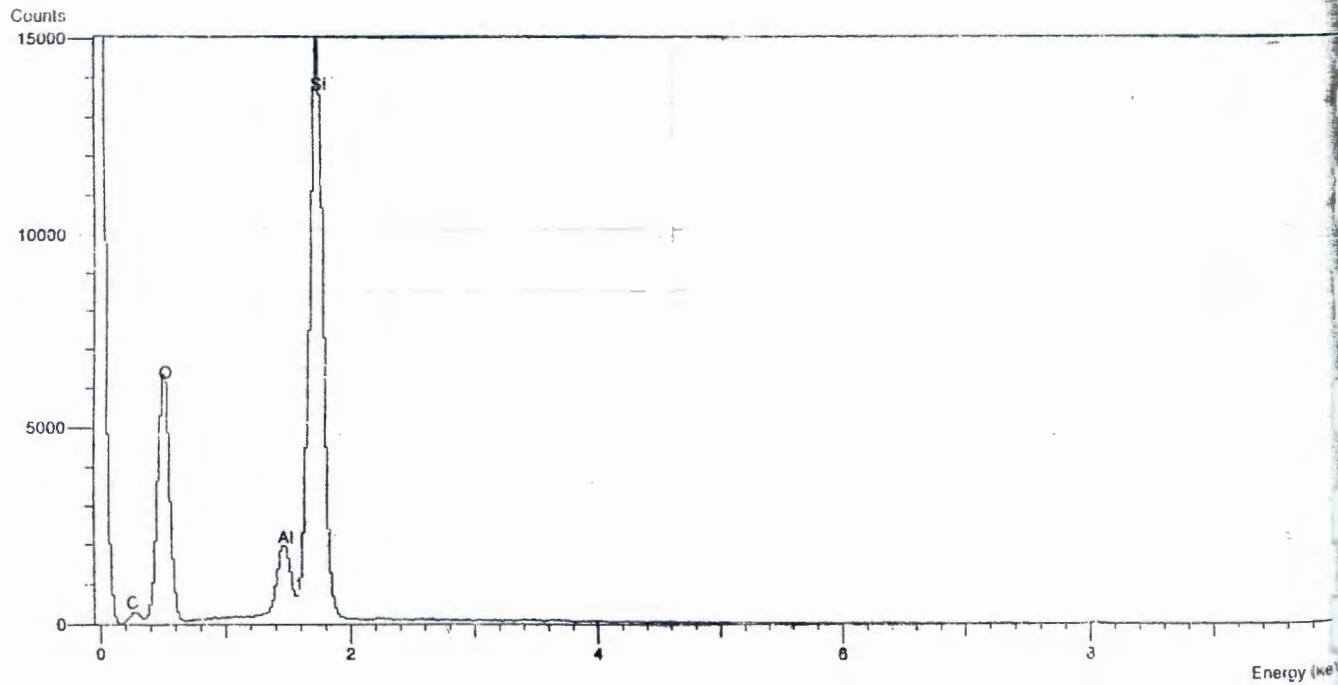
Fig.18. EDS analysis of a particle inside the corrosion pit in Fig. 15

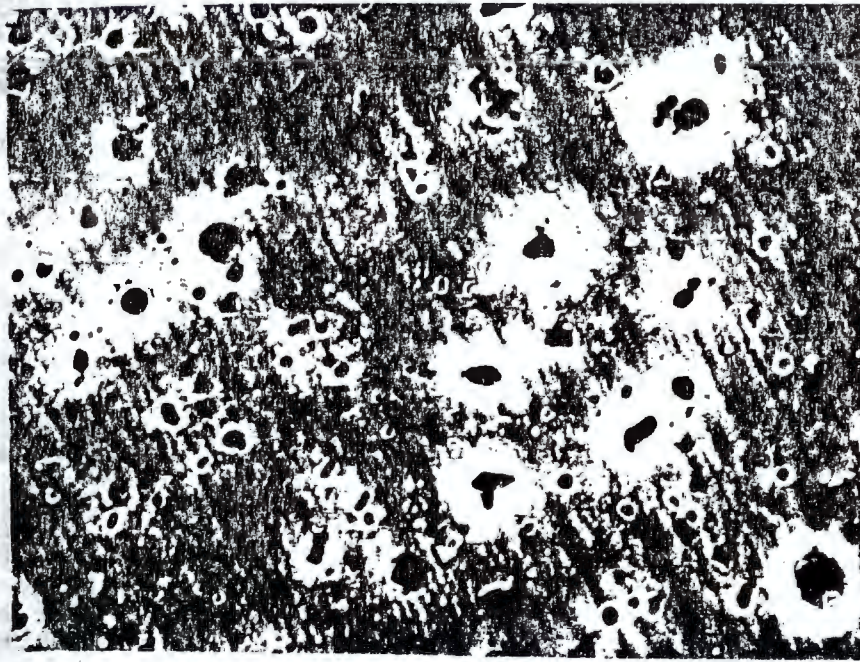
The purity of the 1120 aluminium wire (99.50%), rendered the metallographic studies difficult. It did not respond well to all the etchants used. However, the etched surface obtained is shown in Fig.19. It contained dark patches and no grain boundary was discernible in spite of the high magnification of the

Fig. 19 Etched surface of the failed aluminium wire sample.

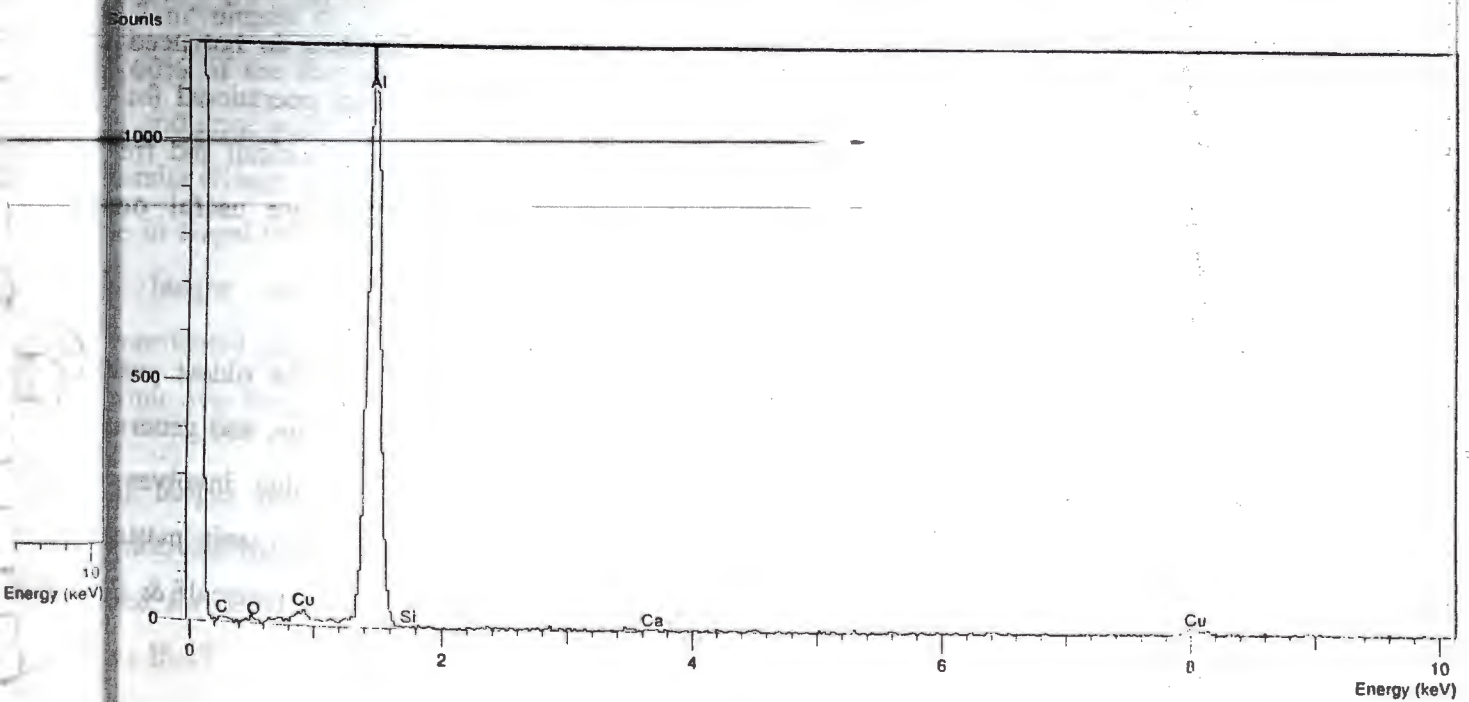
SEM (1,600 x) used. The EDS analysis of the dark patches, Fig. 20, shows it to contain Cu, Si, C, O, and little Ca. The presence of these elements is in agreement with what was obtained when the surface corrosion pit and some particles were analysed by the EDS.

Fig. 20 . EDS analysis of the black patches on the etched surface of aluminium sample as in Fig. 19
