PITTING CORROSION SUSCEPTIBILITY OF SUPER AUSTENITIC STAINLESS STEELS IN SEA WATER

C.A. Loto

ABSTRACT

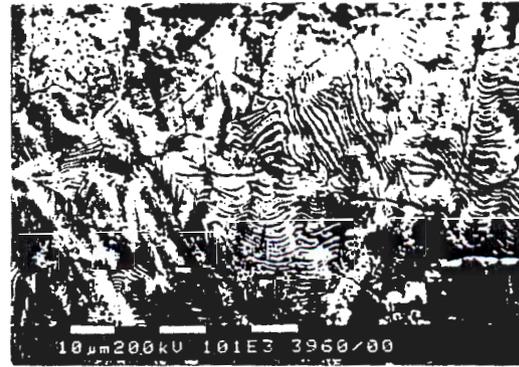
FIG. 1

The as-received tubes surface, for example as in Figs. 1(a) and 2(a) were rough with etch-like appearance. The grain boundaries were microscopically visible in some cases. A comparison of some of the tubes surface before and after the test shows some distinct difference with respect to changes in surface feature(s), Fig. 1(b) and 2(b). In particular, sites of local corrosion attack could be located in the tested 316L alloy.

- 1(a) S.E.M. Micrograph of the as-received inner surface of AL6XN (NO8367) alloy tube.
- (b) S.E.M. Micrograph of the corroded inner surface of AL6XN alloy exposed to sea water environment.
- 2(a) S.E.M. Micrograph of the as-received inner surface of 316L (S316603) alloy tube.
- (b) S.E.M. Micrograph of the corroded inner surface of 316L alloy tube.
3. Optical microscope photograph of the split and cleaned tested alloy tubes exposed to sea water in a specially designed test rig.
- 4(a&b) S.E.M. micrographs of two different features of microscopic corrosion pits on the inner surface of AL6XN (NO8367) alloy tube exposed to sea

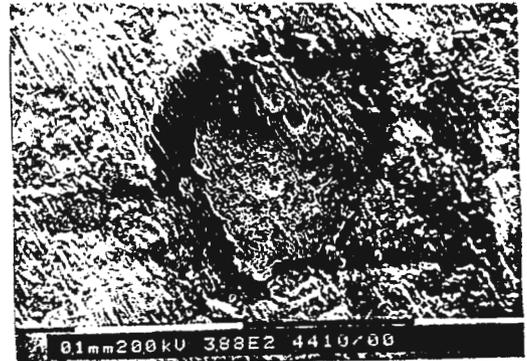
FIG. 6.

5. S.E.M. micrograph of a local corrosion attack site on inner surface of 1925HMO (NO8925) alloy tube exposed to sea water in the test rig.
6. S.E.M. micrograph of the inner surface of the tested 254SMO (S31254) alloy tube showing a ring form of local corrosion attack.

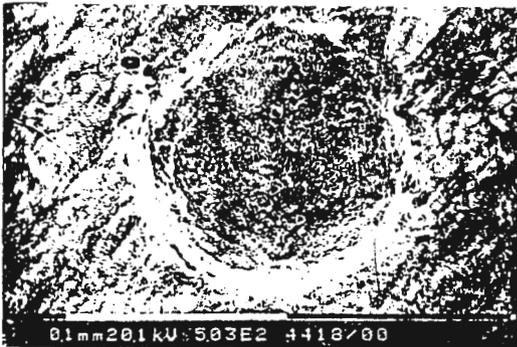
FIG. 4.

All the steel alloys corroded slightly with very little microscopic pits in the steam outlet portion. Quite a number of microscopic pits or sites of local corrosion attack were obtained along the weldment of the tubes made with AL6XN (NO8367) alloy in all the test runs as exemplified in Fig. 4. The 1925 HMO (NO8925) steel alloy was very resistant to pitting corrosion, though it suffered under-deposit corrosion in the steam chamber portion. The 254 SMO steel alloy was also very resistant to pitting corrosion. A ring form of local corrosion attack was, however, once obtained in its outlet portion, Fig. 6. Though, not a super austenitic stainless steel due to its relatively lower Mo content, the 316L (S31603) alloy was used along with the other steel alloys for comparison purpose. It failed visibly in all the test runs. In many cases, a cluster of pitting corrosion was observed; the pits were fairly deep penetrating and some times, perforation(s) occurred. An example of a microscopic pit observed in this steel is presented in Fig. 7. The corrosion pits observed in all the super austenitic stainless steels were not deep penetrating. They were shallow, flat, and some roundish.

All the steel alloys were relatively very corrosion resistant in sea water except the 316L which has lower Mo content. Corrosion pits could not be identified distinctly in 904L and 254 SMO alloys. The AL6XN alloy had microscopic corrosion pits, all along the weldment. This could be due to welding defects during fabrication. Though no deep penetration of any of the pits could be observed, the long term effect is very difficult to determine. However, the pitting condition did not seem to pose any danger during a short term use.

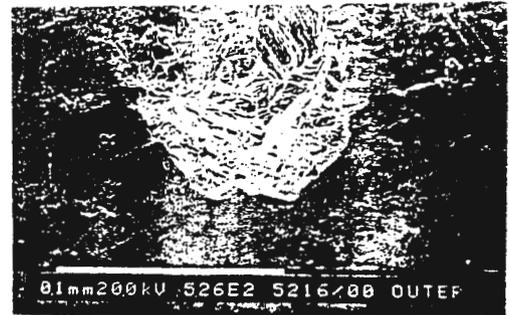
FIG. 7.

7. S.E.M. micrograph of the microscopic pit on the inner surface of 316L alloy tube used exposed to sea water in the test rig.
8. S.E.M. micrograph of the biofouling/biological materials in the outlet portion of the inner surface of 904L (NO8904) alloy tube, within which bacteria and other microorganisms were located.

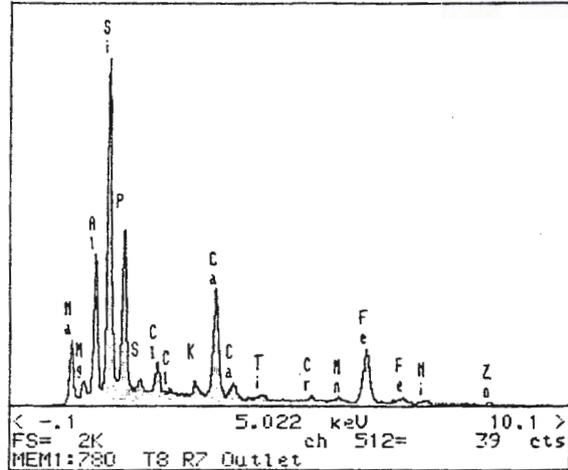
FIG. 12

The EDAX analysis, Fig. 12, confirms the presence of different chemical elements and these include Si, P, Ca, Na in addition to Cr, Mo, Ni etc. Sulphur could not be detected distinctly as it shares the same signal with Mo and it is also being marred by the gold (Au) used in locating the specimen surface. The effects of these elements are not clearly known. While the chloride ions (Cl⁻) from the sea water would make a significant contribution towards the depassivation of the alloys' protective film, others such as Cr, Ni, Mo, and Si were presumably giving protective effects of stabilising the alloys passive film, and at the same time, preventing the biofilm's growth that could lead to increased corrosion.

12. EDAX analysis of the biofilm in the outlet portion of 316L (S31603) alloy tube.
13. X-ray diffraction spectroscopy (XRD) analysis of the biofilm obtained from the outlet portion of AL6XN (S08367) alloy tube.

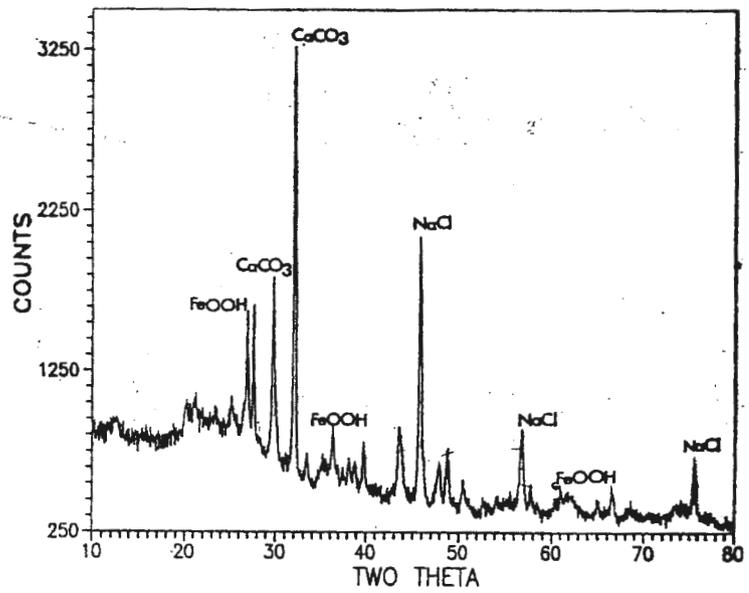
The X-ray diffraction analysis, Fig. 13 confirms the presence of CaCO₃, NaCl and FeOOH in the outlet biofilm. Since no significant corrosion was observed in the alloys except the 316L, the effects of these chemical compounds on the corrosion resistance or pitting corrosion susceptibility of these alloys could not be ascertained.
