FAILURE ANALYSIS

# Microstructural Analysis of Ethylene Furnace Steel Alloy Tubes

C.A. LOTO, *Tshwane University of Technology, Pretoria, South Africa*

*Several radiant tubes of an ethylene ( $C_2H_4$ ) furnace at a petrochemical plant were analyzed after failure. Experimental results suggest that the failures were caused by exposure of the tubes to excessive temperature during service. It was recommended that the furnace temperature be closely controlled to avoid overheating the tubes.*

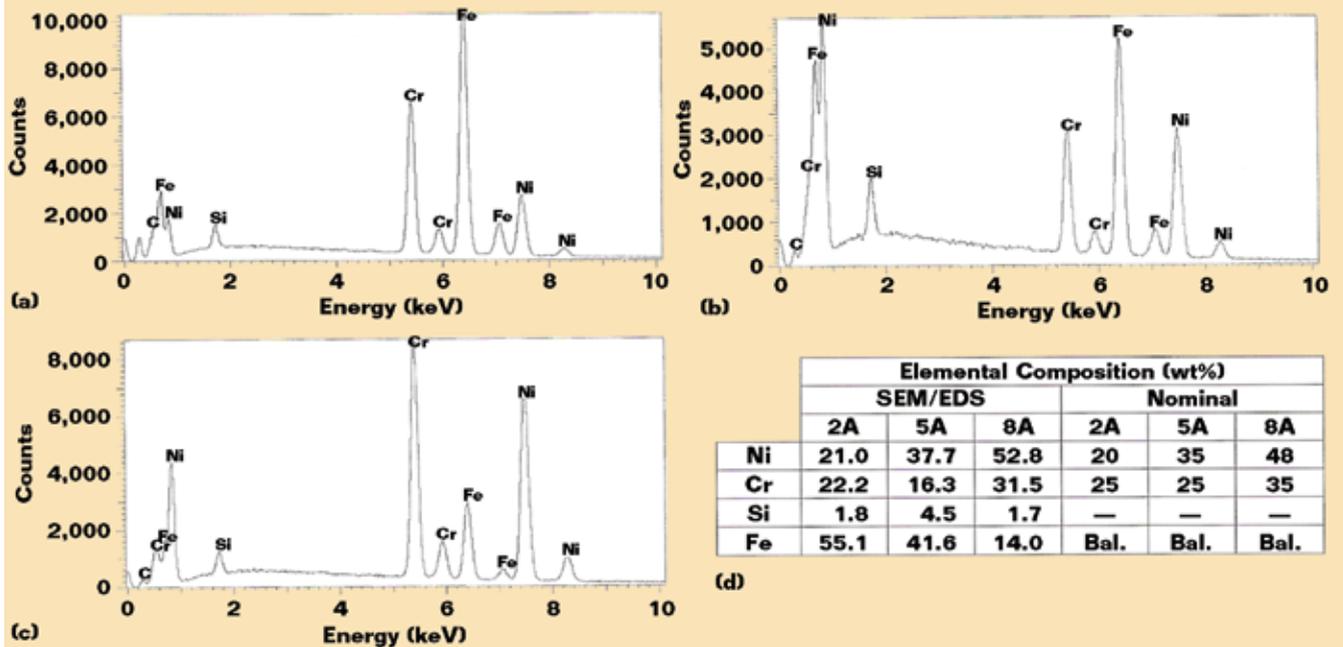
FIGURE 1

EDS spectra derived from uncarburized austenite region for material verification of Tubes (a) 2, (b) 5, and (c) 8. (d) Results of the semi-quantitative analysis of above spectra along with the nominal compositions of the selected alloys.

analyses of the tube samples. Representative EDS spectra and composition analysis for each tube material and their nominal compositions are presented in Figures 1(a) through (d).

There was a difference observed in the composition between the nominal and measured values as indicated by the representative EDS spectra and composition analysis for each tube material. This observation was not, however, unexpected due to the exposure of the tubes at elevated temperature(s) in service. This exposure caused the precipitation of M-carbides (where M is Cr, Nb) within the matrix and at the grain boundaries, thus altering the starting composition of the matrix.

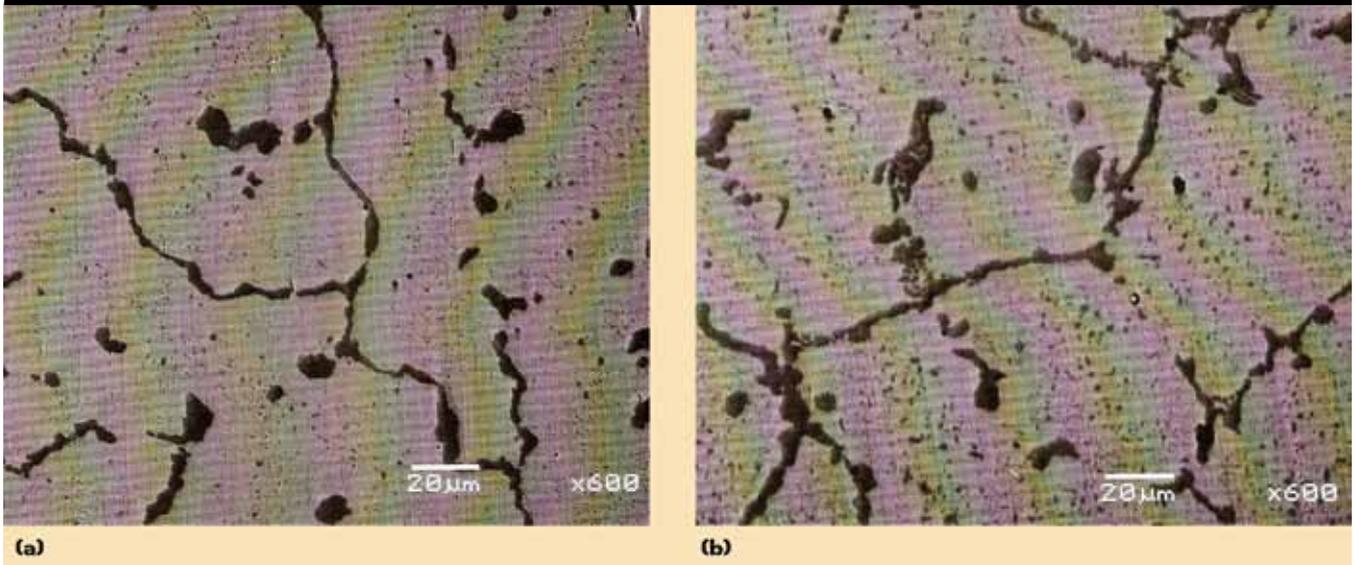
FIGURE 2

Secondary electron SEM image obtained from (a) uncarburized and (b) carburized regions of Tube 2.

Microstructure of the uncarburized area of a representative furnace tube sample, particularly those designated as Tubes 1 and 2 with a nominal composition of 25Cr-20Ni-Fe (HK 40), was determined. This is presented as a secondary electron SEM image in Figure 2(a). These tube materials consist of relatively large equiaxed grains with precipitation at the grain boundaries. EDS showed that the matrix was comprised of austenite (Fe-Cr-Ni solid solution). The grain boundary consisted of a Cr-rich carbide. The presence of coarse and fine particles was also observed at the austenite matrix.

Figure 2(b) shows the microstructure of a carburized zone of the sample mentioned above. It is apparent here that the C-rich carbide precipitation present within the austenite grains are coarser in size when compared with those in the uncarburized zone.

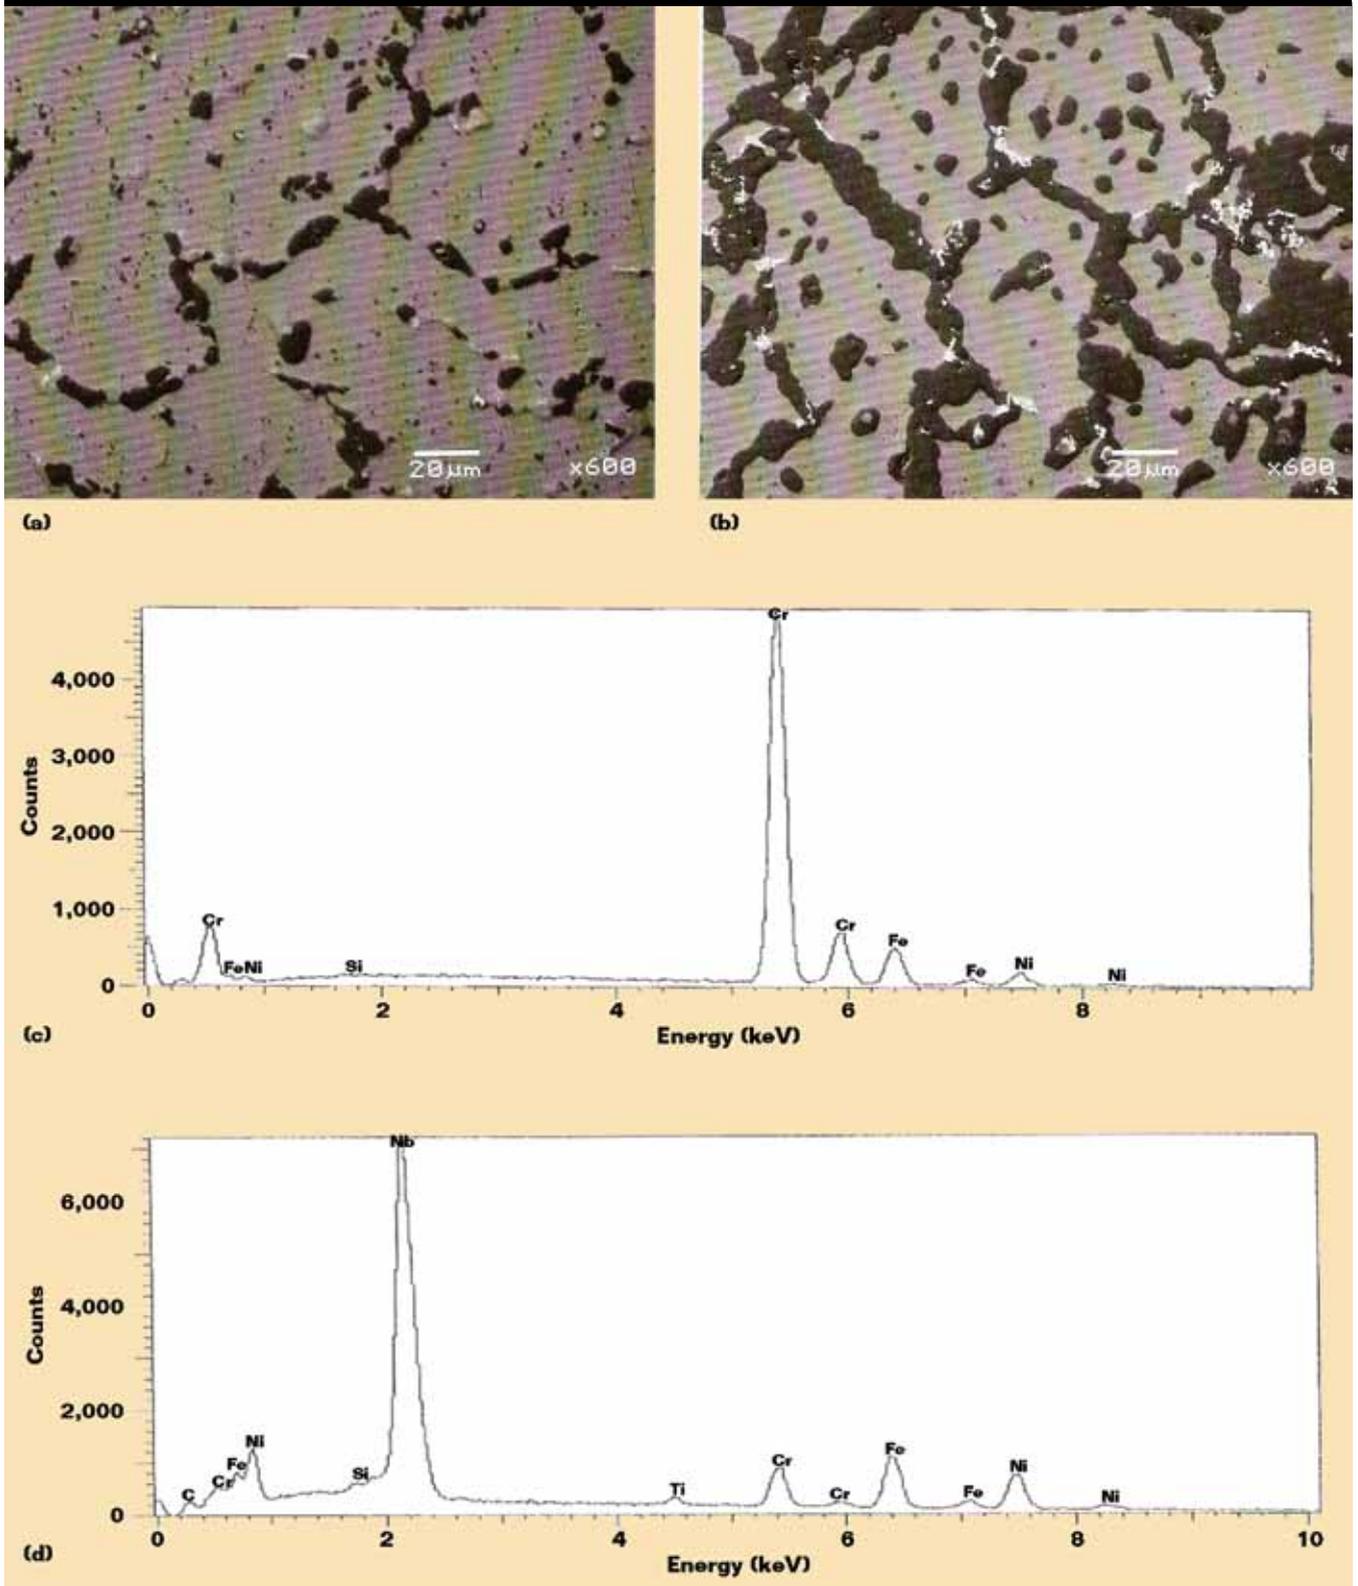
FIGURE 3

A typical microstructure obtained from an uncarburized region of the tube material of Tubes 3 to 6 (with the nominal composition of 25Cr-35Ni-Fe) is presented in the secondary electron SEM image of Figure 3(a). The carbide precipitation appears relatively coarse both at the austenite grain boundaries and within the matrix itself when compared to the uncarburized region of the tube material of Figure 2(a) (Tubes 1 and 2). This observation was corroborated by the EDS analysis where Cr concentration was determined to be 13 wt% at various regions within the austenite. The carburized region from the same sample shows a high degree of carbide precipitation at the grain boundaries and the appearance of blocky carbide particles in the matrix, as shown by the SEM image in Figure

3(b). The grain boundary precipitate was predominantly comprised of Cr, as shown by the EDS spectrum in Figure 3(c). This exhibited a continuous network. The white precipitates adjacent to the grain boundaries are Nb-rich, as shown by the EDS spectrum in Figure 3(d).

In Tubes 3 to 6, the carbide precipitation appears relatively coarse, both at the austenite grain boundaries and within the matrix. The depletion of Cr within the matrix indicates a tendency of Cr to diffuse and form Cr-rich carbides at the austenite grain boundaries and/or coarse pre-existing carbides within the austenite. Diffusion of Cr is enhanced at an elevated temperature. The higher the temperature, the greater the carburized zone and the coarser the carbide precipitates.

Tube 5: secondary electron SEM image of (a) uncarburized region, (b) carburized region, and EDS spectrum from (c) grain boundary precipitate showing Cr enrichment, and (d) white precipitate showing Nb enrichment.

In the carburized region of the steel alloy tube material samples (Tubes 3 to 6), the white precipitates adjacent to the grain boundaries are Nb-rich, as shown by the EDS spectrum in Figure 3(d). Relatively small additions of Nb to heat-resistant castings can increase their resistance to thermal shock. Furthermore, Nb acts as a carbide stabilizer by forming MC-type carbides, which cause massive carbide precipitation at the grain boundaries.

It is recommended that the furnace temperature be closely controlled to avoid overheating during ethylene production as well as decoking.

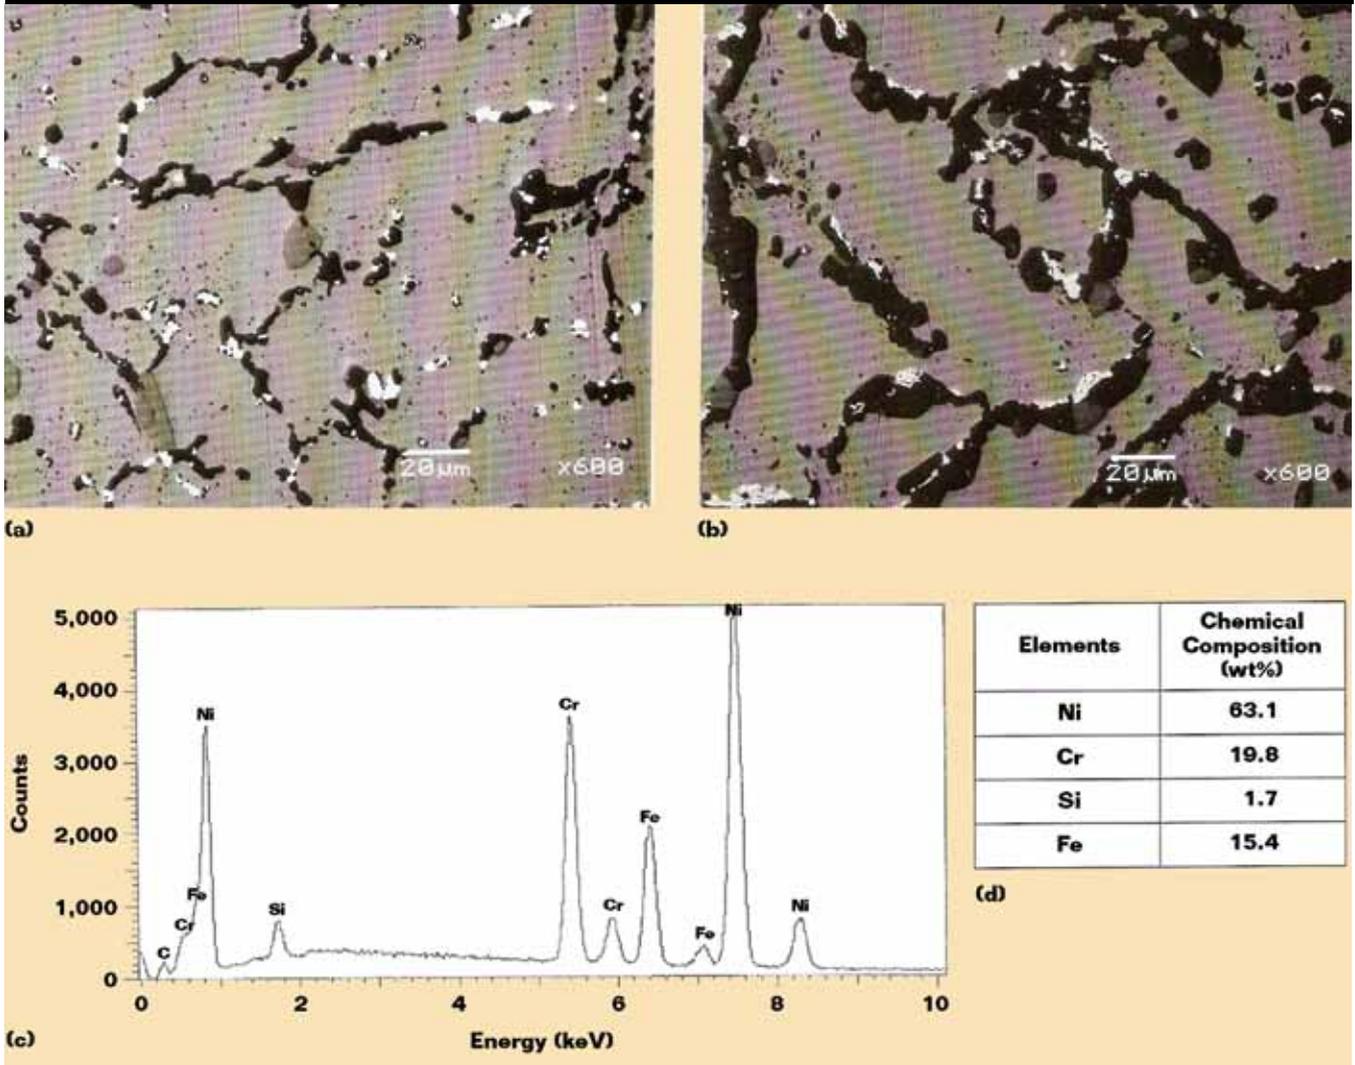
FIGURE 4

Tubes 7 to 9 (with composition of 35Cr-48Ni-Fe) have the highest Cr and Ni% composition when compared to others. Figures 4(a) and (b), respectively, show typical microstructures obtained from the uncarburized and carburized regions of the tube material. The microstructures are comprised of dark Cr-rich and white Nb-rich precipitates along with grayish precipitates. These are comparatively richer in Ni as shown in the EDS spectrum and elemental composition (Figures 4[c] and [d], respectively).

Tube 8: secondary electron SEM image of (a) uncarburized region, (b) carburized region, and EDS spectrum from (c) light gray precipitates showing a large peak of Ni, and (d) elemental composition derived from spectrum.

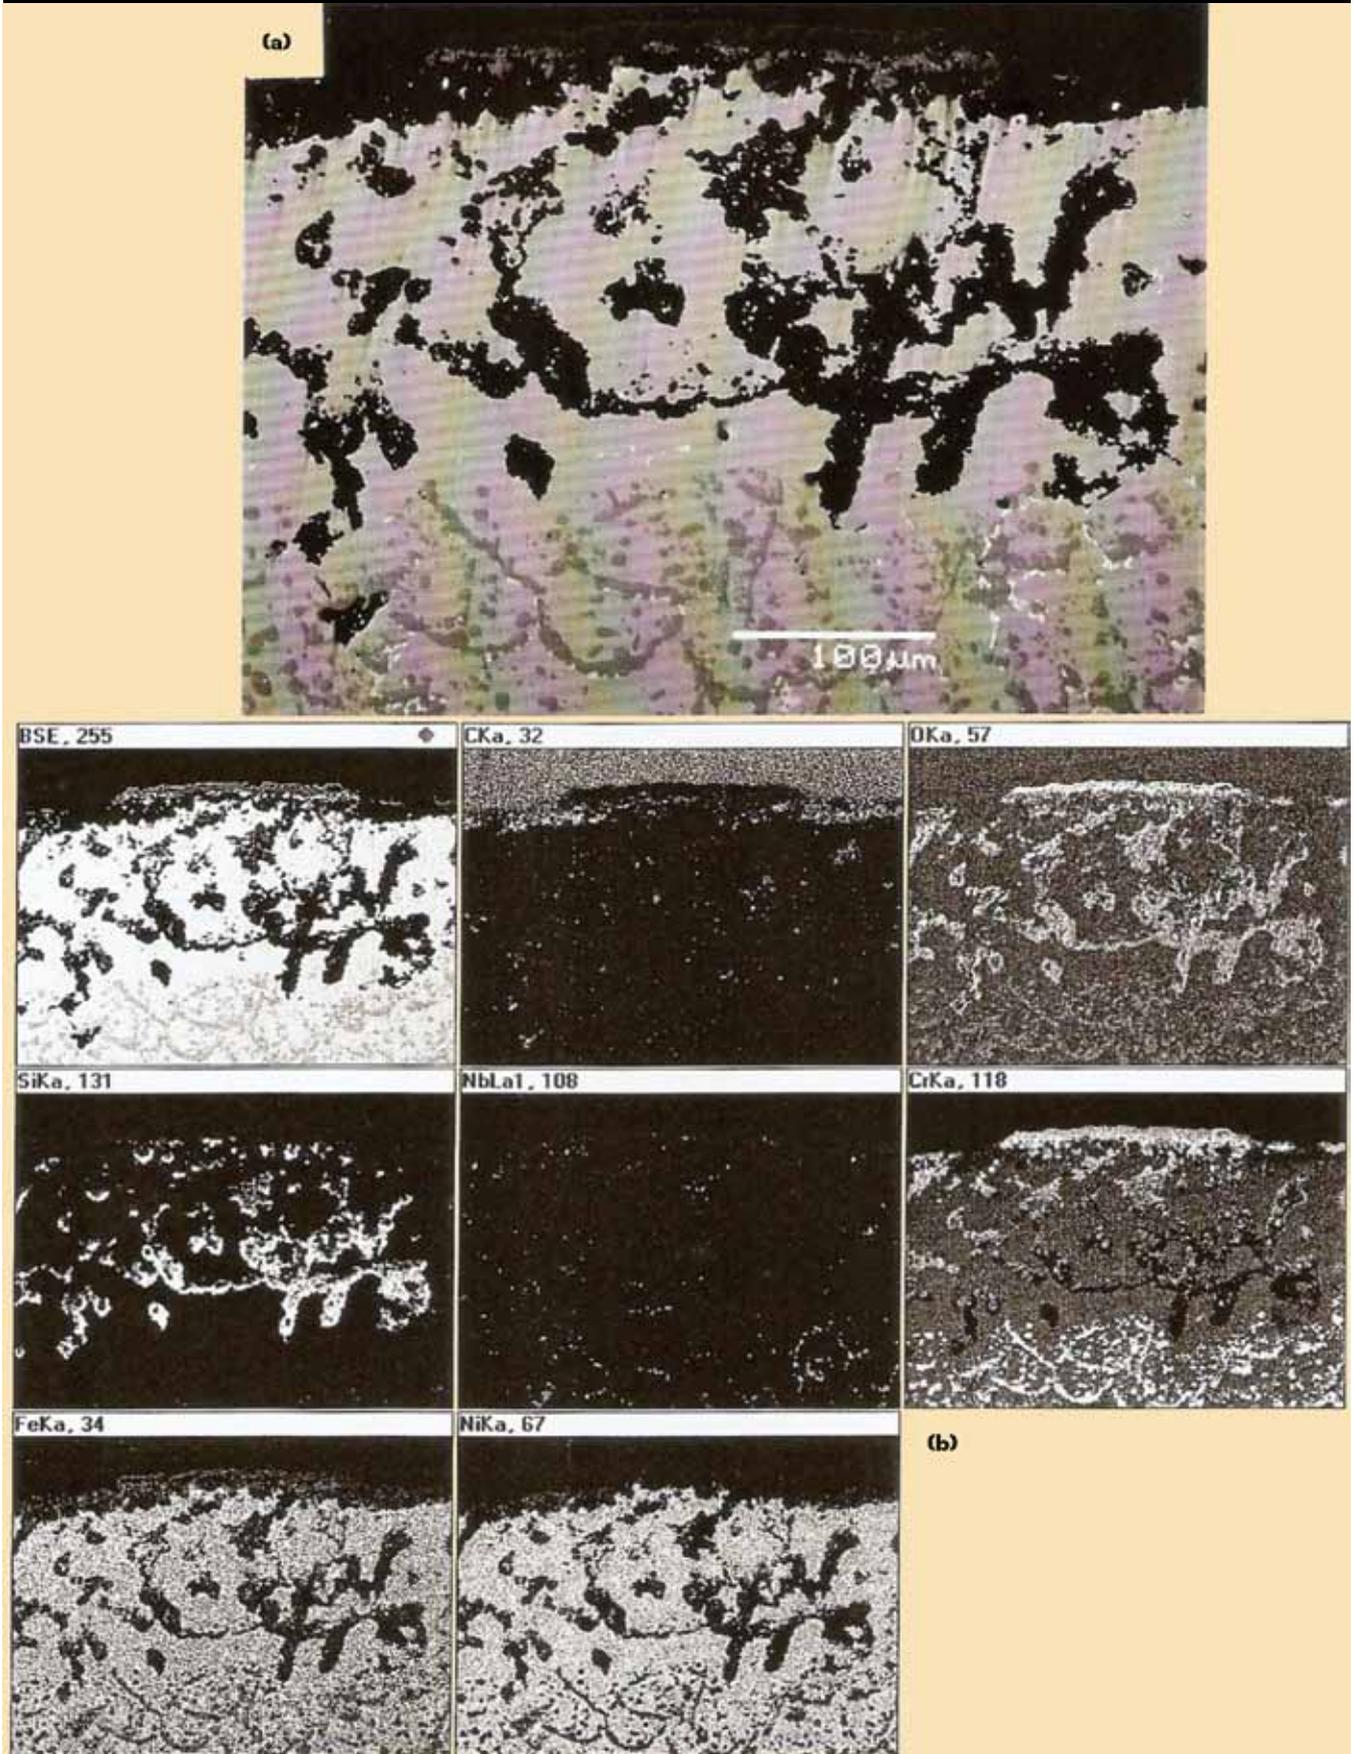
FIGURE 5

Presented in Figure 5(a) is a typical morphology of the scale formed at the internal surface of tubes as shown in the backscattered electron SEM image. An x-ray map shown in Figure 5(b) and the various EDS spectra obtained from the region reveal that the oxide formed at the surface is Cr-rich while Fe and Ni could also be detected in the scale. In addition, Si, and Cr oxide to some extent, were detected at the austenite grain boundaries immediately beneath the alloy surface.

The previously described results obtained from the analysis of the scale formed on the furnace tube materials, as presented in Figures 5(a) and (b), indicate that the alloys were not capable of developing a protective oxide scale. This could be due, in part, to the relatively low oxygen potential in the environment typically encountered in ethylene production. The

(a) Backscattered electron SEM image showing the typical morphology of scale formed at the internal surface of all tube materials and (b) an x-ray map showing the distribution of various elements within the scale and the underlying region.
