FAILURE ANALYSIS

Microstructural Analysis of Ethylene Furnace Steel Alloy Tubes

C.A. LOTO, *Tshwane University of Technology, Pretoria, South Africa*

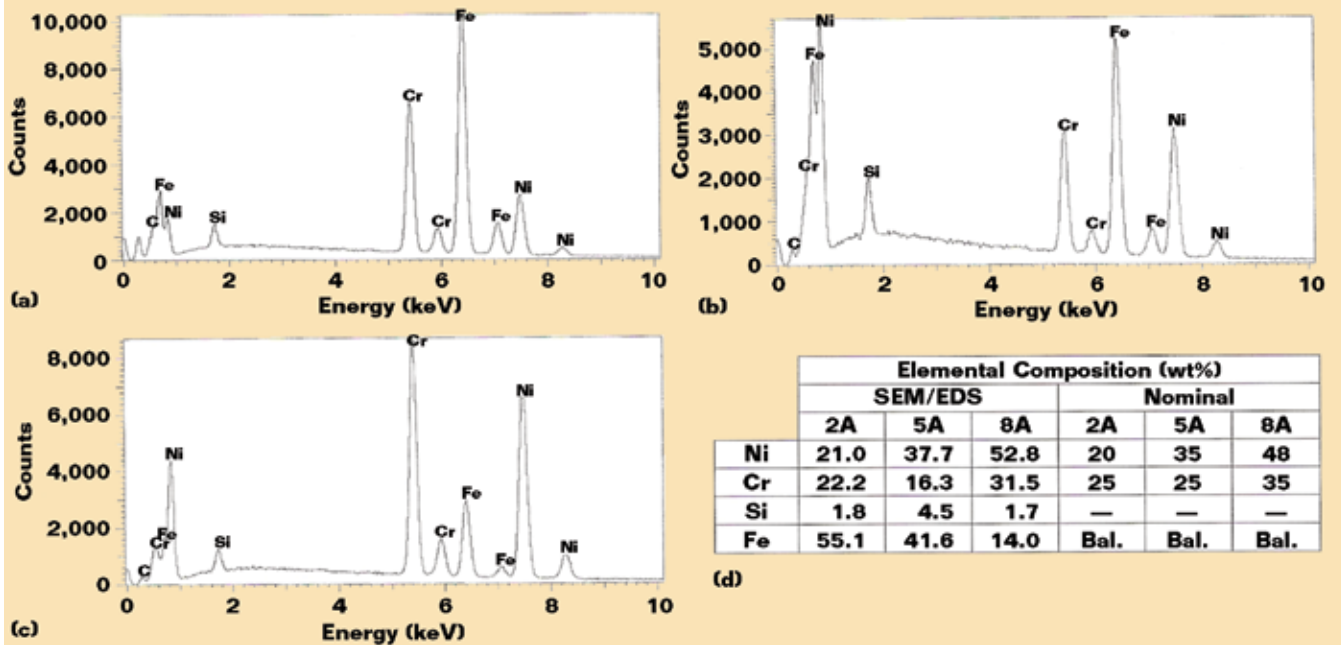
FIGURE 1

EDS spectra derived from uncarburized austenite region for material verification of Tubes (a) 2, (b) 5, and (c) 8. (d) Results of the semi-quantitative analysis of above spectra along with the nominal compositions of the selected alloys.

analyses of the tube samples. Representative EDS spectra and composition analysis for each tube material and their nominal compositions are presented in Figures 1(a) through (d).

There was a difference observed in the composition between the nominal and measured values as indicated by the representative EDS spectra and composition analysis for each tube material. This observation was not, however, unexpected due to the exposure of the tubes at elevated temperature(s) in service. This exposure caused the precipitation of M-carbides (where M is Cr, Nb) within the matrix and at the grain boundaries, thus altering the starting composition of the matrix.

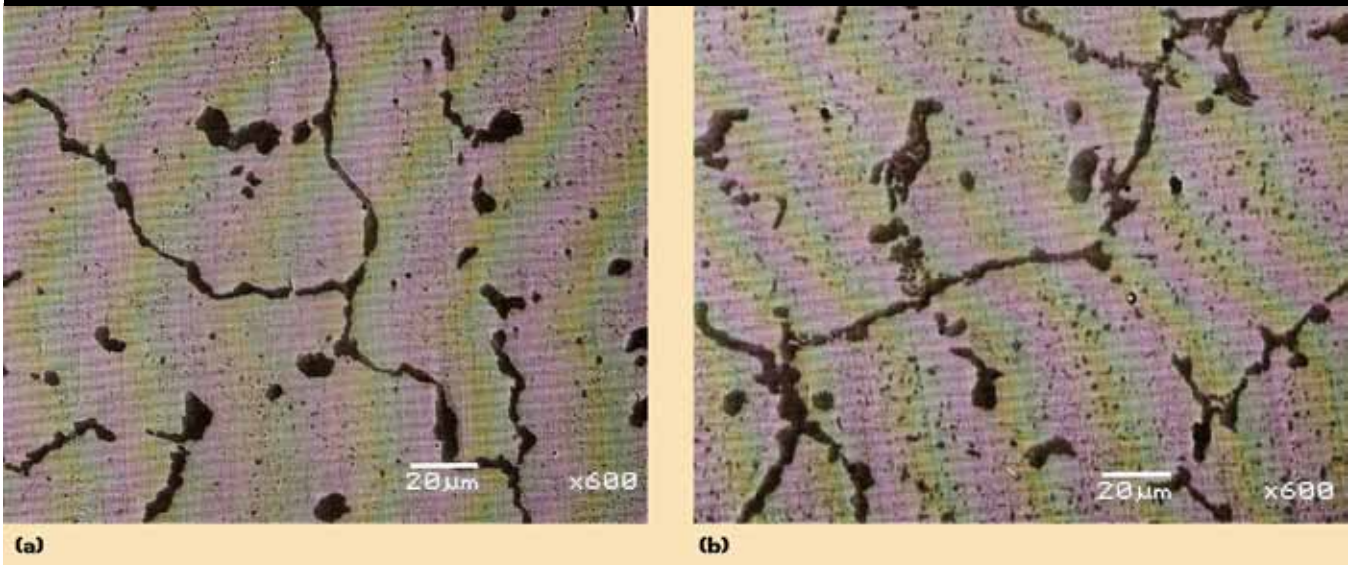
FIGURE 2

Secondary electron SEM image obtained from (a) uncarburized and (b) carburized regions of Tube 2.

Microstructure of the uncarburized area of a representative furnace tube sample, particularly those designated as Tubes 1 and 2 with a nominal composition of 25Cr-20Ni-Fe (HK 40), was determined. This is presented as a secondary electron SEM image in Figure 2(a). These tube materials consist of relatively large equiaxed grains with precipitation at the grain boundaries. EDS showed that the matrix was comprised of austenite (Fe-Cr-Ni solid solution). The grain boundary consisted of a Cr-rich carbide. The presence of coarse and fine particles was also observed at the austenite matrix.

Figure 2(b) shows the microstructure of a carburized zone of the sample mentioned above. It is apparent here that the C-rich carbide precipitation present within the austenite grains are coarser in size when compared with those in the uncarburized zone.

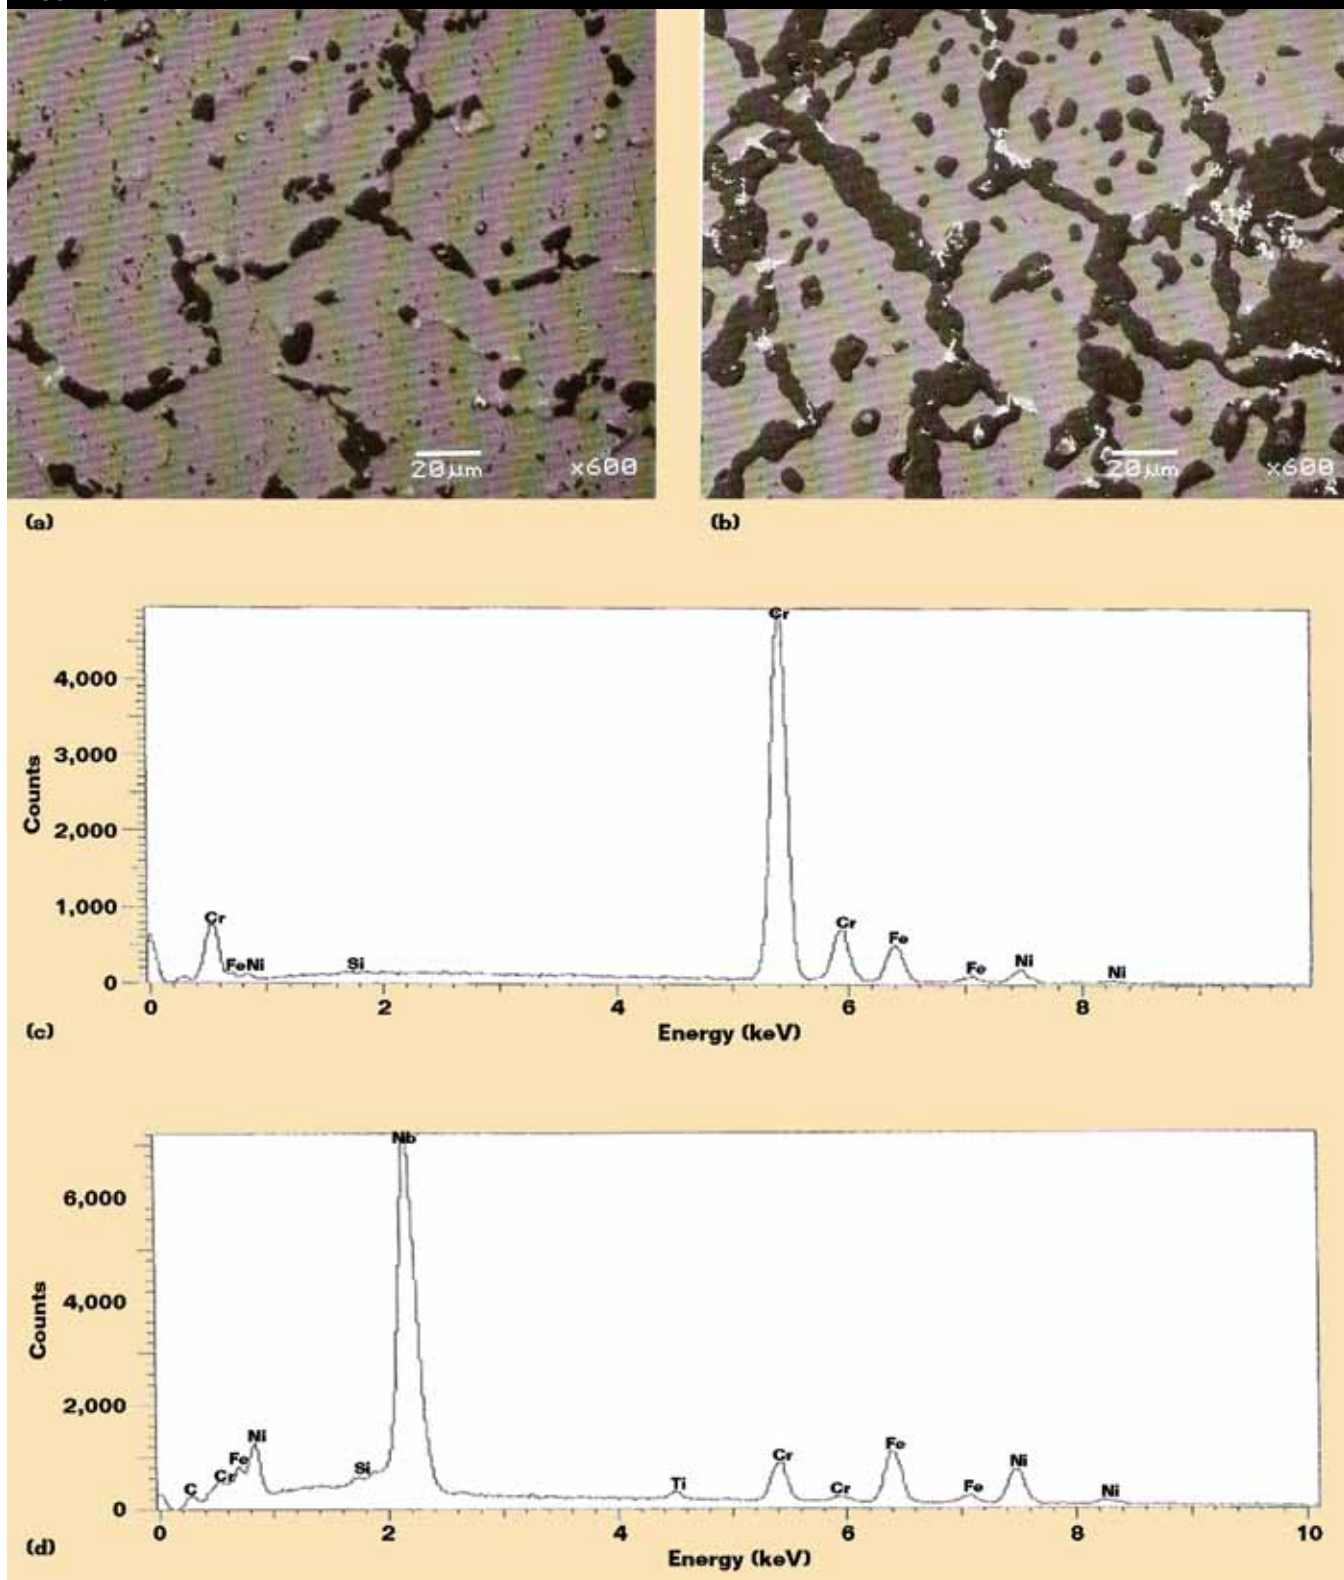
FIGURE 3

A typical microstructure obtained from an uncarburized region of the tube material of Tubes 3 to 6 (with the nominal composition of 25Cr-35Ni-Fe) is presented in the secondary electron SEM image of Figure 3(a). The carbide precipitation appears relatively coarse both at the austenite grain boundaries and within the matrix itself when compared to the uncarburized region of the tube material of Figure 2(a) (Tubes 1 and 2). This observation was corroborated by the EDS analysis where Cr concentration was determined to be 13 wt% at various regions within the austenite. The carburized region from the same sample shows a high degree of carbide precipitation at the grain boundaries and the appearance of blocky carbide particles in the matrix, as shown by the SEM image in Figure

3(b). The grain boundary precipitate was predominantly comprised of Cr, as shown by the EDS spectrum in Figure 3(c). This exhibited a continuous network. The white precipitates adjacent to the grain boundaries are Nb-rich, as shown by the EDS spectrum in Figure 3(d).

In Tubes 3 to 6, the carbide precipitation appears relatively coarse, both at the austenite grain boundaries and within the matrix. The depletion of Cr within the matrix indicates a tendency of Cr to diffuse and form Cr-rich carbides at the austenite grain boundaries and/or coarse pre-existing carbides within the austenite. Diffusion of Cr is enhanced at an elevated temperature. The higher the temperature, the greater the carburized zone and the coarser the carbide precipitates.

Tube 5: secondary electron SEM image of (a) uncarburized region, (b) carburized region, and EDS spectrum from (c) grain boundary precipitate showing Cr enrichment, and (d) white precipitate showing Nb enrichment.

In the carburized region of the steel alloy tube material samples (Tubes 3 to 6), the white precipitates adjacent to the grain boundaries are Nb-rich, as shown by the EDS spectrum in Figure 3(d). Relatively small additions of Nb to heat-resistant castings can increase their resistance to thermal shock. Furthermore, Nb acts as a carbide stabilizer by forming MC-type carbides, which cause massive carbide precipitation at the grain boundaries.

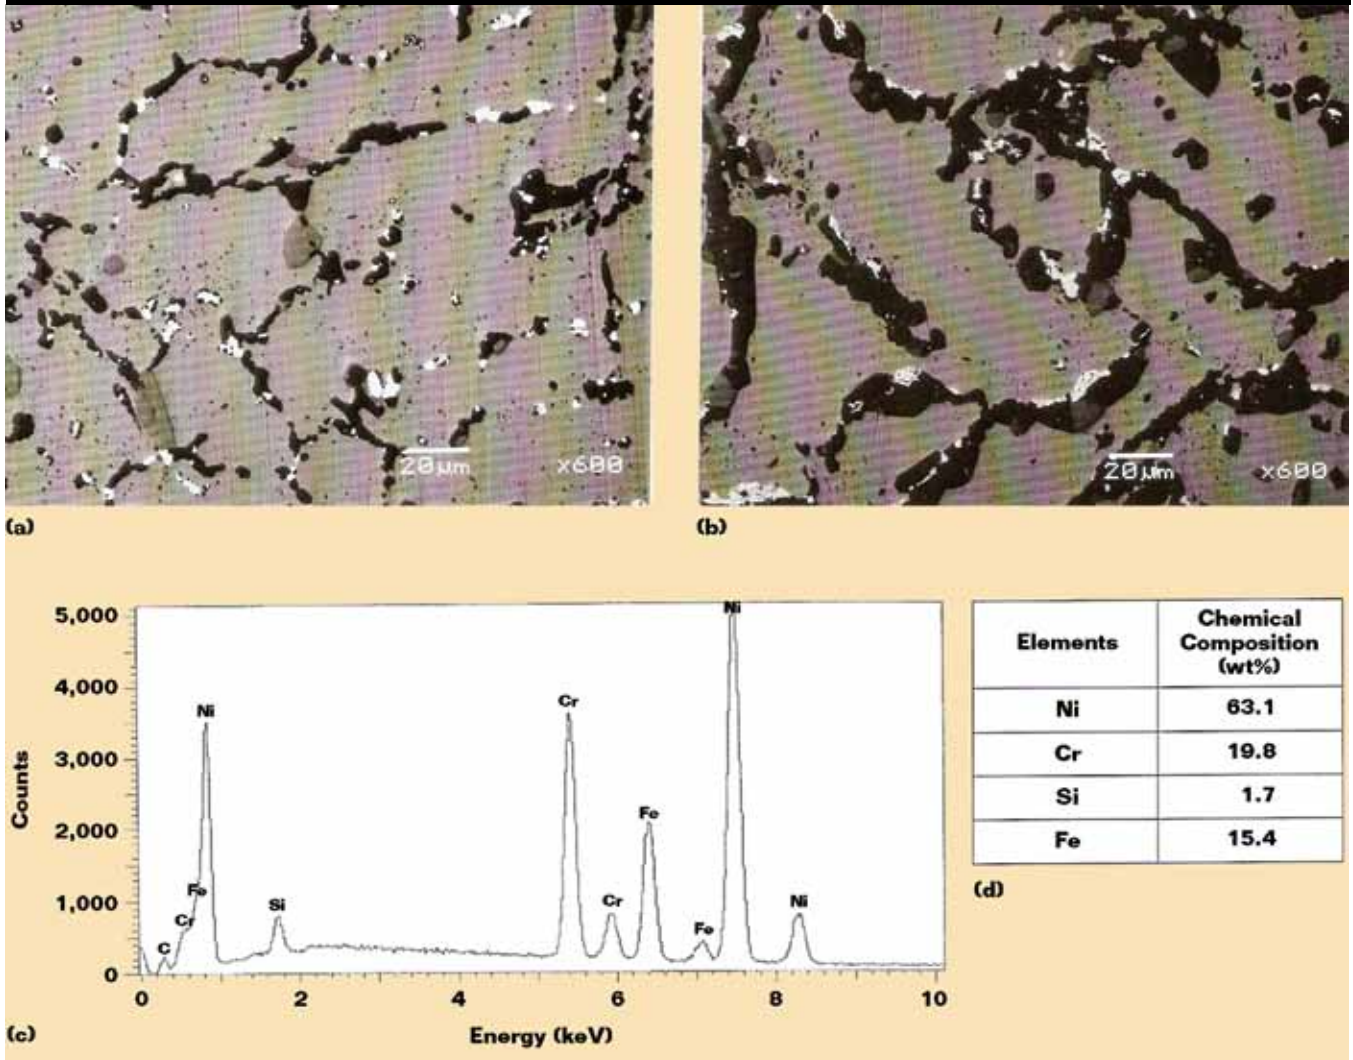
FIGURE 4

Tubes 7 to 9 (with composition of 35Cr-48Ni-Fe) have the highest Cr and Ni% composition when compared to others. Figures 4(a) and (b), respectively, show typical microstructures obtained from the uncarburized and carburized regions of the tube material. The microstructures are comprised of dark Cr-rich and white Nb-rich precipitates along with grayish precipitates. These are comparatively richer in Ni as shown in the EDS spectrum and elemental composition (Figures 4[c] and [d], respectively).

Tube 8: secondary electron SEM image of (a) uncarburized region, (b) carburized region, and EDS spectrum from (c) light gray precipitates showing a large peak of Ni, and (d) elemental composition derived from spectrum.

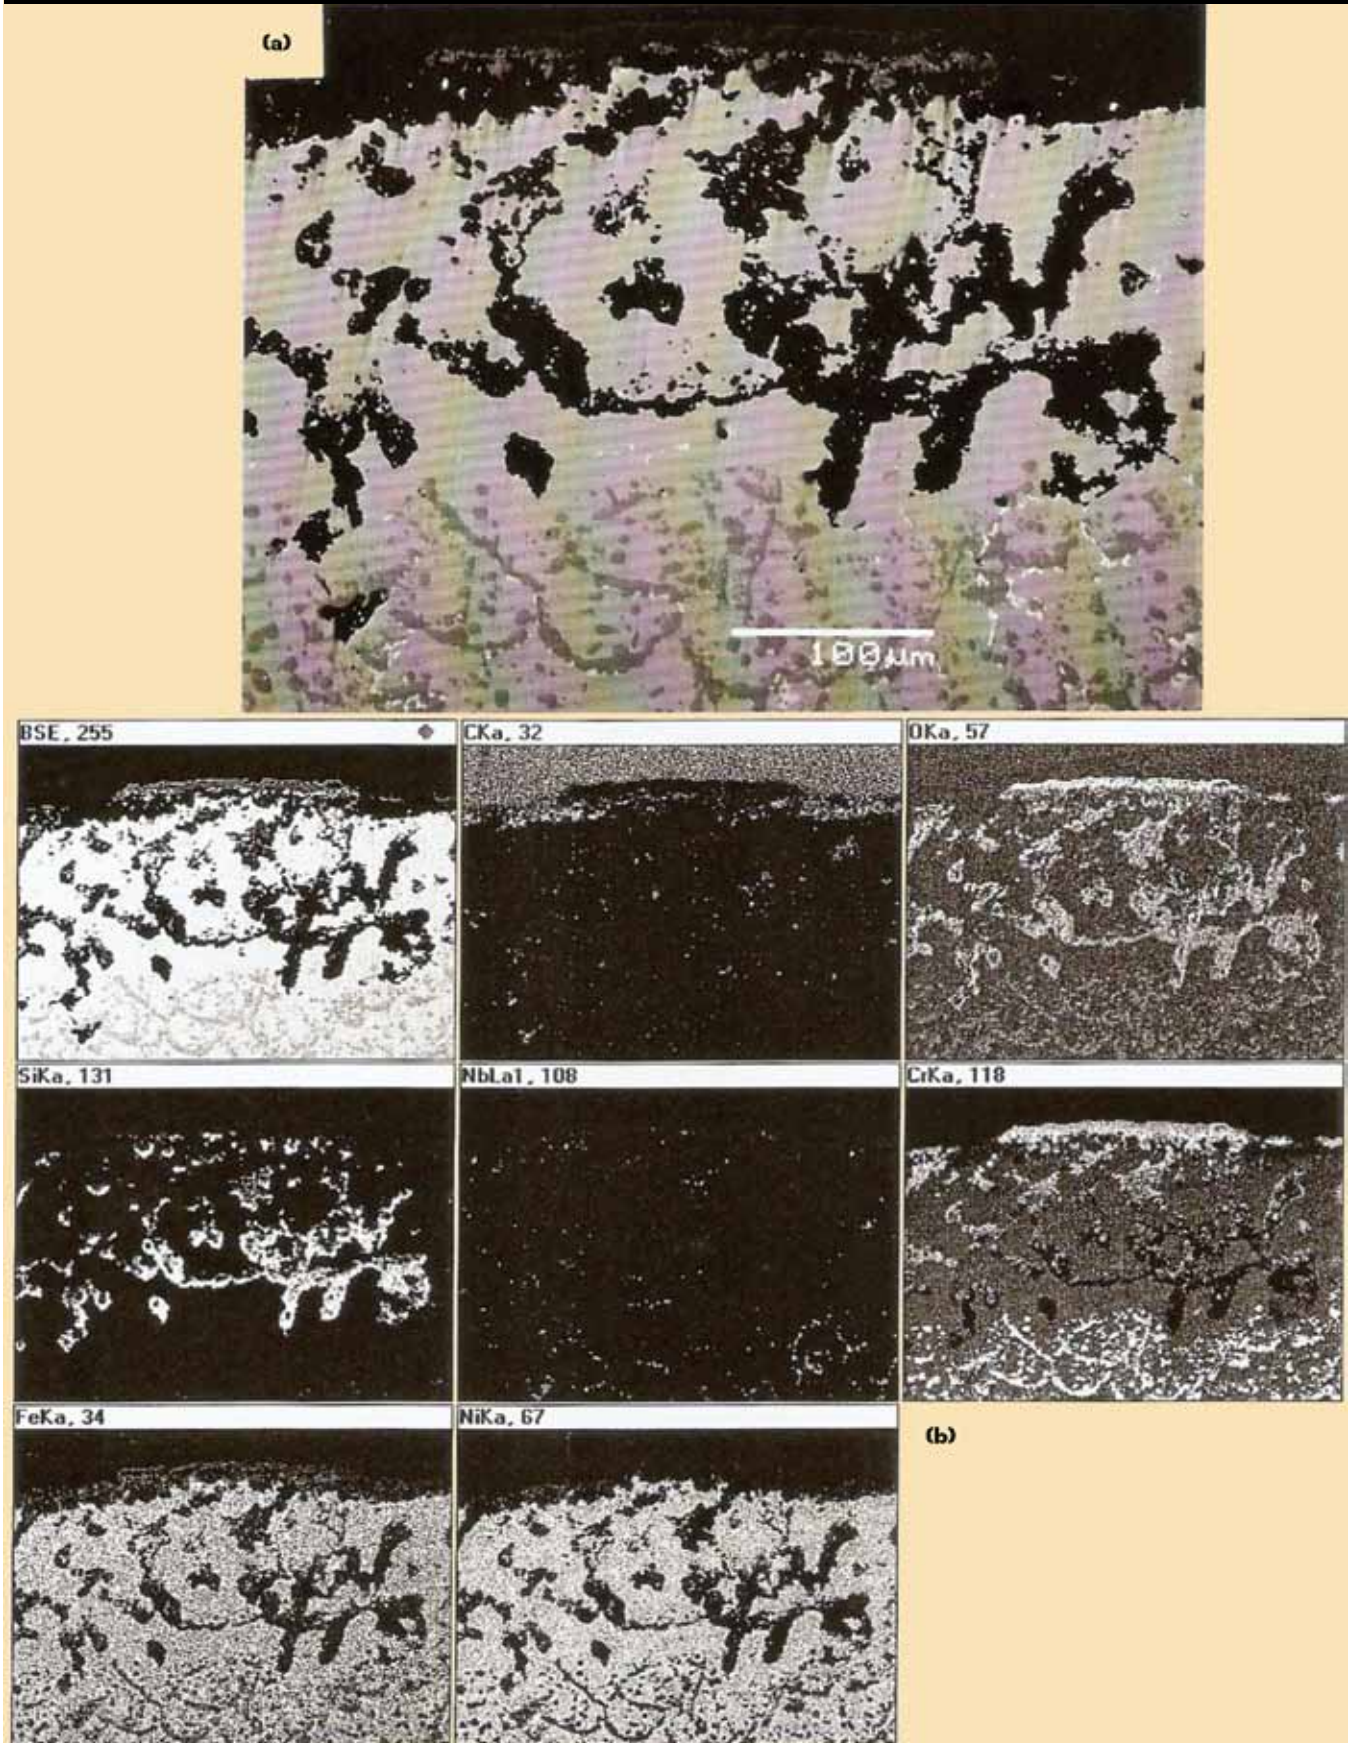
FIGURE 5

Presented in Figure 5(a) is a typical morphology of the scale formed at the internal surface of tubes as shown in the backscattered electron SEM image. An x-ray map shown in Figure 5(b) and the various EDS spectra obtained from the region reveal that the oxide formed at the surface is Cr-rich while Fe and Ni could also be detected in the scale. In addition, Si, and Cr oxide to some extent, were detected at the austenite grain boundaries immediately beneath the alloy surface.

The previously described results obtained from the analysis of the scale formed on the furnace tube materials, as presented in Figures 5(a) and (b), indicate that the alloys were not capable of developing a protective oxide scale. This could be due, in part, to the relatively low oxygen potential in the environment typically encountered in ethylene production. The

(a) Backscattered electron SEM image showing the typical morphology of scale formed at the internal surface of all tube materials and (b) an x-ray map showing the distribution of various elements within the scale and the underlying region.
