## Electrical resistivity application for road failure assessment at an industrial hub in Ogun State, Nigeria

Elizabeth Toyin Okeniyi <sup>1, 2, \*</sup>, Theophilus Aanuoluwa Adagunodo <sup>1</sup>, and Joshua Olusegun Okeniyi <sup>3, 4</sup>

**Abstract.** This paper employs the geophysical surveying technique of two-dimensional electrical resistivity imaging (2D ERI) for gaining insights into the causes of incessant road failures being encountered at an industrial hub, along Idiroko Road, in Ota, Ogun State, Nigeria. These utilises occupation of three traverses, each of 100 m for the 2D ERI, constituting a control of a stable road portion, and a stable and unstable portions of a crucial turning along the dual carriage highway of Idiroko Road in Ota. The obtained 2D ERI measurements were rendered to the processing of the RES2DINV software for the derivation of the 2D resistivity inverse model. Results show that the portions of the roads that are stable exhibited higher values of apparent resistivity compared to portions exhibiting frequent road failures. Ensuing sub-surface layer characterisations by the 2D ERI revealed geo-electrical layers exhibiting permeable soil formations

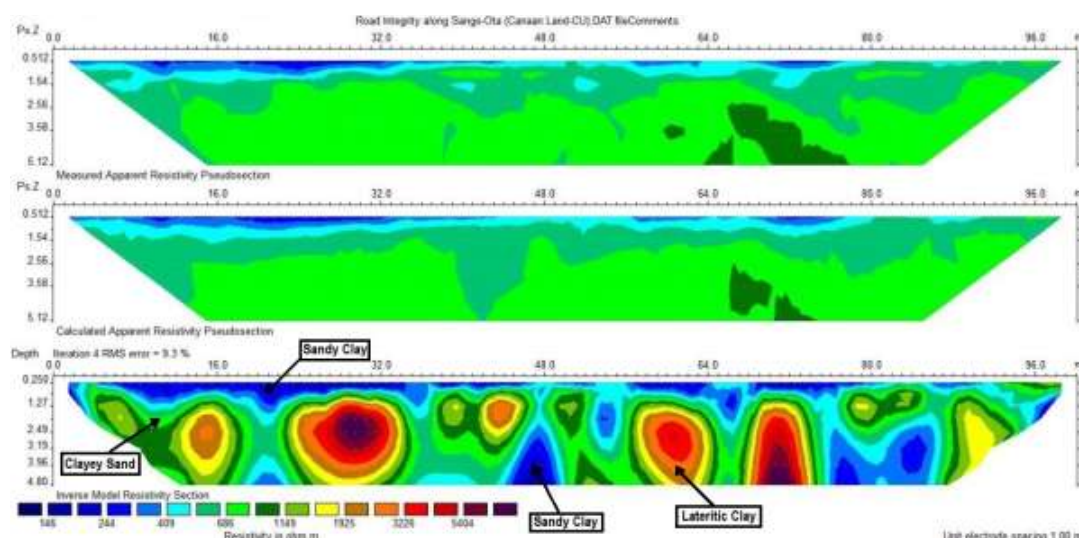
Fig. 3. 2D ERI for the traverse at base station S Idiroko road passing Winners Chapel, Ota, Ogun State, Nigeria.

The 2D ERI from traverse S revealed the presence of three geo-electrical layers. This includes the topsoil that is composed of soil formation having apparent resistivity values ranging from 142.6  $\Omega\text{m}$  to 397.6  $\Omega\text{m}$ , the second layer having 571.8  $\Omega\text{m}$  - 1089.4  $\Omega\text{m}$  and which shows high amount of sand that indicate the area as being permeable. The third layer exhibited apparent resistivity between 1925  $\Omega\text{m}$  and 5404  $\Omega\text{m}$  that indicate clayey sand. The inverted 2D (ERT) resistivity models from Fig. 3 shows that sandy clay and clayey sand, are high towards the top of the soil with lateritic clay not evenly distributed and these make the area suitable as the control where the road is very stable.

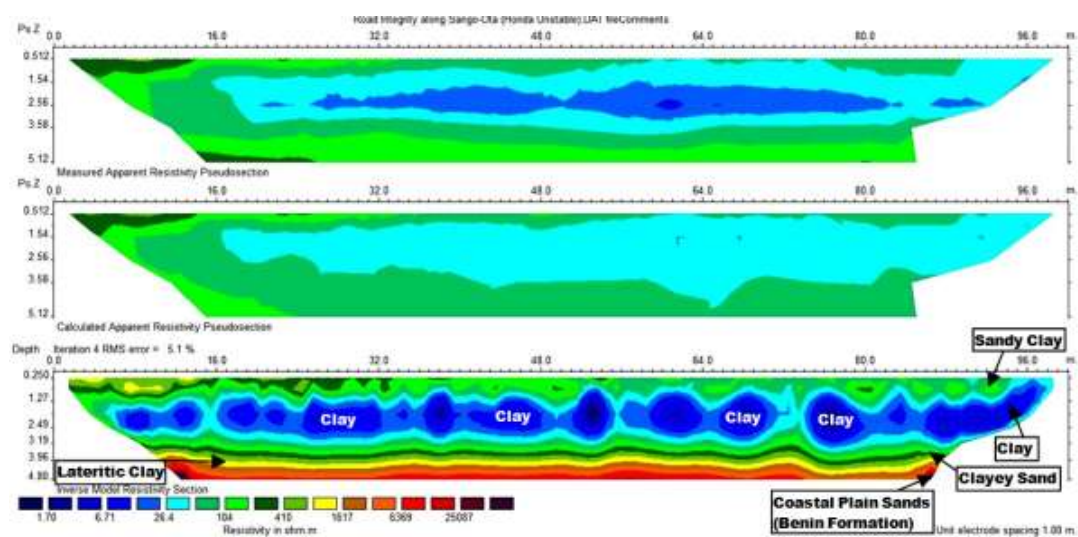
Fig. 4. 2D ERI for the traverse at location A (unstable portion of Idiroko Road access link to the industrial hub in Ota, Ogun State, Nigeria).

The 2D ERI from the resistivity models of traverse A, Fig. 4, showed the presence of four geo-electrical layers wherein the topsoil comprises of sandy clay followed by clay, then clayey sand and lateritic clay. The soil formation at this location exhibited apparent resistivity values from 90.7  $\Omega\text{m}$  to 108  $\Omega\text{m}$  that is characteristic of sandy clay. This is followed by the layers having 32.8  $\Omega\text{m}$  to 268.1  $\Omega\text{m}$  range of apparent resistivity values, which depict the presence of water hindered from percolation and the consequent implication of the location not being permeable. These low apparent resistivity results, when viewed in the light of previous study from the literature [21], are typical of expansive clay and sandy clay prevalence that are known to contribute to instability of road materials.

through the spot, because the trucks and other industrial vehicles would have offloaded their luggage while returning back to the factories along this axis. This is in agreement with the work of Akinola et al. [24]. In contrast, the unstable portion of the road exhibited subsurface soil formation that is impermeable (clay), which makes the portion harbour water close to its surface, in the rainforest region wherein the industrial hub in Ota, Ogun State, Nigeria is located. This would have accounted for the inability of the road to withstand the stress of excess capacity being imposed on it and heavy industrial loaded trucks that are known to ply through the study area [4]. The results from this study is therefore giving indications that the condition being imposed by the subsurface soil formation had to be addressed in the course of carrying out further repair and maintenance of the Idiroko road in the high capacity junction of the industrial hub in Ota, Ogun State, Nigeria.

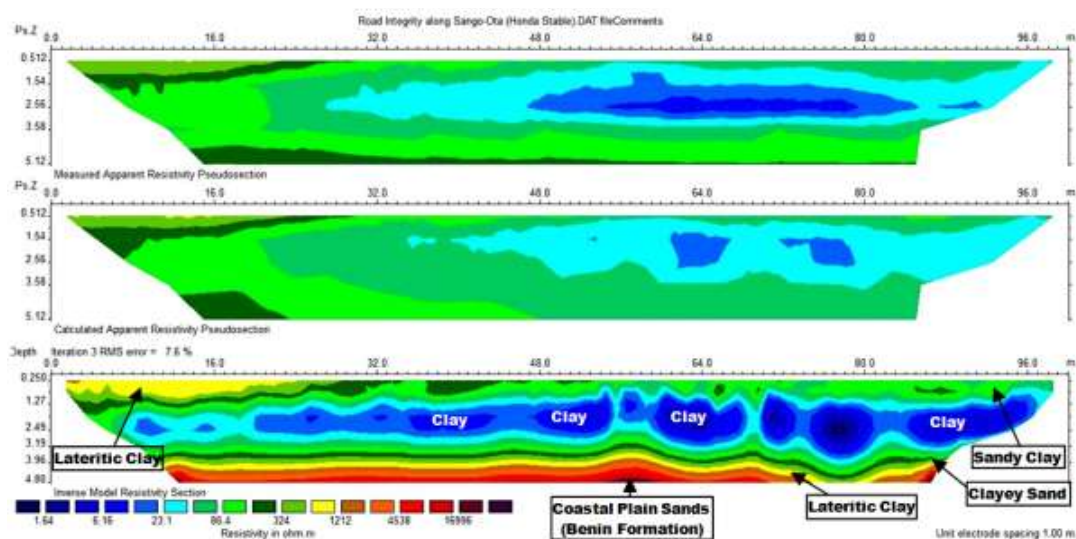
The 2D ERI models from the traverse at traverse B, from Fig. 5, also showed the presence of four geo-electrical layers that includes sandy clay at the topsoil, clay at the second layer

followed by clayey sand, before lateritic clay that undulated through Benin formation, which is composed of coastal plain sands. Thus, the location is characterised with topsoil formations with apparent resistivity values from 156.9  $\Omega\text{m}$  to 203  $\Omega\text{m}$  indicating the presence of sandy clay, followed by soil layers of apparent resistivity between 1.64  $\Omega\text{m}$  to 80.0  $\Omega\text{m}$  indicating a clayey zone. The third layer is of apparent resistivity 156  $\Omega\text{m}$  and 269.9  $\Omega\text{m}$ , which further ran into deeper layer of lateritic clay that makes the area permeable. In comparison, traverse A and traverse B relatively have the same formations, while traverse A is highly deteriorated, traverse B shows to be stable and maintained relative durability in the past. This suggest that though the geological formation at the second layer (which is interpreted as a clayey zone) could be the major causative factor for this deterioration, the loaded trucks from Badagry, Agbara and other industrial settings along this axis to other parts of the country could also be another contributing factor to this deterioration. Generally, clay contains very tiny particles that could store water. Due to its low permeability, it exhibits a tight grasp on water which expands when wet and shrinks when dry [19]. This characteristic has made clay unsuitable to support heavy loads [22], because pressure on pavement components could lead to cracks in the cause of swelling (upward movement) and shrinking (downward movement) of the clayey zone in the near surface [23].

Fig. 5. 2D ERI for the traverse at location B (stable portion of Idiroko Road access link to the industrial hub in Ota, Ogun State, Nigeria)

The results from the study show that the base station, traverse S maintains relatively stable road due to its subsurface soil formation that is permeable to the percolation of water. Meanwhile, the stability of traverse B could be attributed to the weight of the vehicles plying
