Electrical resistivity application for road failure assessment at an industrial hub in Ogun State, Nigeria

Elizabeth Toyin Okeniyi ^{1, 2, *}, Theophilus Aanuoluwa Adagunodo ¹, and Joshua Olusegun Okeniyi ^{3, 4}

Abstract. This paper employs the geophysical surveying technique of two-dimensional electrical resistivity imaging (2D ERI) for gaining insights into the causes of incessant road failures being encountered at an industrial hub, along Idiroko Road, in Ota, Ogun State, Nigeria. These utilises occupation of three traverses, each of 100 m for the 2D ERI, constituting a control of a stable road portion, and a stable and unstable portions of a crucial turning along the dual carriage highway of Idiroko Road in Ota. The obtained 2D ERI measurements were rendered to the processing of the RES2DINV software for the derivation of the 2D resistivity inverse model. Results show that the portions of the roads that are stable exhibited higher values of apparent resistivity compared to portions exhibiting frequent road failures. Ensuing sub-surface layer characterisations by the 2D ERI revealed geo-electrical layers exhibiting permeable soil formations that allow water to percolate in th

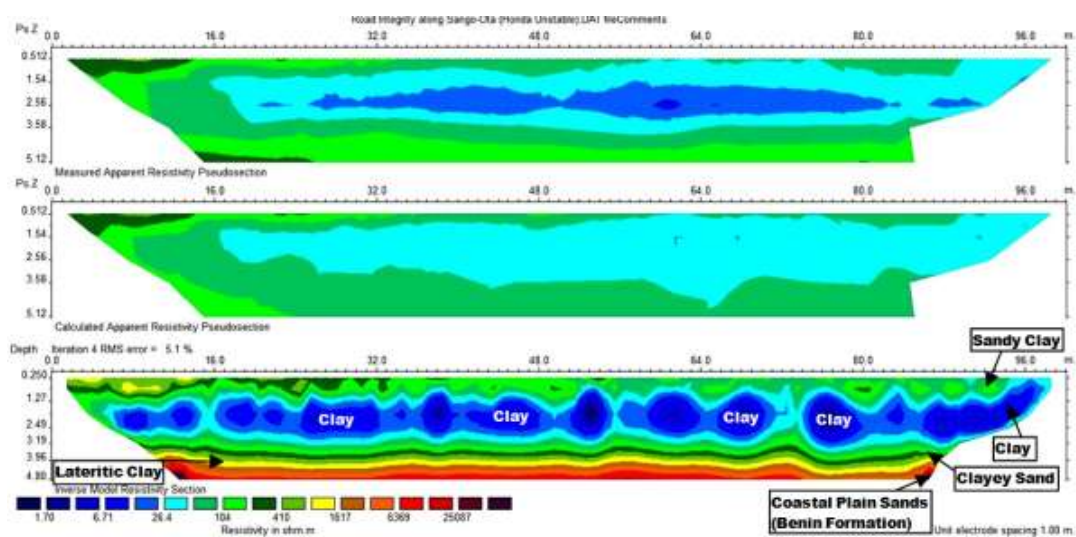
Fig. 4. 2D ERI for the traverse at location A (unstable portion of Idiroko Road access link to the industrial hub in Ota, Ogun State, Nigeria).

The 2D ERI from the resistivity models of traverse A, Fig. 4, showed the presence of four geo-electrical layers wherein the topsoil comprises of sandy clay followed by clay, then clayey sand and lateritic clay. The soil formation at this location exhibited apparent resistivity values from 90.7 Ωm to 108 Ωm that is characteristic of sandy clay. This is followed by the layers having 32.8 Ωm to 268.1 Ωm range of apparent resistivity values, which depict the presence of water hindered from percolation and the consequent implication of the location not being permeable. These low apparent resistivity results, when viewed in the light of previous study from the literature [21], are typical of expansive clay and sandy clay prevalence that are known to contribute to instability of road materials.

through the spot, because the trucks and other industrial vehicles would have offloaded their luggage while returning back to the factories along this axis. This is in agreement with the work of Akinola et al. [24]. In contrast, the unstable portion of the road exhibited subsurface soil formation that is impermeable (clay), which makes the portion harbour water close to its surface, in the rainforest region wherein the industrial hub in Ota, Ogun State, Nigeria is located. This would have accounted for the inability of the road to withstand the stress of excess capacity being imposed on it and heavy industrial loaded trucks that are known to ply through the study area [4]. The results from this study is therefore giving indications that the condition being imposed by the subsurface soil formation had to be addressed in the course of carrying out further repair and maintenance of the Idiroko road in the high capacity junction of the industrial hub in Ota, Ogun State, Nigeria.

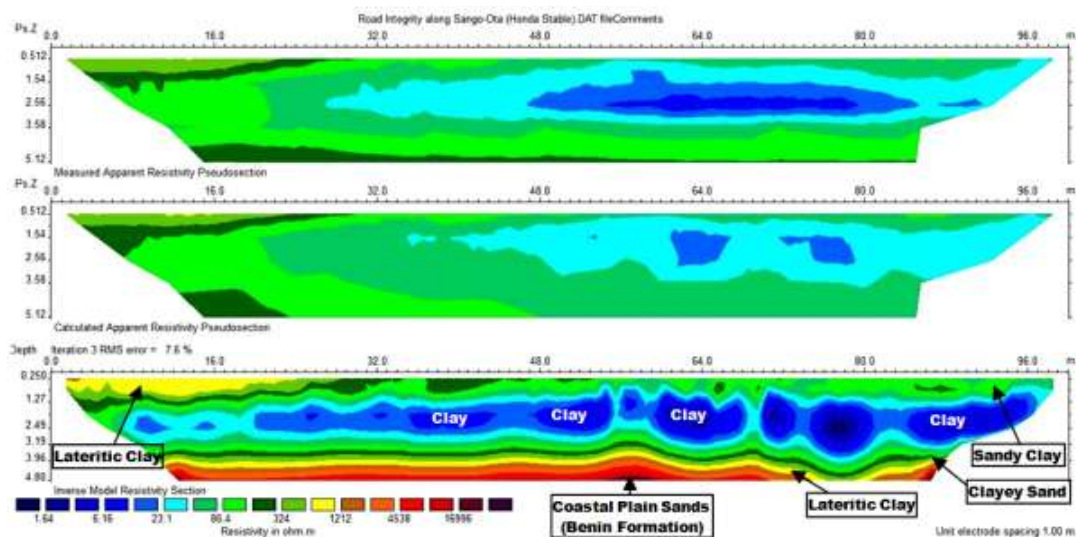
The 2D ERI models from the traverse at traverse B, from Fig. 5, also showed the presence of four geo-electrical layers that includes sandy clay at the topsoil, clay at the second layer

followed by clayey sand, before lateritic clay that undulated through Benin formation, which is composed of coastal plain sands. Thus, the location is characterised with topsoil formations with apparent resistivity values from 156.9 Ωm to 203 Ωm indicating the presence of sandy clay, followed by soil layers of apparent resistivity between 1.64 Ωm to 80.0 Ωm indicating a clayey zone. The third layer is of apparent resistivity 156 Ωm and 269.9 Ωm , which further ran into deeper layer of lateritic clay that makes the area permeable. In comparison, traverse A and traverse B relatively have the same formations, while traverse A is highly deteriorated, traverse B shows to be stable and maintained relative durability in the past. This suggest that though the geological formation at the second layer (which is interpreted as a clayey zone) could be the major causative factor for this deterioration, the loaded trucks from Badagry, Agbara and other industrial settings along this axis to other parts of the country could also be another contributing factor to this deterioration. Generally, clay contains very tiny particles that could store water. Due to its low permeability, it exhibits a tight grasp on water which expands when wet and shrinks when dry [19]. This characteristic has made clay unsuitable to support heavy loads [22], because pressure on pavement components could lead to cracks in the cause of swelling (upward movement) and shrinking (downward movement) of the clayey zone in the near surface [23].

Fig. 5. 2D ERI for the traverse at location B (stable portion of Idiroko Road access link to the industrial hub in Ota, Ogun State, Nigeria)
