Investigations on the Material Efficacy of Failed Helical Gears in a Gear Train

O. O. Joseph,* O. A. Abidakun, A. O. Aniyikaye, O. O. Folorunsho

Department of Mechanical Engineering, Covenant University, P.M.B.1023, Ota, Nigeria

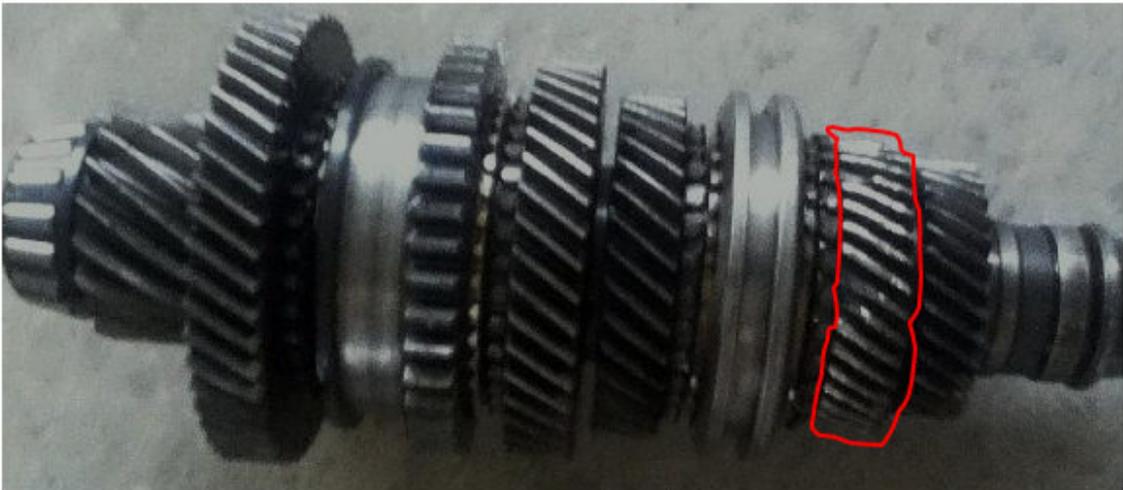
showed several worn teeth and seven fractured teeth (indicated by the red curve) and the remaining five had no visible sign of failure. The appearance of the gear train is as shown in Fig. 1. The helical gear is a five speed manual transmission gear. The passenger car has 202horse power and 6000revolution per minute (rpm) engine power. For the purpose of analysis, two helical gears were randomly chosen as representative samples of the six. The gear showing visible signs of fractures and wear was taken and denoted as Sample A, and another showing no visible sign of failure was chosen as Sample B. Basic data of the representative samples of the failed helical gears is presented in Table 1 and relevant layouts of the gears are shown in Fig. 2.

Figure 1 Appearance of the gear train.

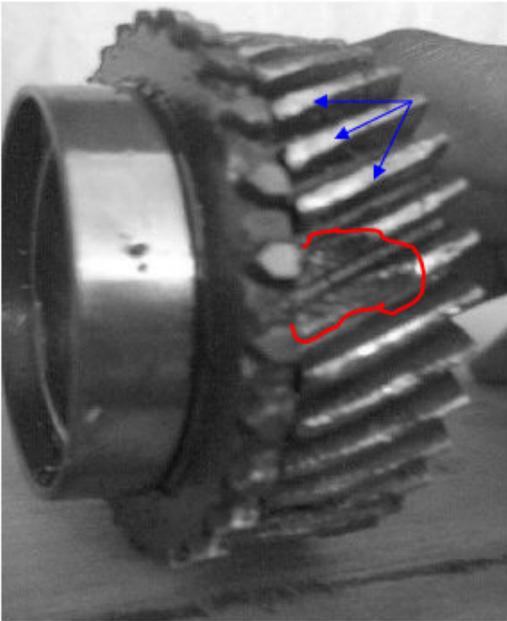
The purpose of which is to ascertain the mode of failure, observation of sample A with the unaided eye revealed surface wear (blue arrow) on nearly all tooth surfaces and tooth fracture (red curve) of seven out of a total number of 28 teeth (Fig. 3). The fractures occurred as a result of wear induced fatigue on the gear teeth. Hence, the failure mode of sample A can be classified as wear failure. This is further confirmed by Fractographic studies which showed cracks propagating from a point on the surface of the metal (which is the origin of crack initiation indicated by the red arrow), upward and downwards along slip planes (Fig. 4).

Figure 3 Unaided view of gear sample A .

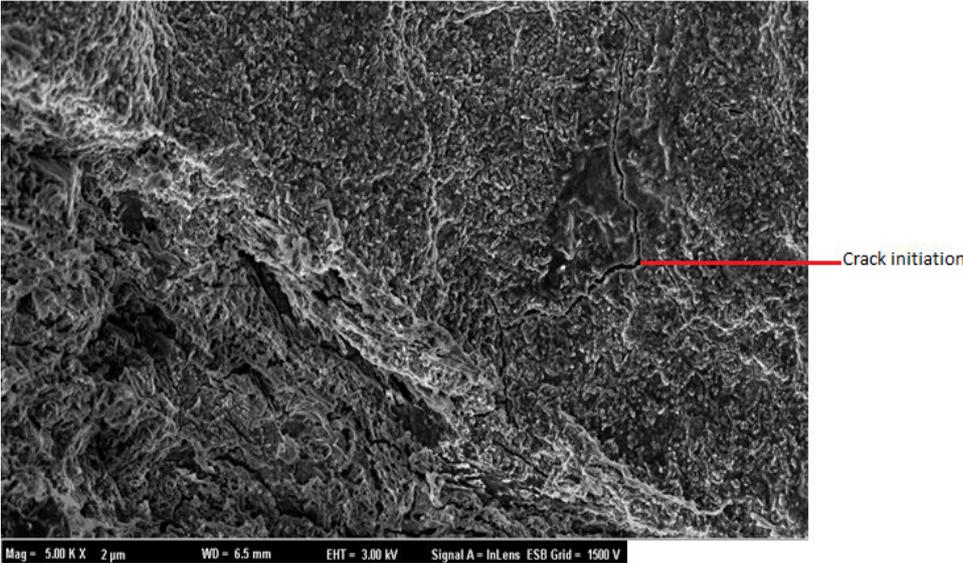
Figure 4 Fractograph of gear sample A.

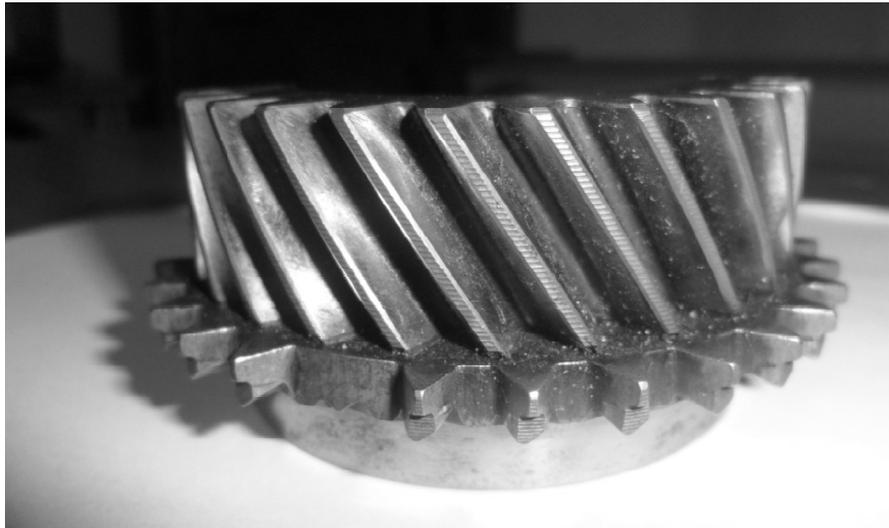
It was observed from the fractograph of sample A that the frictional heat (due to insufficient lubrication) between the rolling gear parts caused re-austenization of pearlite on its surface (lower left), producing as-quenched martensite (upper right) upon cooling, which led to crack initiation in the material. After initiation, repeated rolling contact caused crack growth which eventually led to surface contact damage (spalling). In the case of sample B, visual examination with the unaided eye (Fig. 5) revealed that there was no visible sign of failure. Nevertheless, sample B was subjected to Fractographic examination (Fig. 6). Curiously, developing spalls were observed on the gear tooth of sample B.

Figure 5 Fractograph of gear sample A.

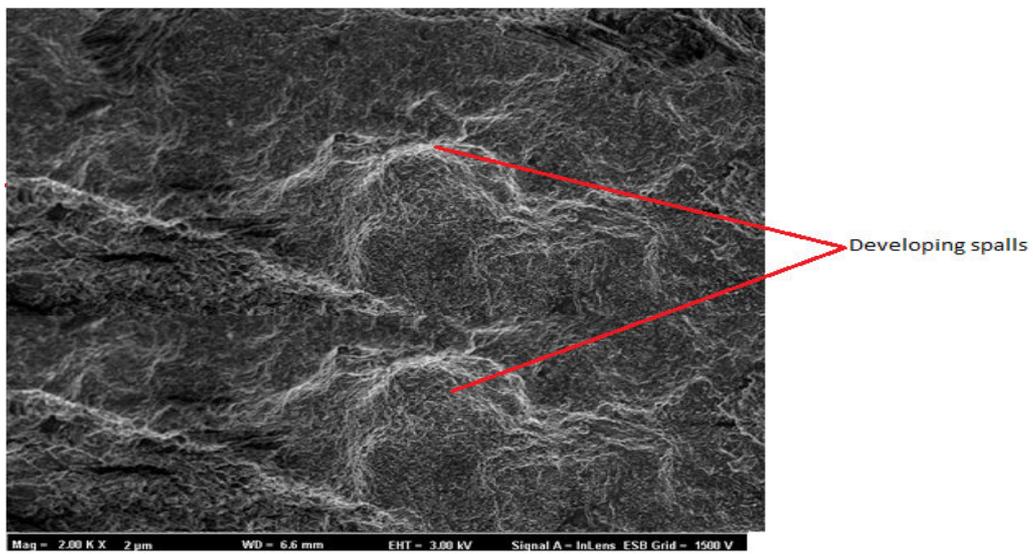
Figure 6 Fractograph of gear sample B.

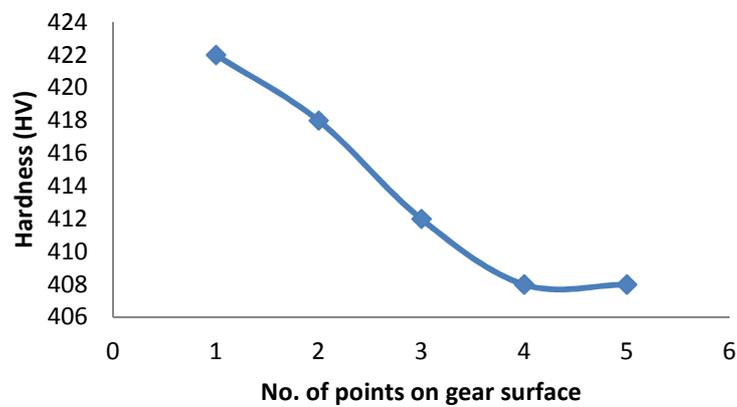
The microhardness distribution of both gears, across the gear tooth was measured using a digital Vickers hardness tester (HVD501 model) with 500kgf load. The results are shown in Figures 7 and 8. The decreasing hardness values from the case of both materials to the core are an indication that the material has been case hardened by carburization which is a normal operation for gear heat treatment.

Figure 7 Hardness distribution of gear sample A.

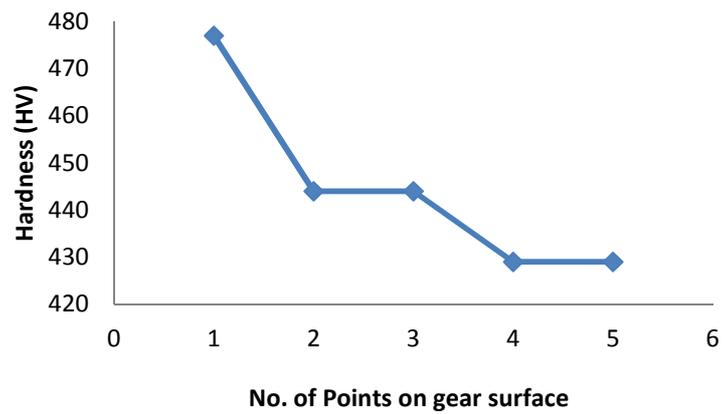
Figure 8 Hardness distribution of gear sample B

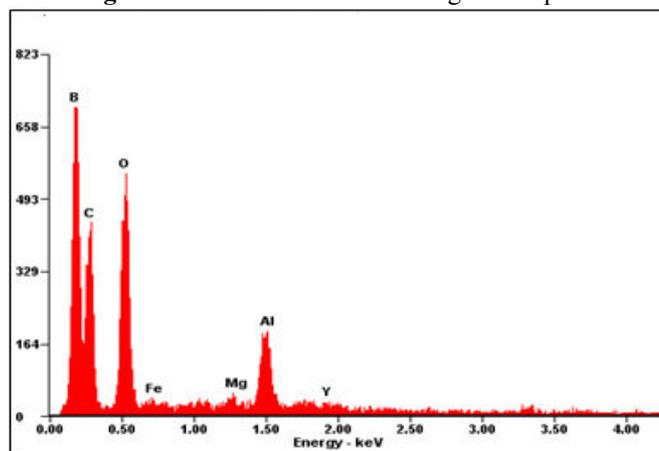
The X-ray spectrum that was generated from a point on sample A and another on sample B are shown in Figs. 9 and 10. EDS of sample A shows high proportions of boron, carbon and oxygen. Boron had reacted with carbon to yield boron carbide which is extremely hard, improving the material's property. On the other hand, it can be asserted that in the absence of sufficient lubrication, the steel being rich in carbide particles, exhibited a low

coefficient of friction which resulted in a high wear rate. Iron oxide, a contaminant, weakened the gear teeth in the presence of frictional heat generated from improper lubrication. The oxide contaminant in sample A was a major contributor to its failure. In the absence of lubrication, wear of the gear metal proceeded by cyclic disintegration of oxide films and subsequent reformation of these films. In other words, oxidative wear occurred. The EDS view of sample B showed the presence of iron, carbon, copper and chromium in the material. There was no indication of contaminants. It is worth noting however, that there is no wear on sample B which is also reflected by its EDS view. These results were further confirmed by microstructural examination.

Figure 9 EDS view of gear sample A.

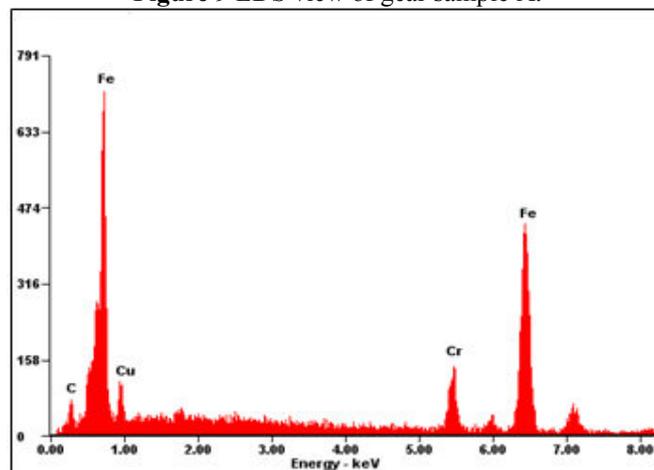
Figure 10 EDS view of gear sample B.

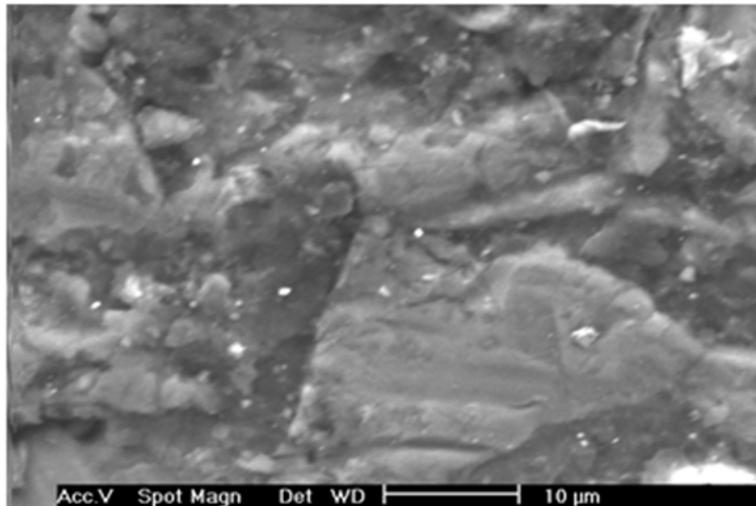
The gear samples were metallographically prepared and observed with a scanning electron microscope under etched conditions. The views obtained are shown in Figs. 11 and 12. Analysis of sample A showed severe subsurface spalling of the gear sample. Subsurface spalls are characterized by oxide inclusions and initiation of contact fatigue cracks (Qiong, 2008). This confirms that actually, there were oxide contaminants in the sample. Spalling of the gear material is a form of subsurface damage which led to crack initiation, crack growth and ultimately, fracture. Carbide precipitates could be seen on the micrograph as well. The unavoidable presence of these carbides contributed to the wear of the material. Hence, the failure mechanism of sample A as seen by the micrograph was by subsurface crack initiated spalling.

Figure 11 SEM view of sample A.

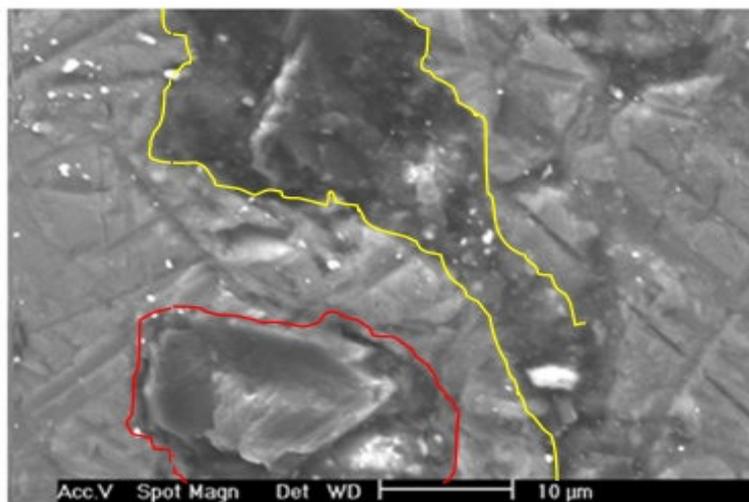
Spalling was observed in sample B. Both modes of spalling (surface and subsurface) were observed. Surface spalling is indicated with the red curve and subsurface spalling with the yellow curve. However, it is noticeable that the surface of sample B remained smooth and lacking in obvious damage, while a few micrometers below the surface, processes culminating in the formation of a wear particle were taking place.

Figure 12 SEM view of sample B.
