EXPERIMENTAL FAILURE INVESTIGATION OF AN AIRCRAFT NOSE LANDING GEAR

ABSTRACT

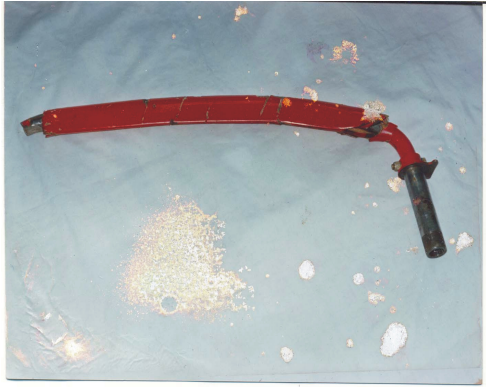
Figure 2: Failed Landing gear

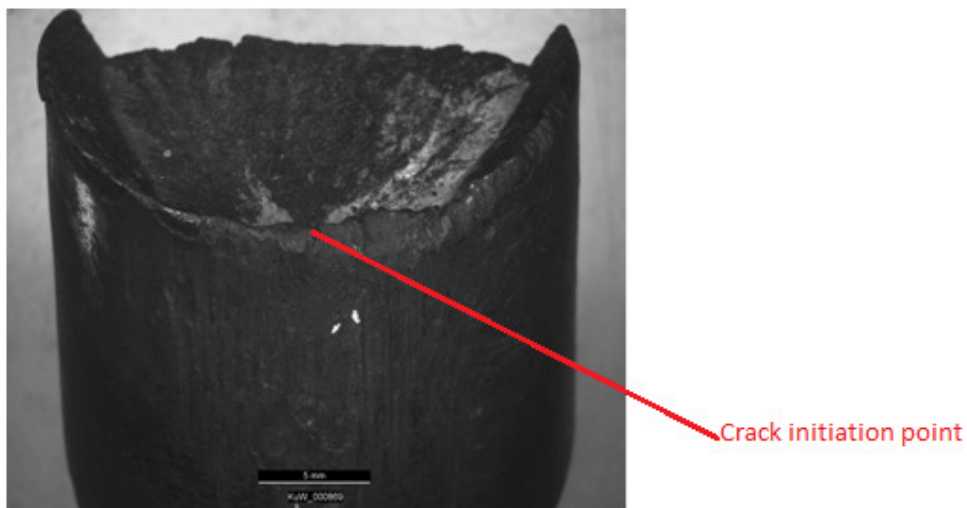
The surface appearance of the failed landing gear is shown in Figure 4. Visual examination of the gear revealed a fractured strut surface with beach marks propagated from a point of crack initiation indicated by the arrow. This is a typical characteristic of fatigue fractures and particularly high cycle fatigue due to the well defined and closely spaced striations. The crack propagation can be seen by the flat plateaus joined by narrow regions of tensile tearing.

Figure 4: Fracture Surface of Gear Strut

There was also a measure of ductile pull which can be seen from the cone shape of the tear.

fracture, being off-centre, is an indication that crack initiation was from a particular area on the strut. The low fatigue resistance of the samples and high stress to which the strut was subjected may have been the root causes of the fracture. This was also ascertained by visual examination where chevrons were seen on the surface originating from a point which could be the initiation site.

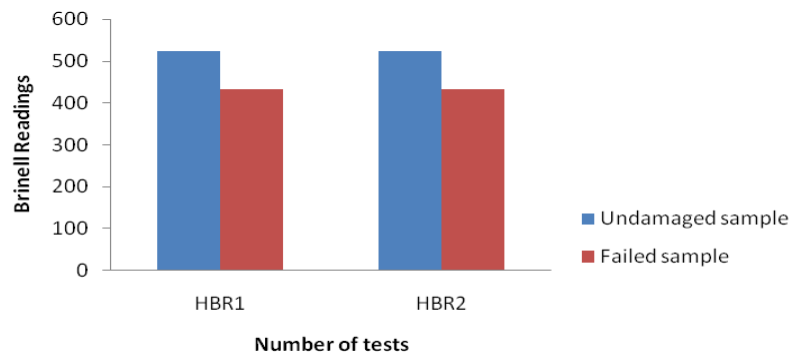
Fig. 5: HBR data for failed and undamaged gear struts

The failed gear’s hardness differed from the undamaged by 92HBr. The marked difference may be due to loss of strength in the material as a result of fatigue. In each case, the hardness distribution across the gear surface was consistent. According to [6], the stronger (harder) the steel, the less likely it is that striations will be observable on the fracture surface. Hence, it can be inferred that the gears’ hardness was probably not sufficient to prevent fatigue damage.

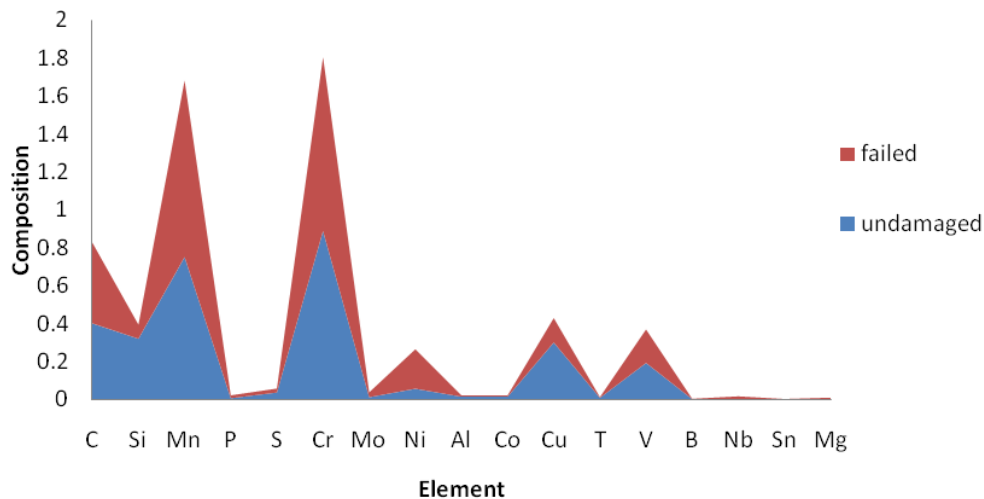
Chemical composition of the gear strut materials was analyzed using a spectrometer. The average values are shown in Fig. 6. Contrary to expectations, the compositions indicate that the material was made from medium carbon steel of the tough grade to SAE 0050 standard instead of spring steel. The strut ought to have been made from spring steel since the aircraft was designed without a shock absorbing mechanism. The spring properties are to enable the materials absorb shock on impact. According to [7], for spring effect, the percentage of Silicon in both samples should be in the range of 1.90% - 2.40%; with carbon content less than 0.65%, strength adequate for springs cannot be obtained.

Fig. 6: Chemical compositions of undamaged and failed gears, the balance being Fe.

Molybdenum is required to increase the strength and toughness of the steel. Less than 0.60% cannot sufficiently provide this effect. Likewise, Nickel content should not be spared since Nickel improves the hardenability of steel. At least

0.50% is needed. Inconsistent design details may have caused the variations between the compositions of both samples. Also, improper material specification could have contributed to the failure of the aircraft’s nose wheel strut.

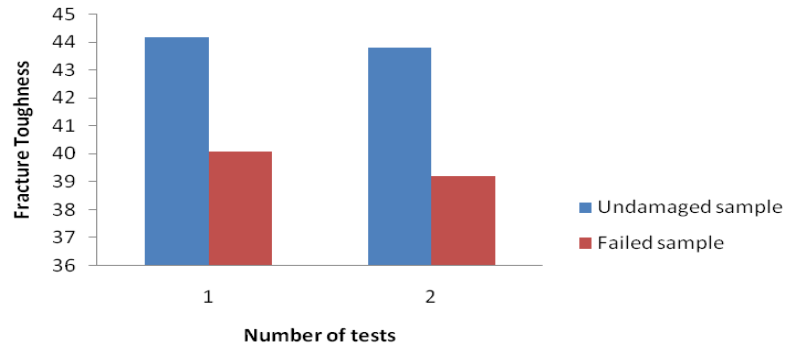
Fig. 7: Fracture toughness of failed and undamaged struts.

According to [8], the fracture toughness of materials to be used for axles, gears, drop forgings, buildings, bridges, washing machine and fridge bodies should be 60J. From the result above, it can be deduced that the gear strut materials may have had insufficient fracture toughness.

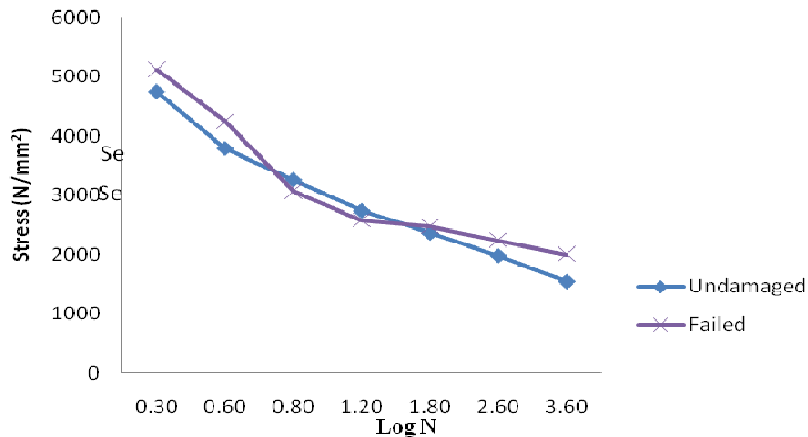
Fig. 8: Endurance Curves for Failed and Undamaged Strut Samples

The fatigue strength (S_e) of the undamaged sample is 3790N/mm^2 while the endurance limit (S_e) of failed sample is 3067N/mm^2 . It is expected that below the endurance limit obtained for either of the samples, the material will not fail, that is, the structure is said to have an infinite life. The curve shows high cycle low stress fatigue strength of the materials. Furthermore, the beach marks (chevrons) characteristic of fatigue which propagates from the initiation site and the zone of

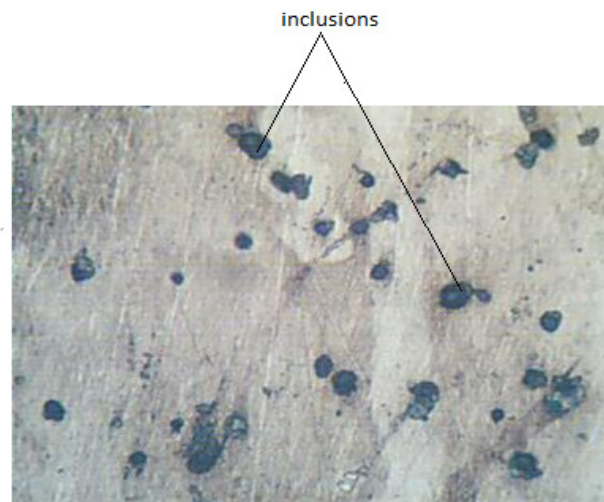
Results are as shown in Figs. 9 and 10. Microscopic examination of the undamaged sample at magnification of X200 revealed few large inclusions with pearlite in ferrite matrix.

Figure 9: Optical View of Undamaged Strut Sample at X200

This defect could be a design problem since it is also present in the undamaged sample; hence there are equal chances of failure of this sample under fatigue loading. Microscopic examination of the failed sample at magnification of X200 revealed the inclusions more widely spread in the core of the material, resulting into pitting; with pearlite in ferrite matrix. Some are seen as degenerated inclusions. The inclusions acted as stress raisers and thus fatigue initiation sites resulting in cracks as shown in Fig. 10.

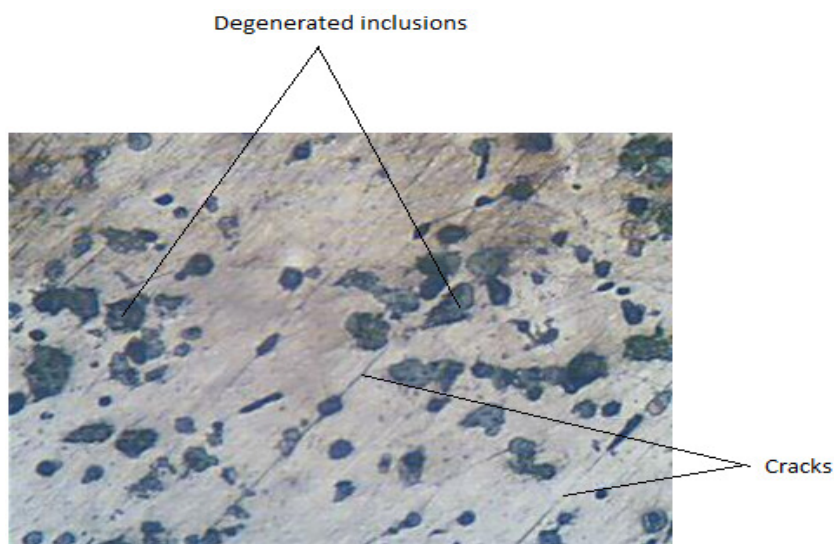
Figure 10: Optical View of Failed Strut Sample at X200 Showing Fatigue Cracks

It is worth noting that the thicker the inclusions in the longitudinal cross-section of a steel product, the higher the tendency for fatigue damage. Hence, the fatigue property of the landing gear can be effectively improved upon by ensuring that the average composition of these inclusions is minimal. Breakage starts from the inclusions if they are thick even though they are ductile. In other words, the width of the inclusions plays an important role in the improvement of the fatigue property of the gear materials. In essence, microstructural defects or inclusions are intrinsic latent defects which could initiate cracks and propagate failure.
