Assessment of Selected Dams in Kwara State, Nigeria

D. O. Olukanni¹, A. A. Adedeji² and A. W. Salami³

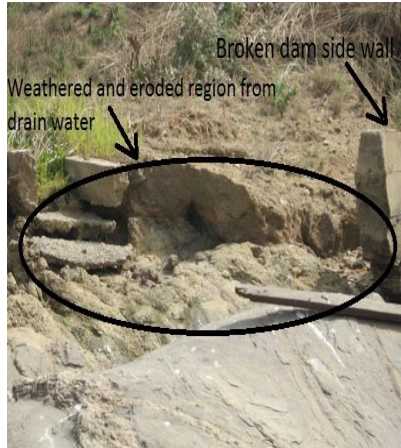
Figure 2 Broken and Eroded part of drainage at right-side retaining wall

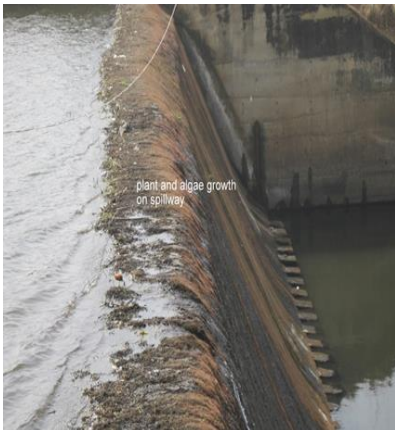
Figure 3. Plant/algae growth and blocks

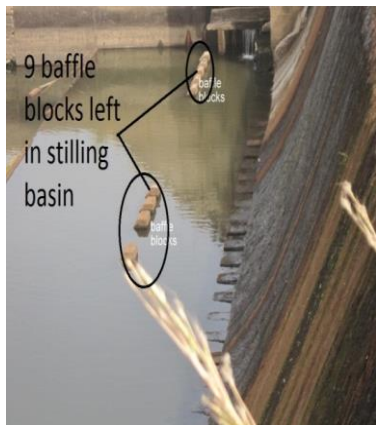
Figure 4 Damaged and eroded baffle decoloration of concrete spillway

Baffle blocks in dam stilling basin are installed to help cut/reduce the force impact of spillway water runoff such that the resulting force impact can be accommodated by the End Sill to allow gentle flow of water after spilling off the spillway towards the downstream. They help in energy dissipation which is to protect the downstream riverbed and banks from erosion and to ensure that the high velocity, turbulent flow from the outlet works does not undermine the dam and adjoining structures (FEMA, 2010). Once the baffle blocks are damaged or reduced in number (significantly, like that of the Unilorin earth dam), water spills from the spillway at a high velocity which will cause damage at downstream areas through erosion and washing away of banks and downstream areas. The distance between the chute blocks and baffle blocks, as well as the baffle blocks and end sill, is important for improved efficiency. Placing the baffle blocks too far upstream leaves them susceptible to cavitation and can cause waves downstream (FEMA, 2010). The design and construction of baffle blocks should also be supervised by a qualified Structural Engineer as weaving and knitting of the reinforcements should be done to design specifications. Damaged baffle blocks and areas in stilling basins should be repaired with shotcrete, a polymer improved cementitious mortar with aggregate that has a 28-day compressive strength over 48.3 MPa. It should be used to repair grout patches that had been damaged by erosion. Shotcrete is recommended for these repairs because it is fast setting, has exceptional bonding properties, and has an abrasion resistance six times greater than that of conventional concrete. This was used for similar repairs (baffle blocks and eroded spots) at the Old River Control Project located on the Mississippi River about 80 km (50 miles) northwest of Baton Rouge LA in 1988 (Curtis and McDonald, 1999).

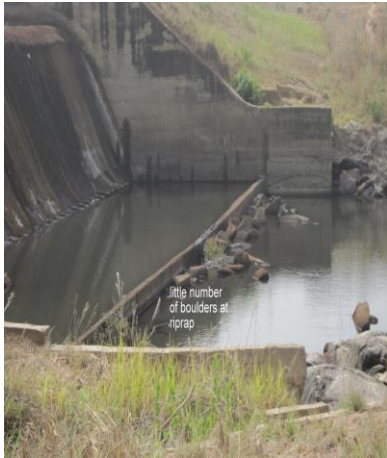
Figure 1 shows disorganized/reduced quantity of rocks/boulders for riprap at the toe of one of dams.

Figure 5 Washed-off riprap boulders at dam toe

to reduce erosion of earth at the toe (Okuta-Oja and Unilorin dams). Checking of Riprap at toe of dam should be done seasonally so as to know the rate/extent of erosion of boulders and when to replace washed off quantity. Crack/seepage repair in Okuta-Oja dam; following the evaluation of the crack, a suitable repair procedure can be selected. The opening in the concrete in Okuta-Oja dam falls within the range of fine external crack $0.1062 < 0.2032$ mm ($0.004 < CW$ 0.008 inch).

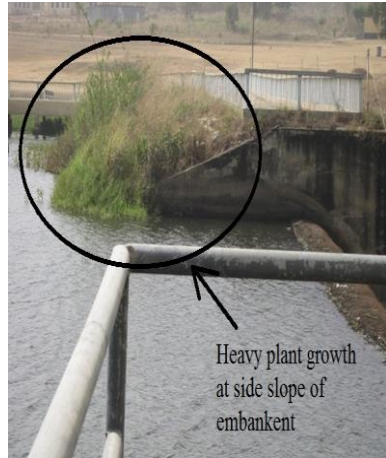
Figure 6 Plants and small trees on upstream sides

The commonest form of poor maintenance in dams can be observed as trees and plant growth at the side of embankments, most dam stations have been found guilty of this act (poor weed control). Small trees/tree crops are usually left to grow at embankment sides. The older the tree crop becomes, the stronger and bigger its roots becomes, the greater the penetration through the

compacted earth, which in turn creates seepage path for dam water to pass through. These plants should be uprooted regularly. Cultivation of Shallow rooted grasses will be advised as they will not only beautify the dam, but also help reduce washing away of earth from the side slopes through rain water.

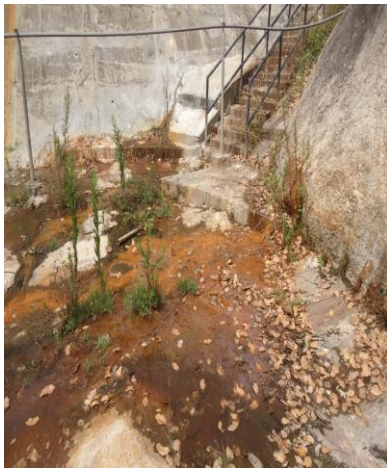
Figure 7 Seepage from the concrete/rock interface

Curtain grouting is performed to reduce deep underground seepage through the foundation and abutments. Pressure grouting using a mixture of cement and water or other materials is probably the most frequently used method to remedy serious foundation or abutment seepage problems in rock. However, it should not be used indiscriminately. Before any grouting effort, an investigation to determine the seepage conditions and locations should be conducted.

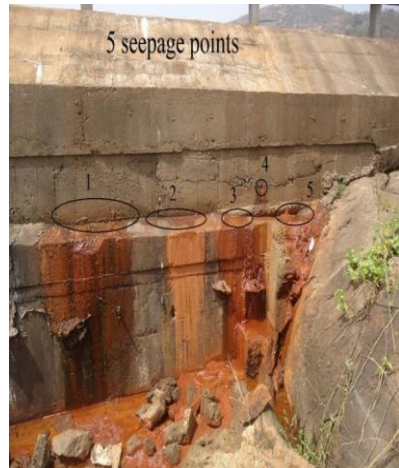
Figure 8 Concrete body seepage

Repair of large cavities in concrete & masonry dams by Hybrid Polyurethane Injection Resin like TamPur 115,116 which is an example of a non-Foaming PU Resin which is used for cavity filling in concrete in both under water and above water. It's a silicate modified PU resin and two component system. TamPur 115 & 116 can be used for any big cavity filling in Masonry or Concrete dam in underwater by using a twin piston PU pump from top. However, trained diver is needed for such repair under supervision from an experienced Engineer who has knowledge of such materials and its application (Mukhopadhyay, 2014).
