Procedia Manufacturing 35 (2019) 97-102

Forensic Investigation of a Failed Intermediate Starwheel Spur Gear Tooth in a Filler Machine

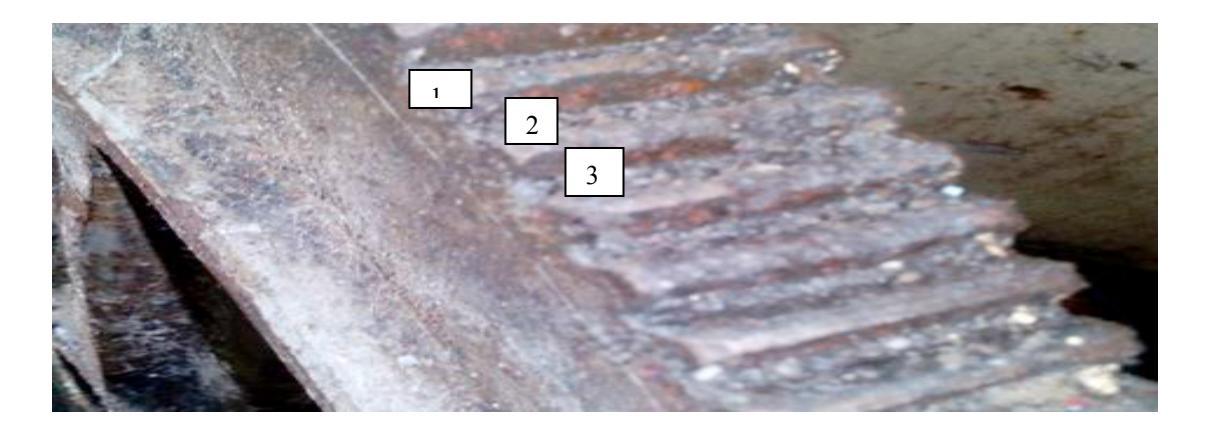
Fig.1. Pictorial view of the failed intermediate spur gear tooth

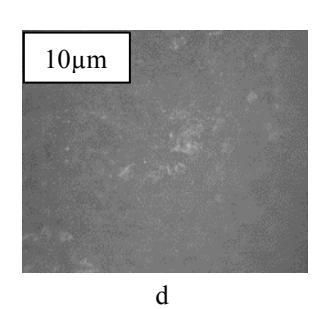
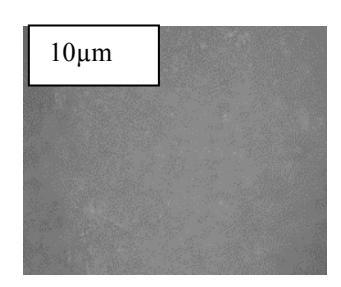
b Fig.2. Tooth 1

Figures 2a-c, represents the micro structures of the failed gear sample labelled as tooth 1. The micrographs were taken at different magnifications to reveal the best structure of the failed gear tooth. It can be observed that 40 and 100 magnifications, gave better micrograph structure unlike that of 10. More so inclusions were observed at the tooth surface which may serve as stress raisers for surface deformation. Similarly, figures 3d-f, also presents the optical micrograph for gear tooth sample denoted by number 2. It can be deduced that higher inclusions as well as pitting corrosion were observed at higher magnifications. This eventually led to crack propagations at various point causing incessant failure of the gear component. On the same hand, figures 4g-i, also revealed the micro structures of the gear tooth number 3. Though failure here is not as severe as that of the one noticed on the gear tooth labelled as 2. However, presence of inclusions on the surface asperities had brought about unevenness in the surface roughness there by leading to gear tooth failure.

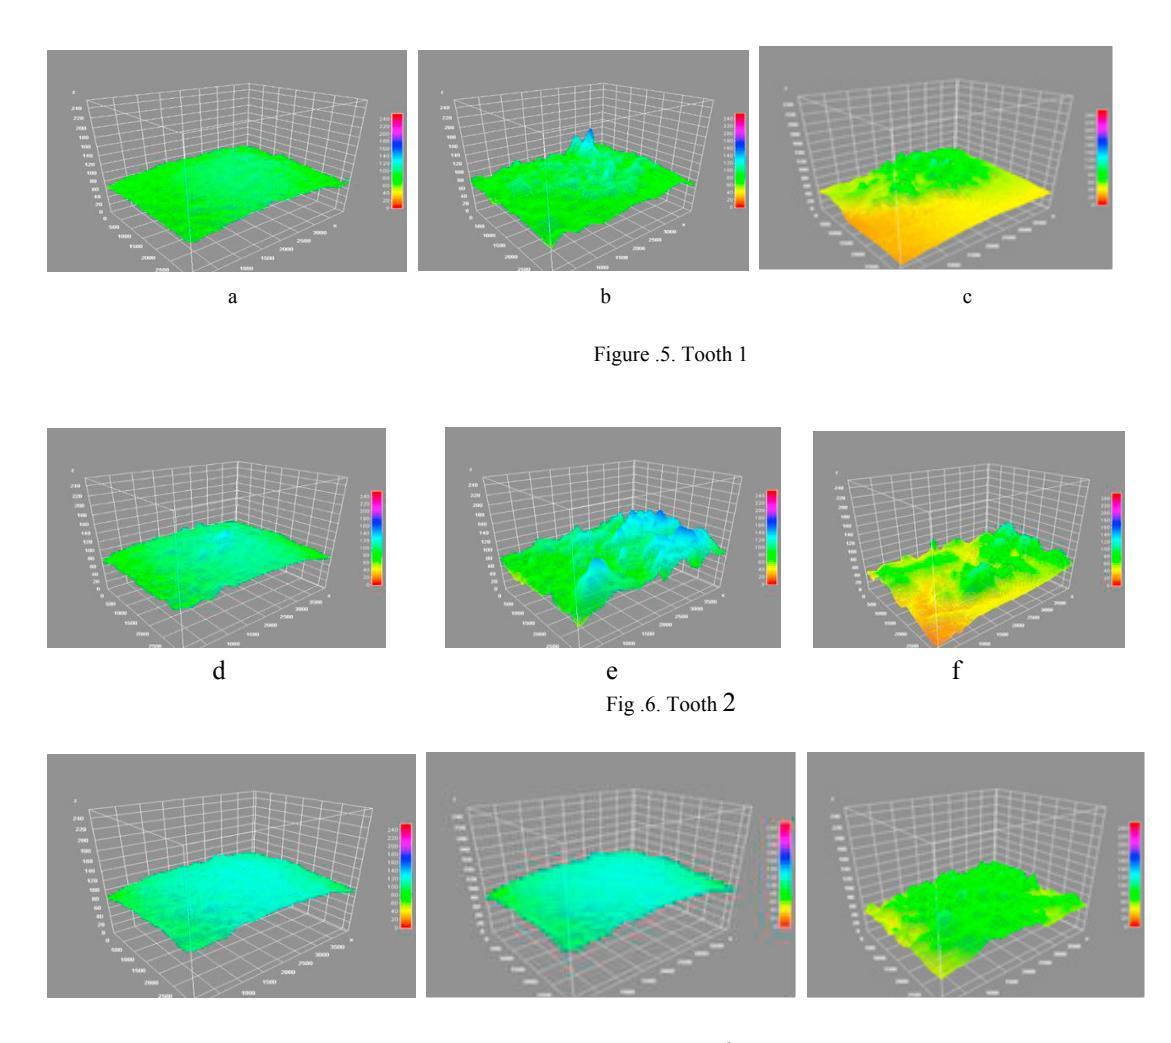
Fig .7. Tooth 3

Similarly, figures6d-f also presents the 3D surface plot for the micrograph of tooth2. Figures 6d and 6f gave a better result of the wear distribution on the surface of the tooth with 6f showing the highest variations in valleys and peak owing to the fact that the magnification considered was higher (100 mag). More so, figures 7g-i also represent the 3D surface plot for the different micrograph of tooth 3. It was observed that variations in the wear pattern was higher for figures 7h and 7i. However, figures 7i presented an increased wear pattern on the gear tooth which is due to persistent tooth misalignment. The significance of the wear behaviour of the investigated gear teeth is that gear misalignment was responsible for the variation in the wear pattern and this justifies incessant failure of the gear tooth.
