Vertical Electrical Sounding to Determine Fracture Distribution At Adumasun Area, Oniye, Southwestern Nigeria.

Abstract: People living in Ibadan, Southwestern Nigeria have started shifting their focus on construction of buildings towards villages that are close to the metropolis. It is therefore imperative to carry out this research in order to recommend the types of structures to be erected at Adumasun area, Oniye, Southwestern Nigeria when the time comes in order to avoid catastrophic failure that might have happened thereafter. The aim of this research is to carry out vertical electrical sounding geophysical survey at Adumasun area, Oniye, Southwestern Nigeria with a view to determining the fracture distribution within the study area. The study area is located between latitude $07^{\circ} 37' 55.37''$ to $07^{\circ} 38' 00''$ North and longitude $003^{\circ} 11' 10.2''$ to $003^{\circ} 11' 16.8''$ East. Schlumberger electrode array was employed for the study using R 50 Resistivity meter for the data acquisition. The geoelectric survey comprised of ten depth soundings, with maximum current electrode spacing (AB) of 200m. 40% of the modeled curves are A-type, 50% are H-type, and

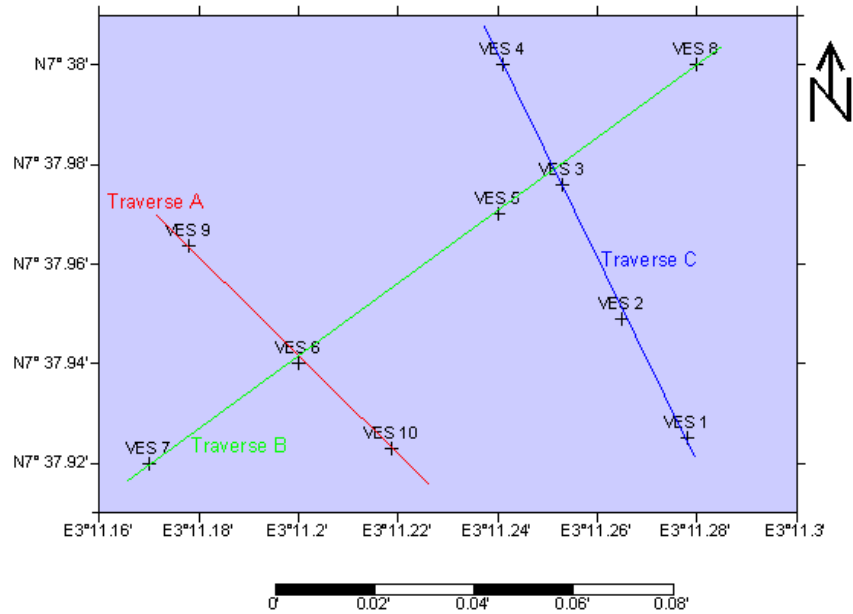
Figure 4: Layout map of VES locations at the study area.

The vertical electrical soundings (VES) were conducted using the Schlumberger electrode array (Zohdy et al., 1974). R 50 Resistivity meter was used for the data acquisition. The geoelectric survey comprised of ten depth soundings (Figure 4), with maximum current electrode spacing (AB) of 200m. The field curves were interpreted through partial curve matching (Koefoed, 1979), engaging master curves and auxiliary point charts (Orellana and Mooney, 1966). The manually derived geoelectric parameters were subjected to an inversion (Vander Velpen, 2004), which successfully reduced the interpretation error to acceptable levels (Barker, 1989). The electrical resistivity contrasts existing between lithological sequences in the subsurface (Doodds and Ivic, 1988; Lashkarripour, 2003) were used in the delineation of geoelectric layers which were used to determine the overburden thickness and to detect the fractured basement within the study area.

Field curves were mirror-image (geoelectrically) by Surfer 8 (Surfer 8, 2002) in three traverses of SE to NW and SW to NE directions. From figure 4, the 10 VES stations were grouped into 3 profiles (A, B and C) according to how convenient they can be located on a straight line to see an image representation of the subsurface. The results of the interpreted VES curves were used to draw 2D geoelectric sections (figures 6a–c) along profiles A, B and C to show the vertical distribution of resistivities within the volume of the earth in the investigated area. The sections consist of sequence of uniform horizontal (or slightly inclined) layers (horizons). Each layer (horizon) in a geo-electrical section may completely be characterized by its thickness and true resistivity. The geoelectric sections show both vertical and lateral variations in layer resistivity. One of the importances of 2D geoelectric sections is that it helps someone to see clearly where there is thin overburden as well as thick overburden within the sounding locations.

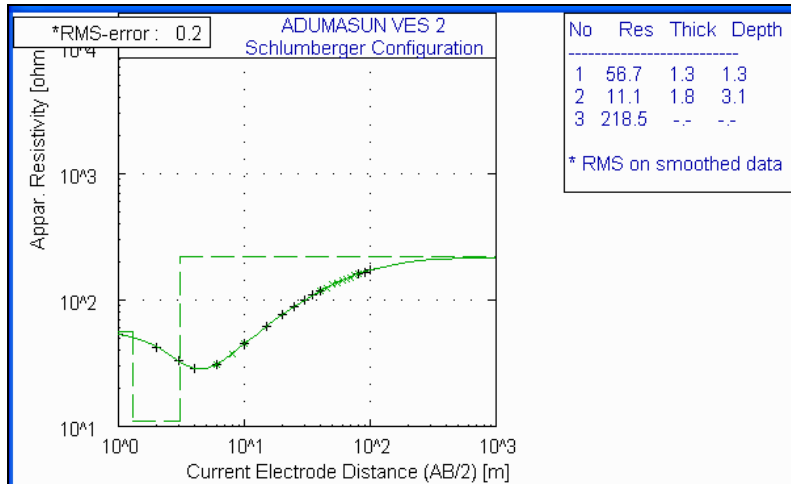
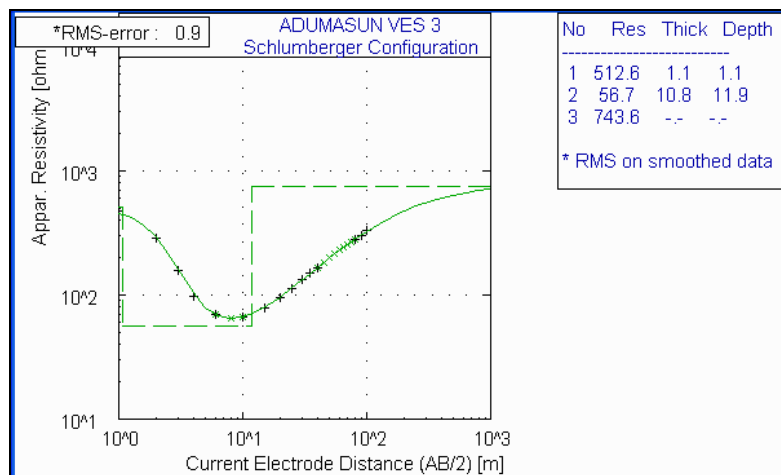
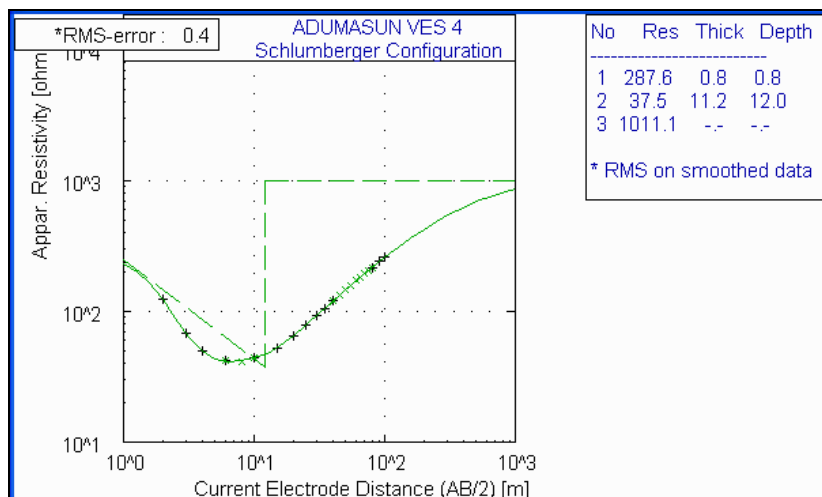
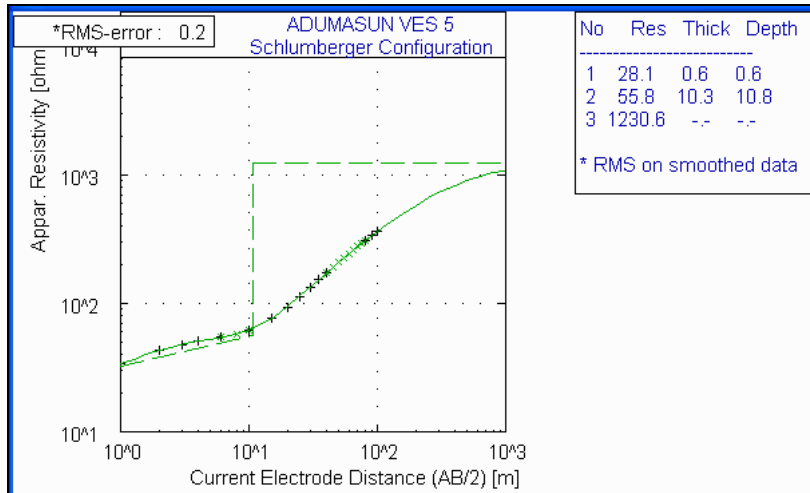
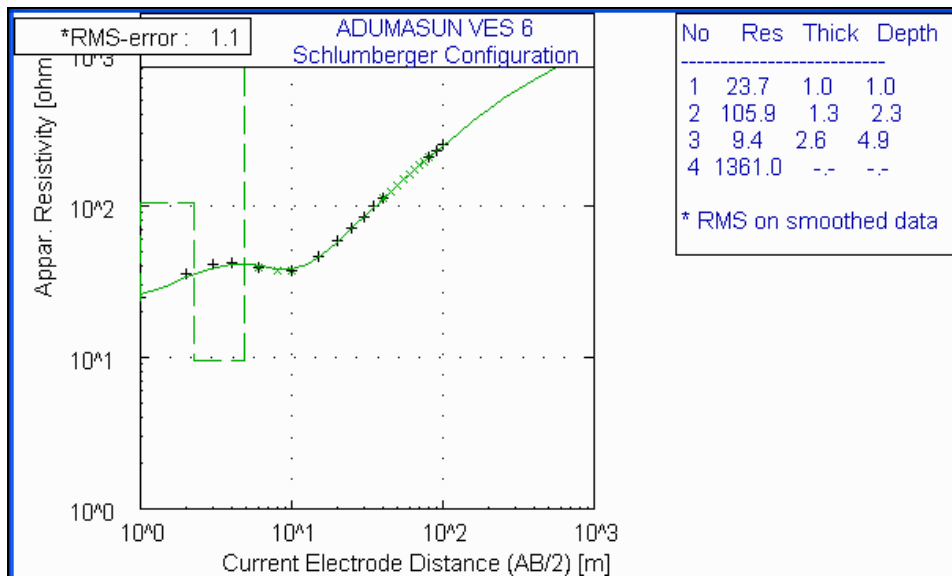
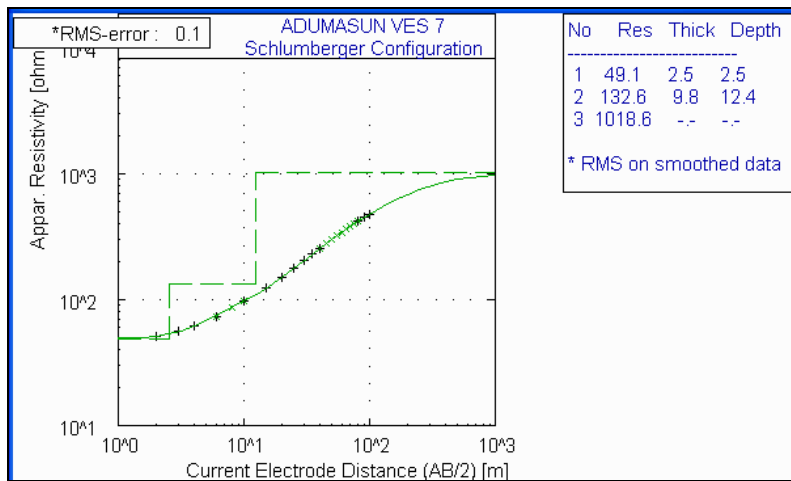
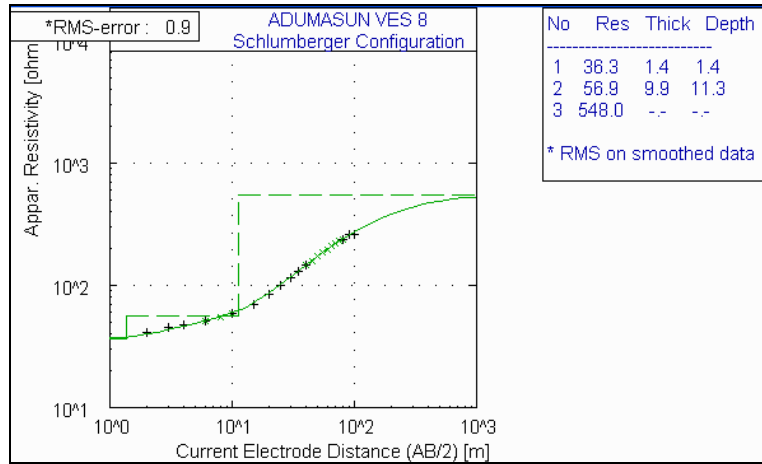
Figure 5(a): The modeled curve for VES 1.

Figure 5(b): The modeled curve for VES 2.

Figure 5(c): The modeled curve for VES 3.

Figure 5(d): The modeled curve for VES 4.

Figure 5(e): The modeled curve for VES 5.

Figure 5(f): The modeled curve for VES 6.

Figure 5(g): The modeled curve for VES 7.

Figure 5(h): The modeled curve for VES 8.

Figure 5(i): The modeled curve for VES 9.

Figure 5(j): The modeled curve for VES 10.

The results were discussed under geoelectric sections, overburden thickness, and resistivity of the bedrock sub-headings. The Schlumberger depth soundings produced a short range of sounding curves: three-layer type A (40%), H type (50%), and four-layer curves of type KH (10%) were recorded. Typical curves are shown in Figure 5 (a-j). Summary of the formation of layer parameters and classification of the resistivity sounding curves are presented in Table 1 and 2 respectively.

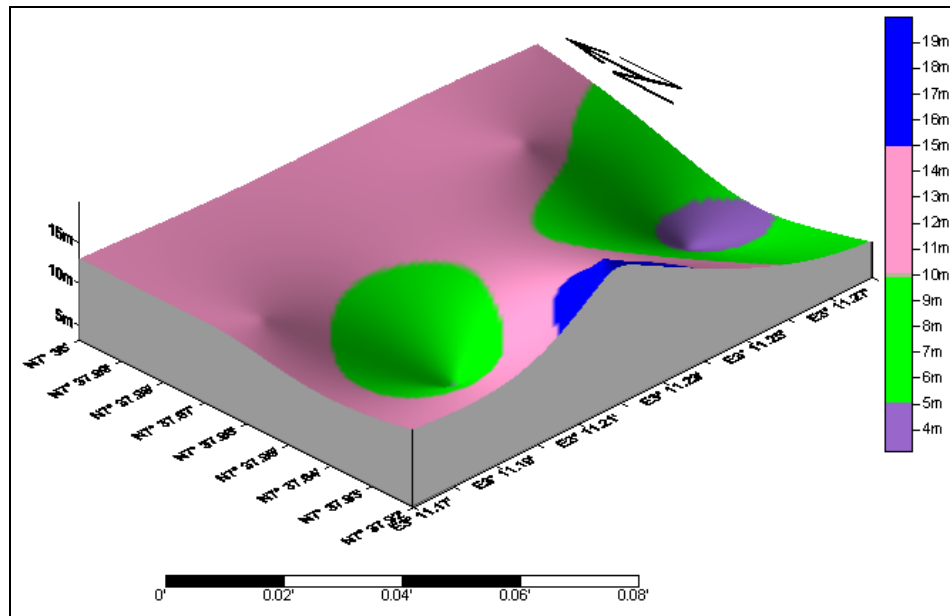
Figure 7: Surface (3-D) plot of overburden thickness at Adumasun.

Surface plot of depth to the basement (overburden thickness) beneath the sounding stations were plotted by surfer 8 (Surfer 8, 2002) as shown in figure 7. This was done to enable a general view of the subsurface thickness of the surveyed area. The overburden is assumed to include the topsoil, the second layer, and the third layer where it is present. The values range from 3.1m to 20.1m with an average of 10.63m. The overburden thicknesses were segmented according to Olayinka et al. (1997). Depth to basement less than 5m (demarcated with twilight violet colour) is regarded as thin overburden, depth to basement ranging from 5m to 10m (demarcated with green colour) is regarded fairly thin, depth to basement ranging from 10m to 15m (demarcated with pink colour) is regarded as averagely thin or thick (but still moderate), depth to basement greater than 15m (demarcated with blue colour) is extremely thick. From the map, overburden thickness ranging from 10m to 15m constitutes 60% of the study area. It is therefore recommended that high-rise building should not be compacted on Adumasun land.

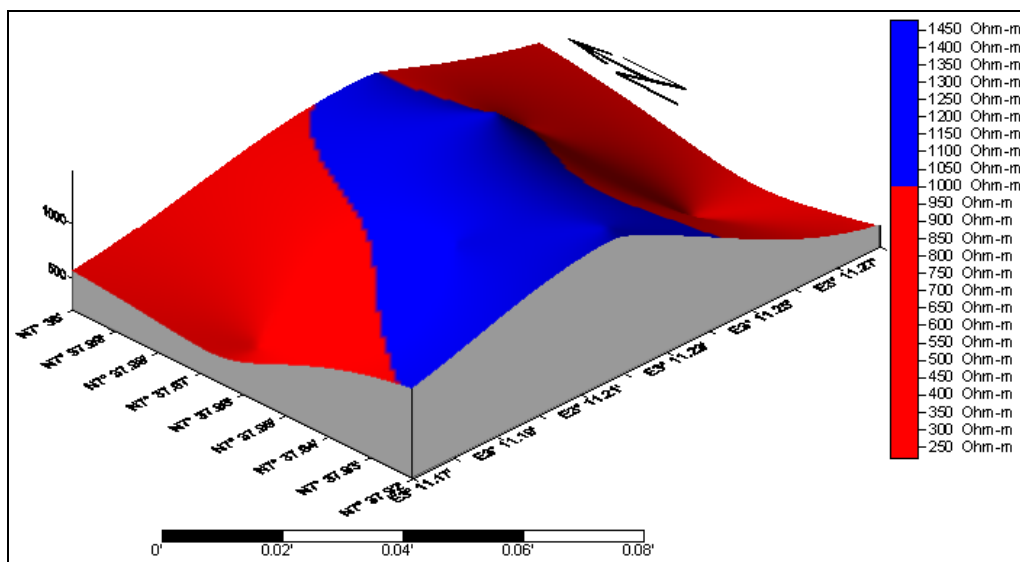
Figure 8: Surface (3-D) plot of bedrock resistivity at Adumasun.

Past study from Olayinka and Olorunfemi (1992) (Olayinka and Olorunfemi, 1992) showed that resistivity of fresh bedrock often exceeds $1000 \Omega \text{ m}$ while the resistivity of fractured basement which is probably saturated with fresh waters often reduces below $1000 \Omega \text{ m}$. This has been adopted to construct surface map of bedrock resistivity at Adumasun (figure 8). Resistivity less than $1000 \Omega \text{ m}$ is demarcated with colour red while resistivity greater than $1000 \Omega \text{ m}$ is demarcated with colour blue. From the map, one-third of the study area showed fresh bedrock while two-third showed fractured bedrock from the general view. This shows that Adumasun is not totally competent for the construction of high-rise buildings.
