## Electromagnetic Investigation into the Cause(s) of Road Failure along Takie-Ikoyi Road, Ogbomoso.

### Abstract

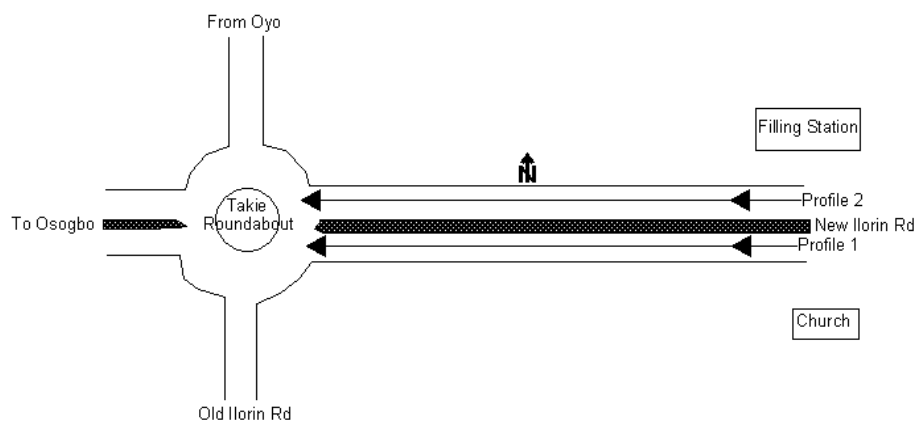
**Figure 1:** Base map of the study area.

Takie-Ikoyi road is located at the heart of Ogbomosho, a major link between Oyo and Ilorin. This road serves as major route for heavy vehicles travelling from Northern part to the Southwestern part of Nigeria and vice-versa. The area under study covers about 300 m long (figure 1) and lies between latitude 08° 08.180' to 08° 08.336' N and longitude 004° 14.162' to 004° 14.250' E.

Very low frequency electromagnetic (VLF-EM) method was used on 2 traverses along the road where each traverse covers a total length of 300 m each (figure 1). VLF-EM measurements were taken at 10 m interval along each traverse with ABEM Wadi portable VLF-EM surveying equipment (plate 1).

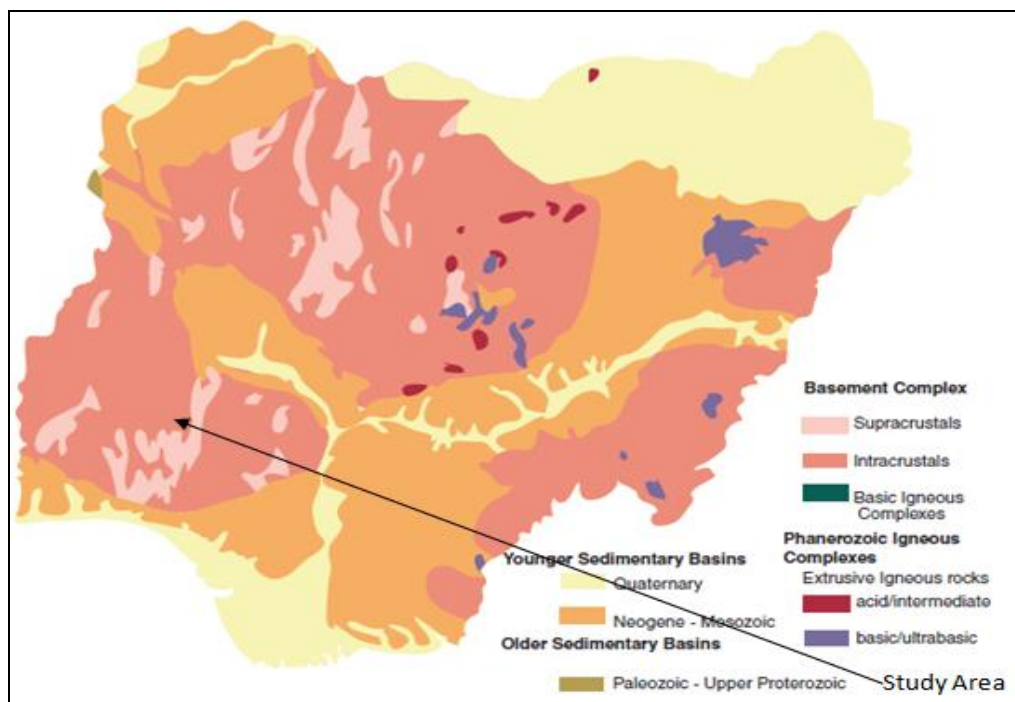
**Figure 2:** The geological map of Nigeria showing the study area.

Ogbomosho is underlain by rocks of the Precambrian complex. The rock formations in the study area are supracrustals and intracrustals rocks (figure 2). The rock groups in the area include quartzites and gneisses (Ajibade et al., 1988). Schistose quartzites with micaceous minerals alternating with quartzo-feldspathic ones are also experienced in the area. The gneisses are the most dominant rock type. They occur as granite gneisses and banded gneisses with coarse to medium grained texture but the main rock types especially in the study area is granite gneisses.

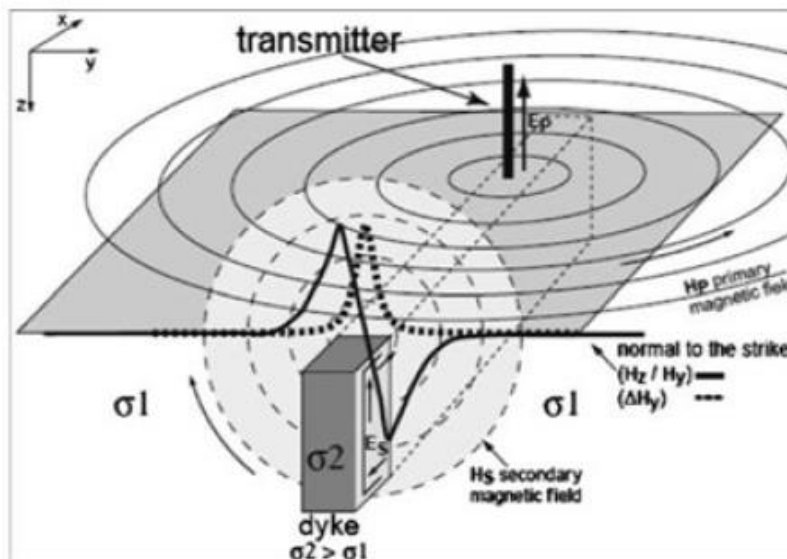
**Figure 3:** Components of VLF Field from Transmitter at Remote Distance (Ezepue, 1984).

The optimal configuration of the survey is to have the orientation of the geologic strike parallel to the direction of the transmitter so that a vertical magnetic component is generated for any electrical conductivity variation by the propagating horizontal and concentric magnetic field and the orthogonal electrical field (figure 3). This response is a powerful tool for study of variety of different geologic targets. The method also requires detection and incessant use of a precise transmitter with stable and sufficiently strong VLF signal for the entire survey. In figure 3,  $\sigma$  = Conductivity,  $H_p$  = Primary Magnetic Field,  $H_z$  = Secondary Magnetic Field,  $E_p$  = Primary Electrical Field, and  $E_z$  = Secondary Electrical Field.

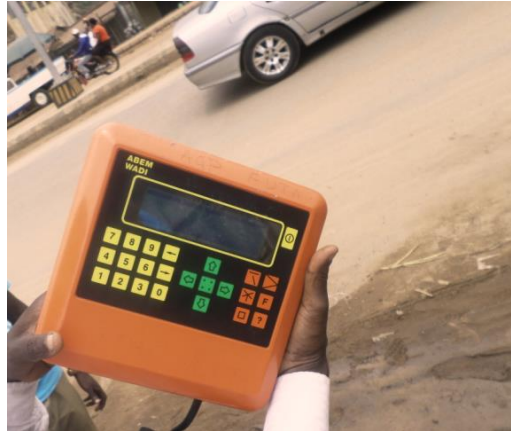
**Plate 1:** The VLF-EM equipment

This equipment makes no contact with the ground, but utilizes very low frequency band of 15–30 kHz with a fixed transmitter measuring the raw and filtered real components of the vertical to horizontal magnetic field ration (Karous and Hjelt, 1983). The raw and filtered real values (%) are plotted against station positions (m) using Microsoft Excel while the 2-D pseudosection map is obtained by using ‘KHFILT’ software. Global Positioning System (GPS), Compass, measuring tape of 50 m long, and photographs (plate 2) were all used in order to achieve the aim of the study.

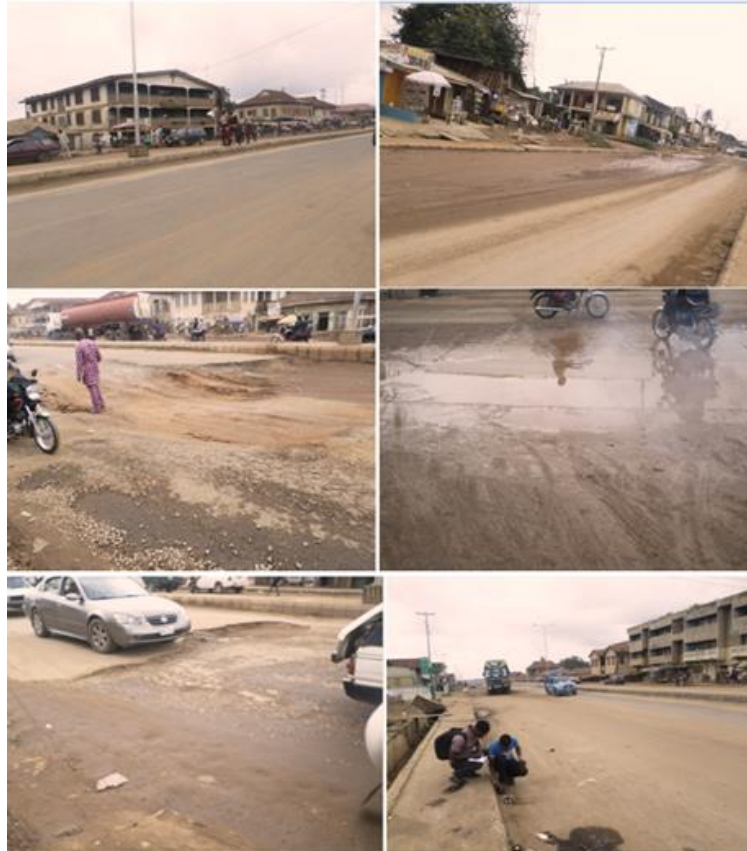
**Plate 2:** Snapshot of some stable and deteriorated portion of the study area.

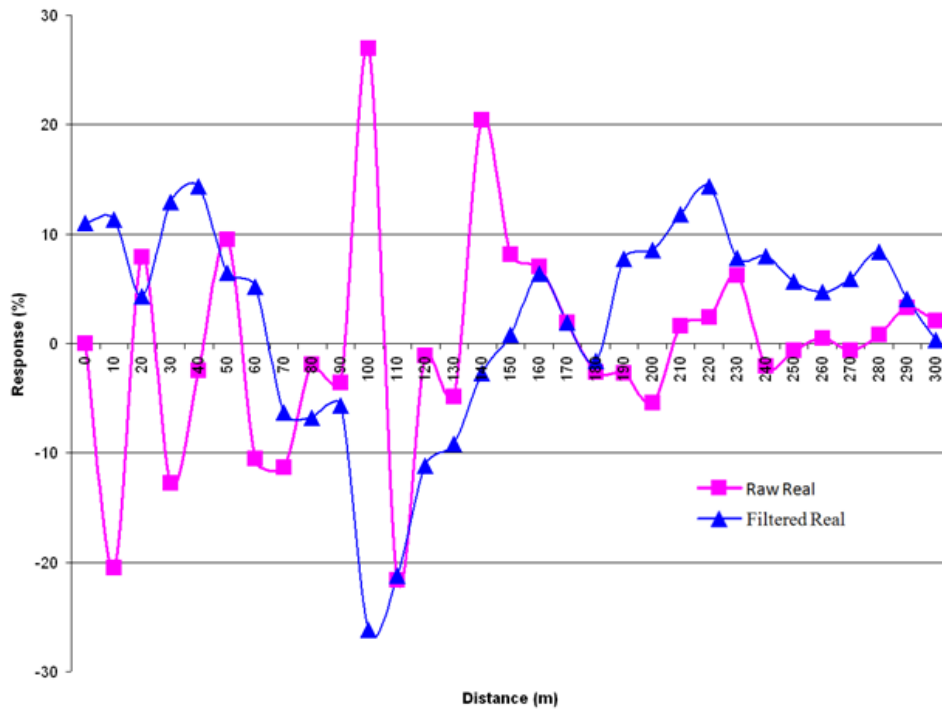
Figure 4a: VLF-EM profile along traverse 1.

However, the plot of Raw Real and Filtered Real plotted against station distances are shown as profile (figure 4a and figure 4b). The interpretation of these profiles are mere qualitative and this involves visual inspection of the profile for points where the maximum peak of the Filtered Real coincides with the point of inflections of raw real as such points are usually suggestive of presence of conductive (weak) zones. One of merits of using this interpretation technique is that the filtered real plot is better used to identify real anomalies, while the raw real plot is better used to identify anomaly positions (Reynolds, 1997). Several of such points were identified on the profiles. Furthermore, the presence of multiple peak Positive filtered real anomalies (as observed on the profiles) is suggestive of inhomogeneity of near surface material.

The results of the processed Very Low Frequency Electromagnetic profiling data were presented as VLF-EM profile and 2-D VLF-EM pseudosection. In order to aid good comparison between the two processing techniques used, VLF-EM pseudosection map was placed directly under VLF-EM graph of the same profile. Figure 4a and figure 4b show the corresponding results of the profiling and pseudosection analysis for profile 1 while figure 5a and figure 5b show the corresponding results of the profiling and pseudosection analysis for profile 2 respectively.

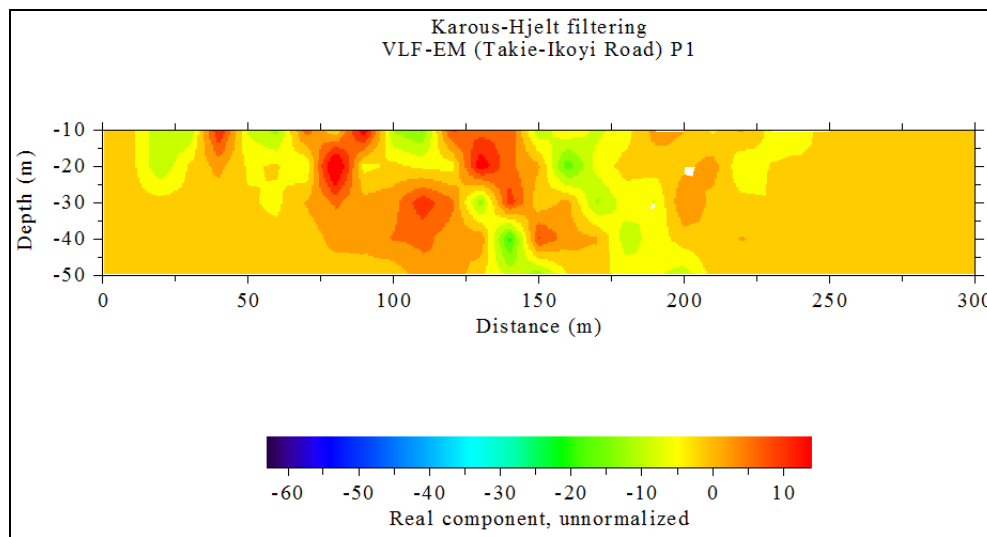
Figure 4b: 2-D pseudosection of traverse 1.

Figure 4b shows the corresponding K-H pseudosection of profile 1. Conductivity is relatively high throughout the profile but some are extremely high. The pseudosection is a measure of conductivity of the subsurface as a function of depth. The conductivity is shown as colour codes with conductivity increasing from left to right (i.e. from negative to positive). Different features of varying degree of conductivity trending in different directions were delineated on the section, for instance, from stations 70 m to 95 m and 120 to 145 m, a dome-like highly conductive body trending in W – E direction is shown. The depths of this conductive body extend up to 50 m. A conductive body at depth of 20 m to 35 m is also noticed beneath stations 196 m to 212 m. This cannot cause road failure due to the depth of investigation. Conductive body towards the surface (from station 35 m to 45 m, 70 m to 95 m, 120 m to 145 m, and 188 m to 200 m) are expected to be excavated and refilled with laterites before the construction began but unfortunately, these zones of weathered layer (clay) were ignored. These zones are the areas that will later fail though some still look stable as at the time of geophysical field survey.

The VLF-EM raw real data have been converted to the pseudosection using the KHfilter software. The visual inspection of this section allows depth of occurrence, width, and dip of the body to be determined. Figures 4b and 5b are typical VLF-EM pseudosections obtained on the traverses. From the figures, the attitude of the body, the length of fractures and depth to top and bottom of fractures can be determined. The occurrence of the fractures on the sections coincides with the delineated fractures obtained on the profiles using Microsoft Excel.

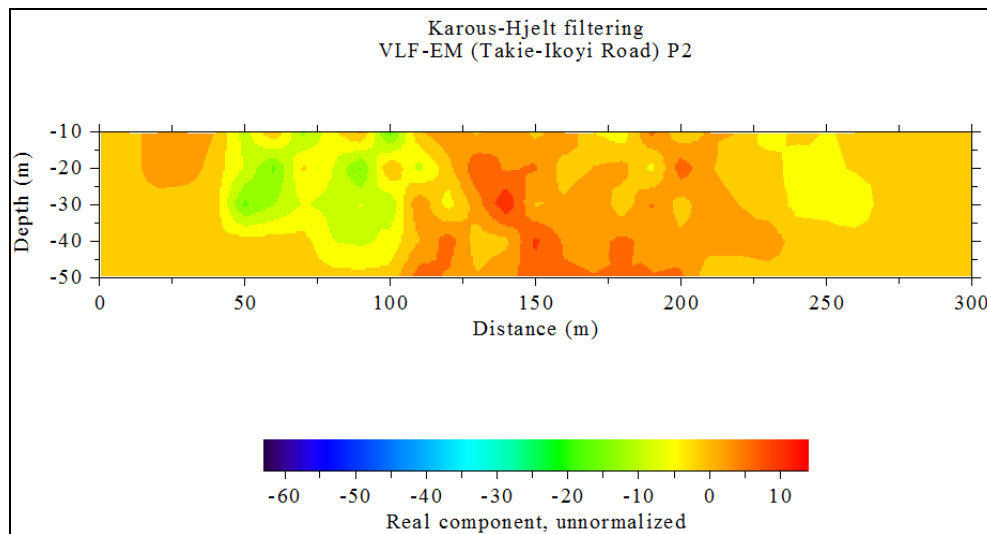
**Figure 5b:** 2-D pseudosection of traverse 2.

In figure 5b, different features of varying degree of highly conductive zones were delineated on the section, for instance, from stations 12 m to 40 m, 112 m to 162 m, 187 m to 195 m, and 205 to 218 m show highly conductive body. Pocket of conductive body noticed from station 112 m to 162 m, and 187 m to 195 m extend to the depth of 50 m. The two profiles show extension of weathered layer (clay) from station 120 m to 145 m (on profile 1) and 112 m to 162 m (on profile 2) respectively. For the purpose of road construction, these weathered zones (clay) needed to be excavated and refilled with laterites before the road was constructed but it seemed this precaution was not taken into consideration before the construction started.
