## AN INVESTIGATION OF THE EFFECTS OF POOR SPECIFICATION ON BUILDING COLLAPSE IN NIGERIA

**ABSTRACT.** This paper examines the effects of specification on building collapse in Nigeria. The study became necessary due to the ugly cases of buildings collapsing in the country over the years. In doing so, the study begins with review of relevant literature on the concept of specification, as well as the factors associated with building collapse. The need for specification in building construction projects was enunciated upon. Other factors that culminate in building collapse, such as load types; man-power; technical skills, etc. are discussed herein. The study further examines identifies and documents cases of building collapse in Nigeria to identify the causes and factors responsible for the collapse. Interviews were conducted with practicing professionals in the construction industry. This was done to obtain professional insights and experiences used as part of the data in the research. Findings from this study highlights consequential role of poor specification in causing building collapse, loss of lives and properties. This paper concludes with identifying the relevance of specific

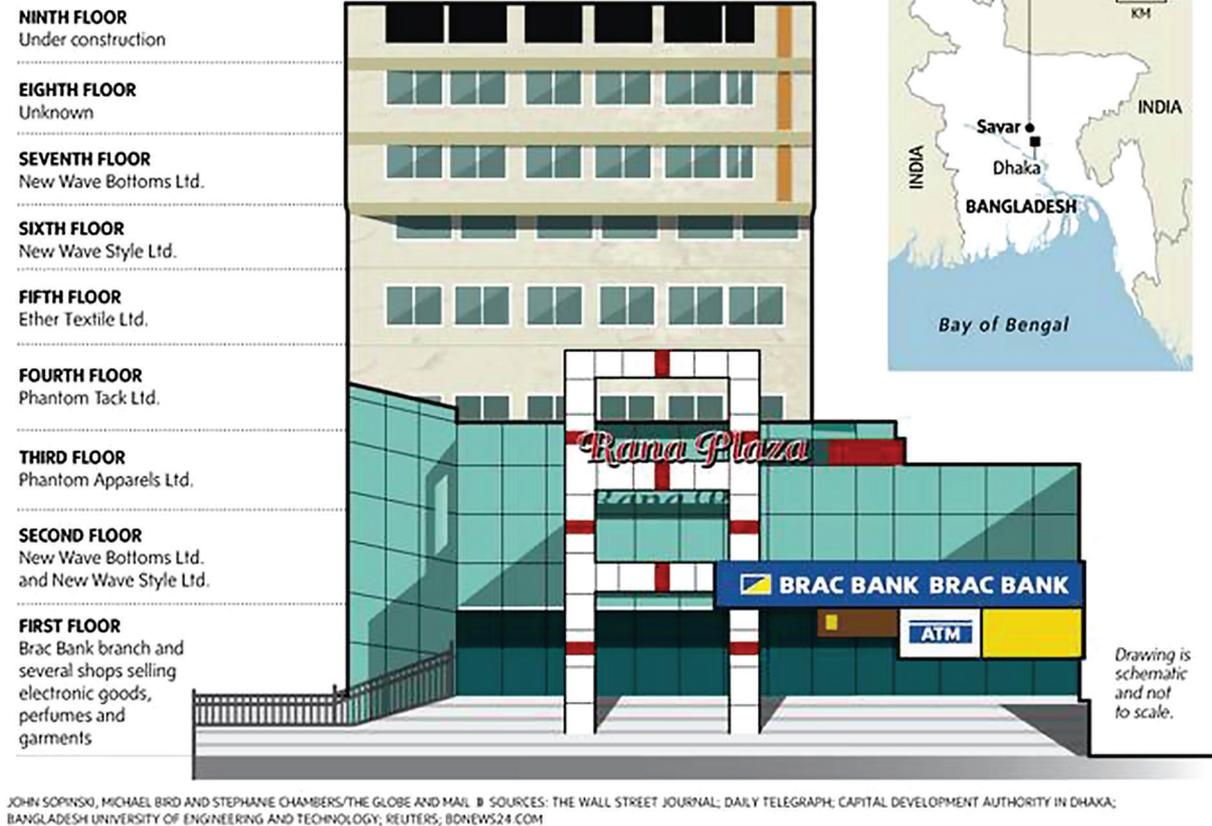
Figure 2. Occupants of all 9 floors of the Plaza (Source: The Wall Street Journal)

Than K. (2013), since the building was not designed to house factories, the possible combinations of load and vibration caused by machinery was never considered by any professional.

The opinions presented the professionals include the possibility of undersized columns and beams, as evidenced in Figure 1 and 2. The insufficient cement mortar bonding also caused the weakening of the concrete with age. Additional loading must be verified through calculations when all drawings are collated for detailed scrutiny.

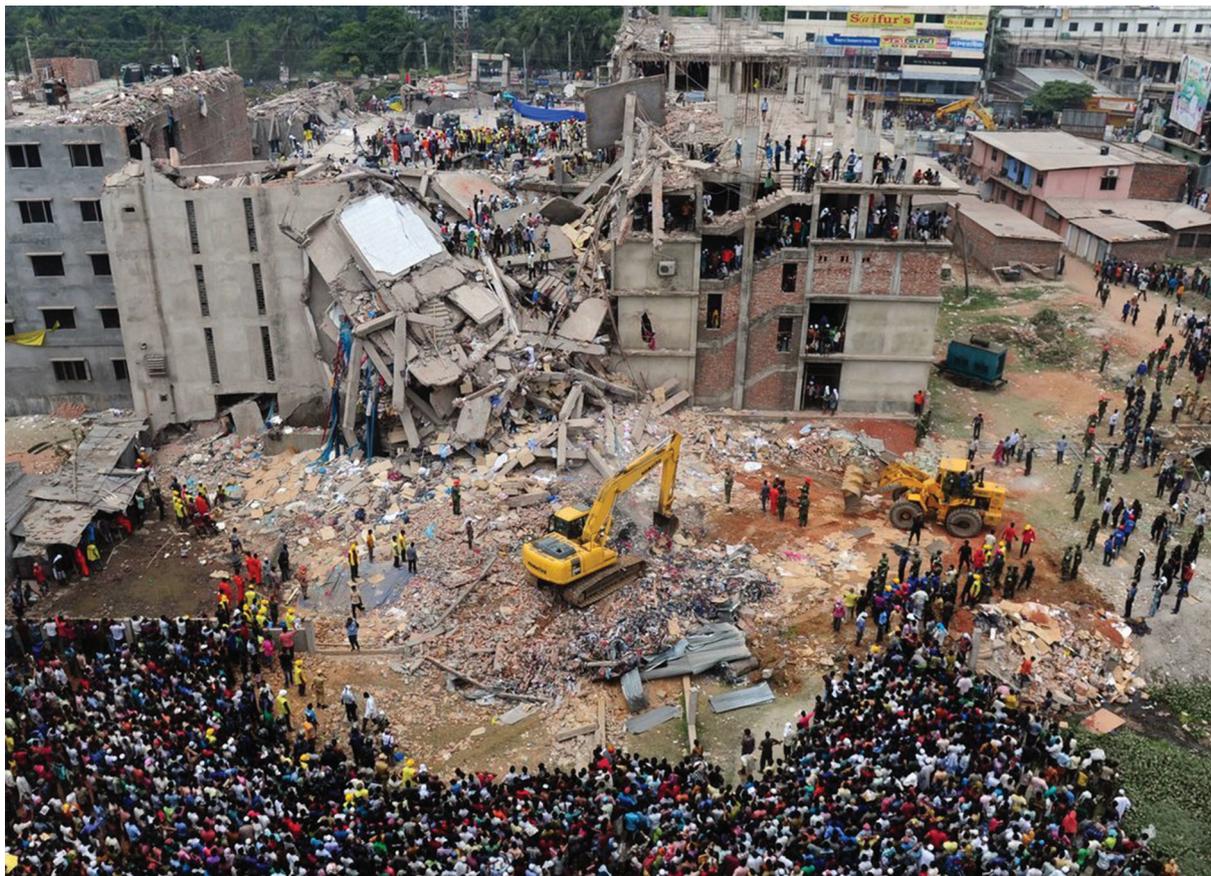
Figure 3. An aerial view of the collapsed plaza

The building was erected on a filled in pond but the foundation was designed for stable subsoil. According to Garvin H, an Engineer who investigated the collapse, “Part of the building was on much softer soil than the other so that part of the building settled down a little bit more”.

3. An overload of the building aggravated by vibrations from of the generators also the use of substandard construction material according to Than (2013), the substandard construction methods are a common problem in developing countries where construction materials can be expensive and building inspections infrequent. Dan Jansen, a civil engineer who investigated the collapse suggested that not enough reinforcement bars were used due to the way it collapsed. The quantity of reinforcing steel used did not allow optimal

load transfer and in addition, there may have not been enough cement in the concrete mix.

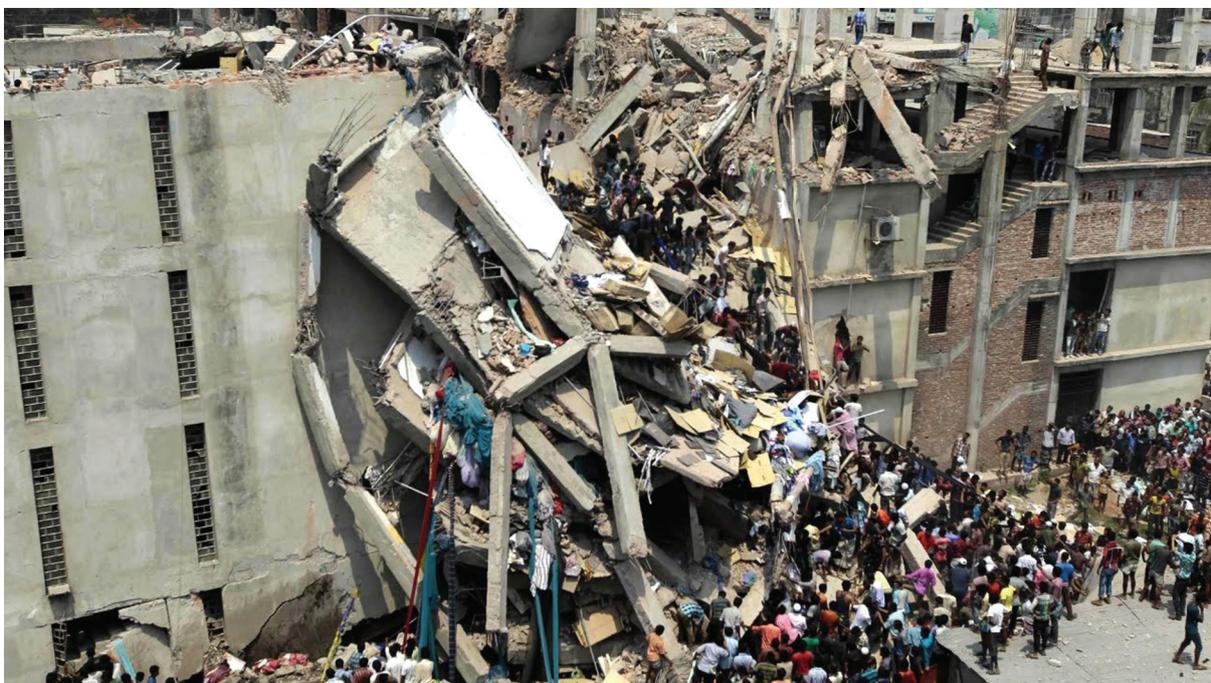
Figure 4. A closer view of the collapse

From the above findings, it can be seen there were design flaws in relation to the materials and methods adopted for the project right from the substructure. The foundation type suitable for the location was not used but rather a cheaper one was used. In addition, substandard materials were used either due to corruption or due to lack of having a proper specification document for the project. It is therefore important to have a specification document drawn up before construction and adhered to during construction to avoid partial or complete collapse of a structure.

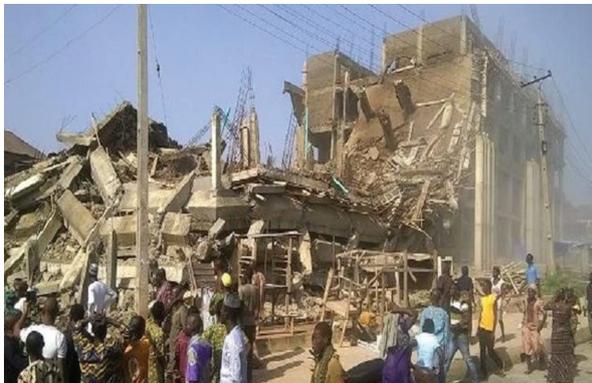
Figure 5. Meiran building collapse (Source:360Nobs.com)

Cause of collapse: Heavy loads placed/substandard materials used for the construction work.

The Lagos State Government attributed the building collapse to overloading of the building structural members and the use of substandard building materials. Furthermore, the site on which the building collapsed has a completed bungalow and a shop extension in front of it, which had a decking stacked with loads of building materials. The building that occupied the site had no planning permit and work was to be halted on the site as building Control officers had instructed to ensure compliance and monitoring. It is safe to infer from the foregone that specifications did not play a vital role during the construction process. It is possible that the construction commenced without a clear direction concerning materials specification, or the builder cum contractor took the liberty of specifying when construction was already in process.

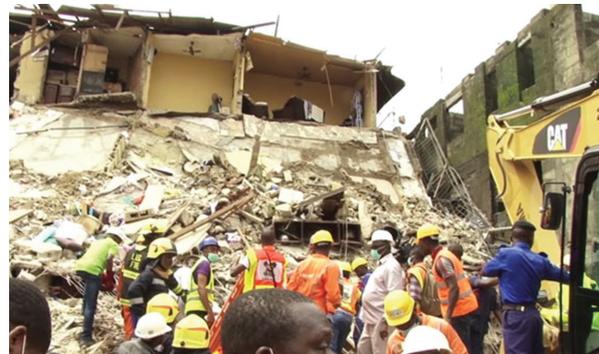
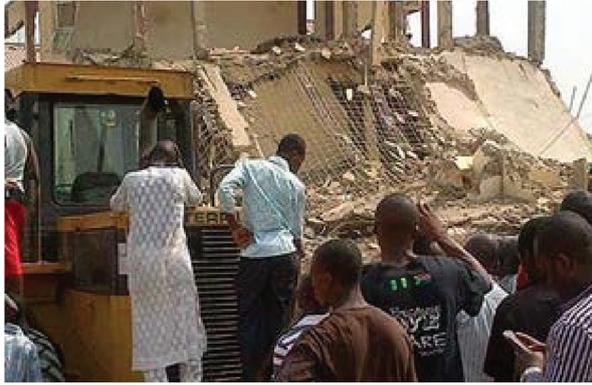
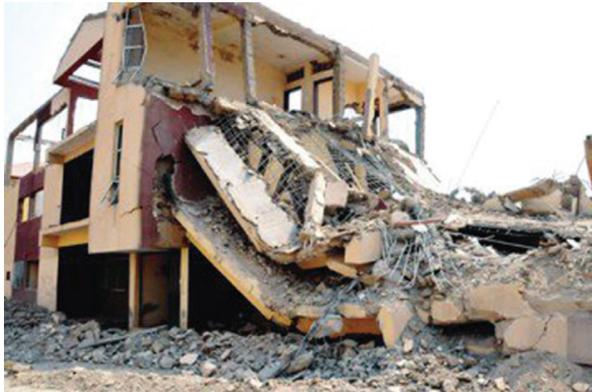
Cause of Collapse: Structural defect/human error

Figure 7. Ruins of Naval Building (Source: google image, 2012)

Figure 8. Ruins of Naval Building(Source: Nnabugwu, 2012)

Figure 9. Ruins of Naval Building(Source: Adepegba, 2012)

It is then safe to assume that material specification, quality of workmanship, which is contained in a specification document, was either non-existent as part of the construction document or its instructions were deliberately ignored. This is a common practice of some contractors to maximize profit, which has led to death and loss of investment.

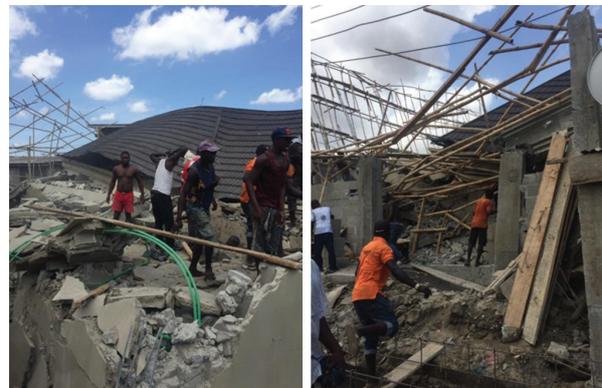
Figure 10. Ruins of the collapsed building

Cause of Collapse: Substandard Building Material and Faulty Foundation.

The building was initially being renovated, but a ‘stop order’ was issued and marked for demolition by the Federal Capital Development Authority (FCDA) due to structural defect observed as the building was said to have deteriorated over time. The collapse occurred when the building was being demolished [16]. The contractor proceeded with the demolition exercise without waiting for the approval of the formal application for demolition already submitted to the FCDA. Aside from starting the demolition without approval from the appropriate authority, inexperience man-power was used to execute the work. They started the demolition process from the ground floor, which was the primary trigger for the collapse [16].

Results from Investigations conducted, indicated impurities such as biotite and muscovite to be present in the concrete mixture, which was one of the factors that may have led to the deterioration of the structural elements [16]. Mica, Feldspar and quartz are composition of an aggregate stone. The mica portion is made up of biotite and muscovite and they are both oxidizing agents that caused structural members to weaken over time [17]. Under close observation, it was noticed substandard materials were used that includes the reinforcement and coarse aggregate. And as well as poor workmanship as the debris revealed poor mix ratio and an uneven distribution of the constituent of the concrete [16].

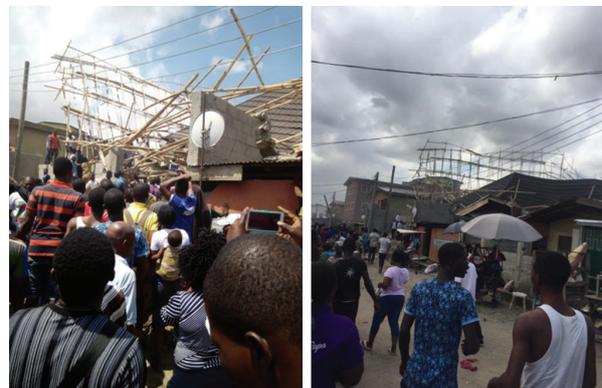
Figure 11. Ruins of the collapsed building

Observation from the site showed a building built with sand-crete blocks on a frame structure made up of reinforced concrete columns, beams and floor slab. Eyewitness account stated that the building was built on the foundation of a demolished structure, due to the perceived need for the client to complete the building in record time. Other possible cause of the building collapse has been attributed to use of sub-standard building materials and shoddy workmanship.

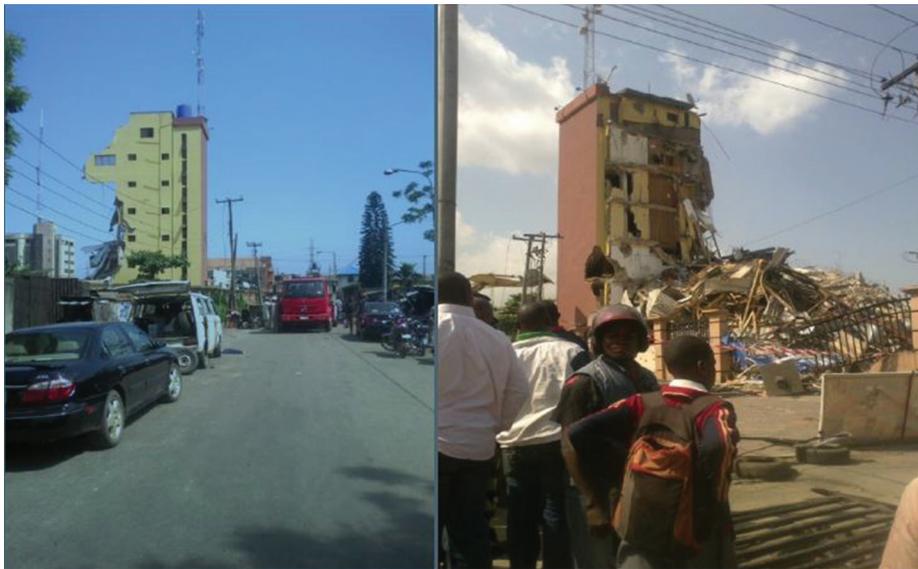
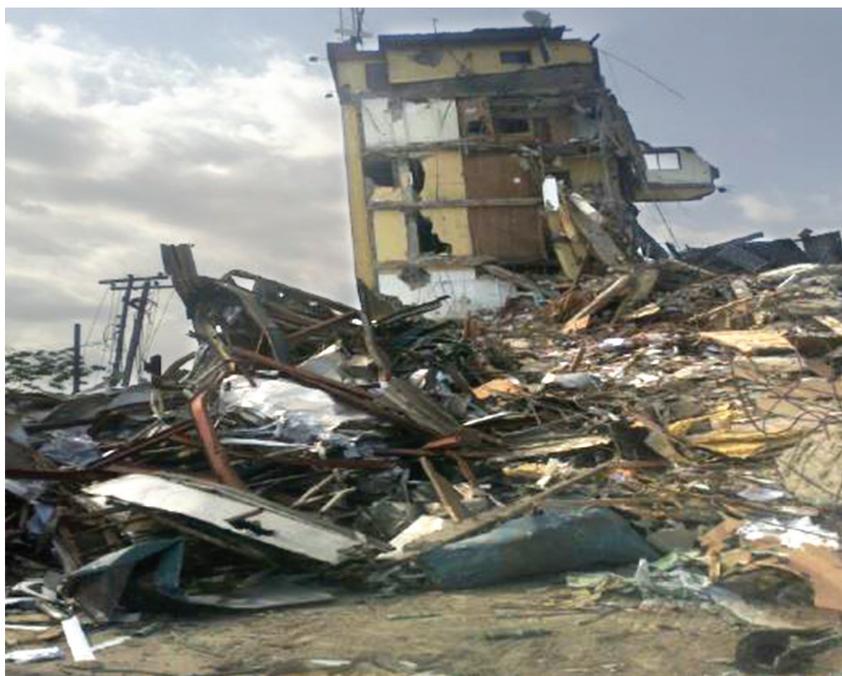
Cause of collapse: Structural defect/human error.

The building was a modern five-storey building with a floor. Visual examination by the Nigerian Building and Road Research Institute (NBRRI) revealed that it was built from reinforced concrete and block walls. There was a communication mast on top of the

building and a large billboard that was hung on the building dangled loosely. Long span Aluminium roofing sheets were used in roofing the building and the building carried a large water tank. Concrete columns and beams were seen dangling loosely from what remained of the building. According to eyewitnesses, it was revealed that a loud bang was heard at about 3pm on the day of the collapse, the wall panels began to give way and fall apart leading to the caving-in of the core of the building at about 6:45pm. Some occupants were said to have earlier noticed cracks on the walls, which was reported to the owner who promised to rehabilitate the building but this didn't happen before the collapse.

Figure 12. Ruins of the collapsed building

**Figure 14.** Ruins of the collapsed building

The professional responsibility cannot be ascertained as the structure had been in occupation for over a decade before its collapse. The post-mortem evaluation by Nigerian Building and Road Research Institute (NBRRI) discovered that since the occupants had observed and complained of several cracks which was a red flag on the imminent danger: this indicates that there was a gross Serviceability Limit Violation: and not an Ultimate limit state violation. From what remained of the structure it was deduced that the core of the structure had settled differently from the other parts, thereby leading to the redistribution of stresses prompting the splits in the auxiliary components such as columns, beams and slabs. Perhaps there had been any significant extension OR development joint between these parts of the structure, the settlement of the centre would not have constituted any problem if it were uniform over appropriate sections of similar loading. The settlement of the core would not have constituted any issue on the off chance that it was uniform over appropriate areas of that are loaded similarly. Nevertheless, for this situation, the stresses were transferred to the areas through the years and the pressure redistributions were kept away from failure by the steel reinforcements present. In any case, the cracks logically expanded throughout the years until the point that an ultimate resistance of a critical area gave way prompting the underlying spalling and cracking sounds that observers gave record of. Moreover, the primary Site examination has uncovered that the Pad foundations on location were in place, with no tilting or sinking, at the point of collapse. Thusly, the differential settlement could have been principally the after-effect of the indi-

- (i) Inappropriate sizing of the columns;
- (ii) Improper bonding;
- (iii) Absence of stability ties for a structure with such height;
- (iv) Insufficient shear reinforcement;
- (v) Improper calculation of the load carrying capacity of the structure;
- (vi) Additional load on the structure (the big billboard and the spire at the top on the roof);
- (vii) Committee noticed the building's foundation even after collapse, did not sink into the ground.
