CORROSION RESISTANCE OF SUPER AUSTENITIC STAINLESS STEEL IN SEA WATER

C. A. Loto* and M. B. Ives,

*Institute for Materials Research,
McMaster University, Hamilton, Ontario,
Canada L8S 4M.*

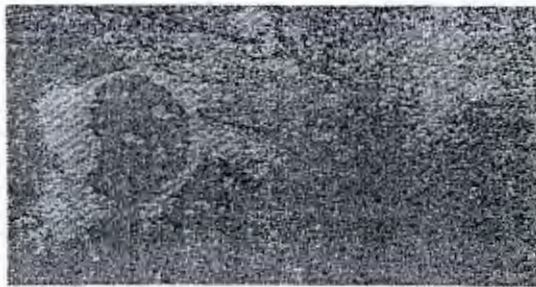
Fig 6

6. Optical microscope photograph of other numerous under deposit local corrosion attack site in AL6XN (NO8367) alloy tube. Mag.x 6.4 (Glass ball size = 2.5mm).
7. Optical microscope photograph of an under deposit local corrosion attack site in AL6XN (NO8367) alloy tube. Mag.x 6.4 (Glass ball size = 2.5mm).
8. EDAX analysis of the biofilm in the steam chamber portion of 904L (NO8904) alloy tube.
9. EDAX analysis of the biofilm in the steam chamber portion of 904L (NO8904) alloy tube.
10. EDAX analysis of the biofilm in the outlet portion of 316L (S31603) alloy tube.
11. EDAX analysis of the corrosion deposit obtained from a macroscopic local corrosion attack site in the steam chamber portion of AL6XN (NO8367) alloy tube used as dummy in two test runs.
