Electrochemical Noise Measurements— Spectral Density Curves

SEM Micrographs

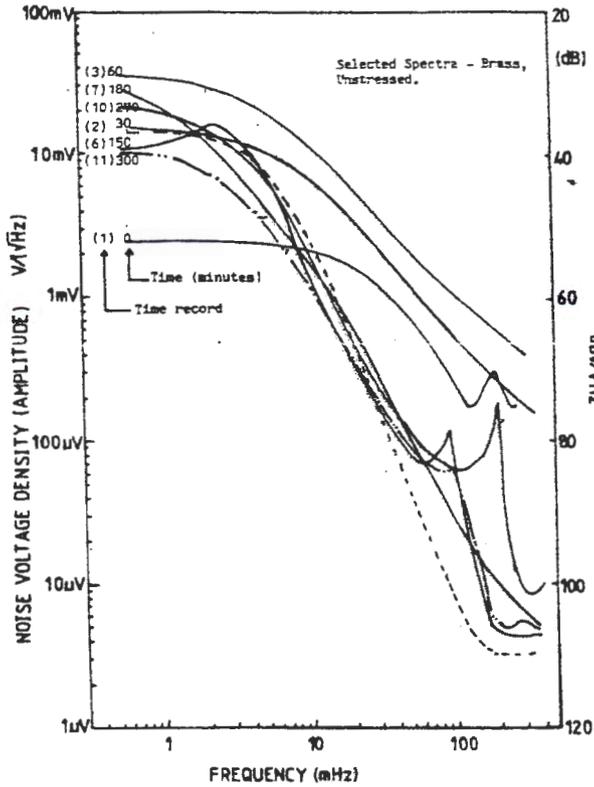
FIGURE 3 — Selected spectra—brass, unstressed.

Figure 3 gives the unstressed specimen's spectral curves. The curves tend to merge at higher frequencies of 10 and 100 mHz. Figure 4 shows the stressed specimen curves. In most cases, the times that a macroscopic crack was observed correspond to the highest noise amplitude at low frequency. For example, the highest noise amplitude occurred at time record 7 (180 min) at the lower frequency and at time record 10 (270 min from the start of the experiment) at higher frequencies. The crack first became discernible when these times were observed. For all specimens tested, the first time record is always observed to have one of the highest noise amplitudes at low frequency, and always the highest at the higher frequency ranges.

The unstressed alpha-brass specimen shows spectra, as denoted by the time record numbers, that are inversely proportional to the frequency. The noise amplitudes are very distinguishable only at the very low frequency and the noise spectral density tends to increase without limit as the frequency decreases. These characteristics indicate a low frequency noise and are typical of $1/f$ or flicker noise.^{12,13}

The highest noise amplitudes recorded for time record 1 to 3 (Figure 3) with roll-off slopes of -19 , -18 , and -19 decibel (db)/decade respectively, may be associated with the formation of the black tarnish film identified as Cu_2O ^{11,14}. The formation of Cu_2O is thought to result from the preferential dissolution of Zn atoms accompanied by the oxidation of the remaining enriched copper layers to Cu_2O ; the oxidation of Cu_2O is believed¹⁵ to involve solid state diffusion processes. In contrast, the formation of the black tarnish, Cu_2O , is also thought by Vermilyea to result from the dissolution of the whole alloy followed by precipitation of Cu_2O ¹⁶. Whichever mechanism is correct, diffusion and dissolution of an electrode have been identified as sources of noise.¹⁷ The diffusion fluxes of reaction species at the electrode/bulk solution interface may contribute to the noise generated at the interface. The randomness of the diffusion phenomenon of a corroding metal may be explained in terms of the collisions between ions of the diffusing species, and/or ions of the diffusing species with solvent molecules, under the influence of the concentration gradient. Also, complete alloy dissolution followed by precipitation of Cu_2O may cause the generation of noise resulting in high noise amplitudes. This behavior is possibly caused by surface inhomogeneity resulting from the metal dissolution, and the randomness of the precipitation reactions which might have contributed to the potential fluctuations. The highest noise amplitudes, as given above, seem to indicate the degree of corrosion process on the specimen.

The time records 4 to 6 have increasing noise amplitude with a single sharp peak at the higher frequencies of 100 mHz. This increasing noise amplitude may correspond to the occurrence of pitting;^{7,18,19} however, the sharp peak is still difficult to explain. Though this has been associated with crevice attack,¹⁸ it is subject to further verification. The roll-off slopes have changed substantially to -36 , -38 and -40 db/decade respectively. The increased surface inhomogeneity, chemical reactivity and the randomness of diffusing fluxes possibly contributed to the increased potential fluctuations of the pitting processes and hence the increasing noise amplitude recorded.

A further increase in noise amplitude was recorded at time record 7 with a roll-off slope of -38 db/decade. This change in the noise behavior may be associated with further pitting.

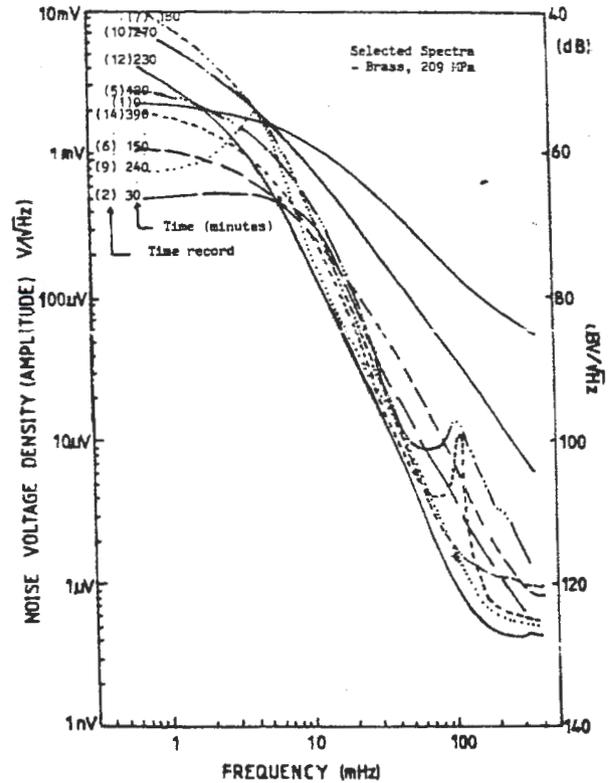
FIGURE 4 — Selected spectra—brass, stress 209 MPa.

Generally, the corroding specimens follow a trend of high noise amplitude at the beginning as indicated, particularly by the curves of the spectral density and the standard deviation/time (Figures 4 and 5). This observation may be associated with the growth of black tarnish film. The high amplitude was followed immediately by a period of low noise amplitude or

noise was generated from more corroding actions such as film rupture and crack growth by dissolution. Secondly, the formation of the black tarnish film, Cu_2O , appears faster as indicated by time record 2 (Figure 4), which has the lowest noise amplitude.

Increased noise amplitudes as indicated by the time records 3, 4 and 5 of the spectral density curves with roll-off slopes of -39 , -39 and -50 db/decade respectively, were obtained (Figure 4). These increasing noise amplitudes which give sharper slopes than time records 1 and 2 presented above, may relate to a process of film-breakdown and probably with the onset of pitting. The roll-off slopes here can be compared with similar corrosion process in the unstressed specimen discussed above. A further decrease in noise amplitude at time record 8 with less steep roll-off slope of -26 db/decade indicates a change in noise behavior from the upward trend: this change may be associated with a repassivation process resulting from a probable reduction in the anodic processes, diffusion processes, and chemical reactions which could lead to a reduction in potential fluctuations. The spectral density curve at time record 9 gives a low noise amplitude at the low frequency but with a single sharp peak at ~ 5 mHz and at 100 mHz. As stated earlier,¹⁸ it is difficult to characterize the single sharp peak with crevice corrosion in this work since crevice corrosion has been observed in association with pitting.

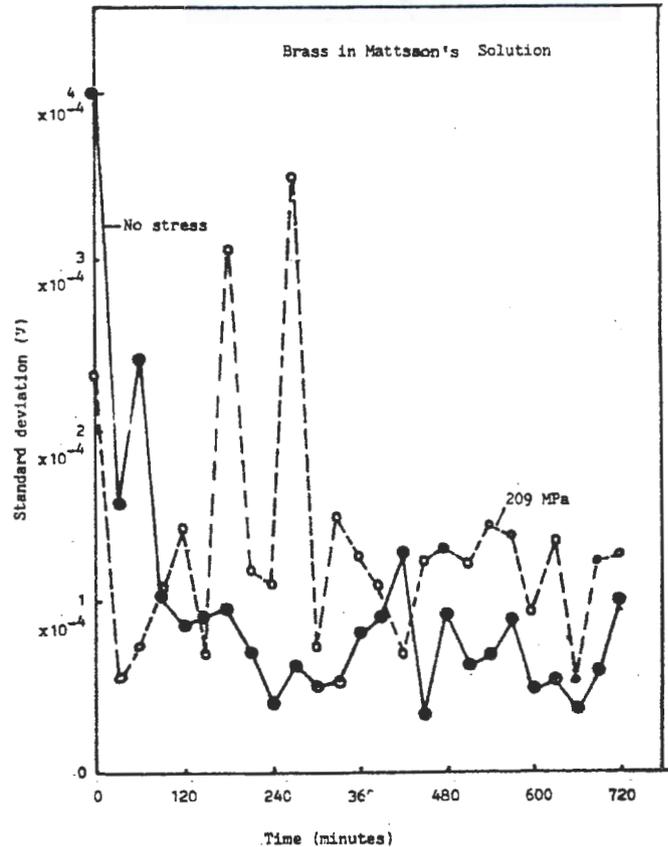
The standard deviation (spectrum)⁽⁵⁾ vs time curves for the unstressed specimen (Figure 5) showed no particular trend. For the stressed specimen - 209 MPa (Figure 5), the highest peaks occurred at 180 and 270 min, respectively, from the start of the experiment and correspond to the times that

FIGURE 5 — Standard deviation vs time—brass, stress 209 MPa and unstressed.

macroscopic cracks were observed on the specimen's surface. This observation is also in agreement with the spectral density curves in which the curves that show the highest noise voltage density (amplitude) at the lower frequency range in the plot are given by the times of 180 min (time record 7) and 270 min (time record 10) respectively (however, this correlation is expected since the standard deviation (spectrum) bears a direct relationship with the spectral density curve as expressed in footnote (5)).

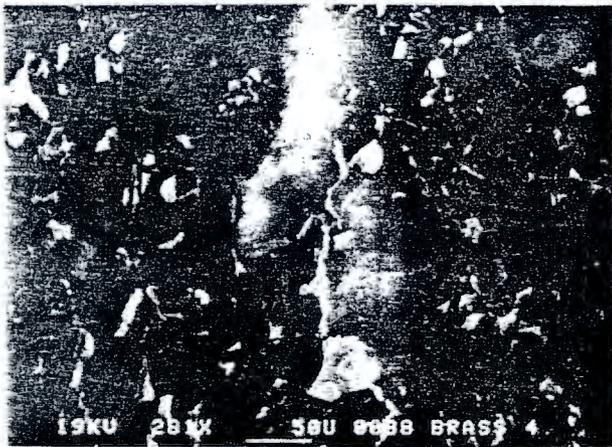
FIGURE 7 — Brass specimen observed cracks—240 min in solution. (Time record 8.)

Within 20 min, the rupture of the black tarnish film on the specimen's surface was observed in solution (Figure 6). The micrographs showed that pitting occurred on the specimen surface within 1 h of its immersion in the Mattsson's solution. A crack was observed on the specimen's surface as at 4 h (time record 8) of the specimen in solution, and the cracks apparently started from the pits (Figure 7). The micrographs also show that more than one crack was formed and all tended to originate from corrosion pits on the specimen surface (Figures 8 and 9).

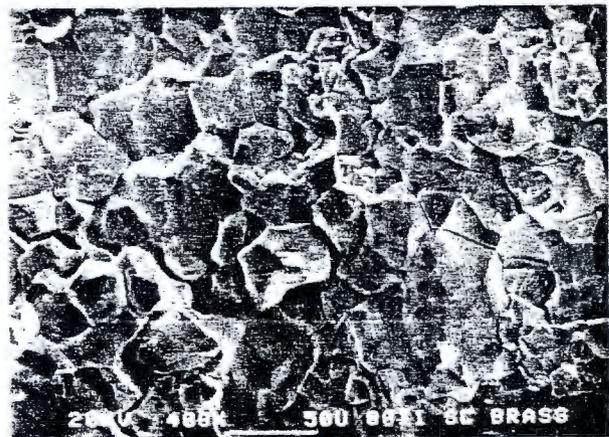
Figure 10 shows the fractured surface of the alpha-brass specimen which indicates intergranular failure, a characteristic of SCC.

FIGURE 10 — Fractured surface of the alpha brass alloy specimen (showing intergranular failure).
