**ELECTROCHEMICAL NOISE GENERATION DURING CORROSION OF STAINLESS STEEL-TYPE 316  
IN ACID CHLORIDE ENVIRONMENT**

# Electrochemical Noise Generation During Stress Corrosion Cracking of the High-Strength Aluminum AA 7075-T6 Alloy<sup>☆</sup>

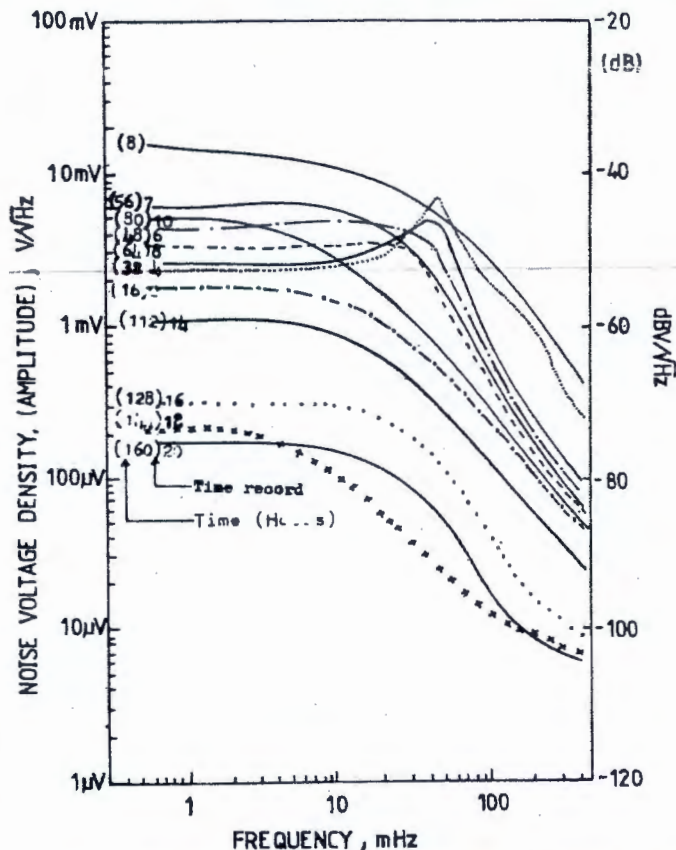
The selected spectral density curves for the austenitic stainless steel specimens are shown in Fig. 1. The noise amplitudes (voltage density) for the specimens decreased from time record 1 to time record 4 (32 hours from the start of the experiment) and thereafter started to fluctuate up to time record 10 (80 hours from the start of the experiment) with a tendency towards decreasing noise amplitude. This phenomenon continued to time-record 14 (112 hours). A trend of high noise amplitudes at the low frequency of about 1 mHz which decrease with increase in frequency passing 100 mHz was obtained. In Fig. 1 the lowest noise amplitudes were recorded for the specimen at the last seven time records, that is, time-records 14 to 20 corresponding to 112 to 160 hours from the start of the experiment.

Fig. 1: Selected spectra-austenitic stainless steel (Type-316) in acid chloride environment

The lower noise amplitudes, that is, from time record 2 to time record 4 (16-32 hours) with average roll-off slope of -22dB/decade may be associated with a passive state of the surface of the specimen due to the inhibiting protective film of the stainless steel. The increased (higher) noise amplitude at time record 5 (40 hour) with a roll-off slope of -26dB/decade may be associated not only with film breakdown but also with active corrosion. This is probably the beginning of general corrosion which dominated the whole corroding surface of the specimens. The fluctuations of the spectral density curves (Fig. 1), indicate the random depassivation and repassivation corrosion processes of the surface of the corroding specimens in the test medium. The noise amplitudes at the low frequency, in particular, were very random and this could be due to the potential fluctuations of the corrosion reactions.

The last seven time-records, that is, time-records 14 to 20 (from 112 to 160 hours from the start of the experiment), gave the lowest noise amplitudes. A drastic reduction of corrosion reactions caused apparently by the stifling effect of the observed heavy precipitation of the corrosion products on the test electrodes in the corrosion cell, must have necessitated this phenomenal corrosion behaviour. These recorded lowest noise amplitudes could also be due to the intense contamination of the test solution by the corrosion products, lessening its chemical reactivities.

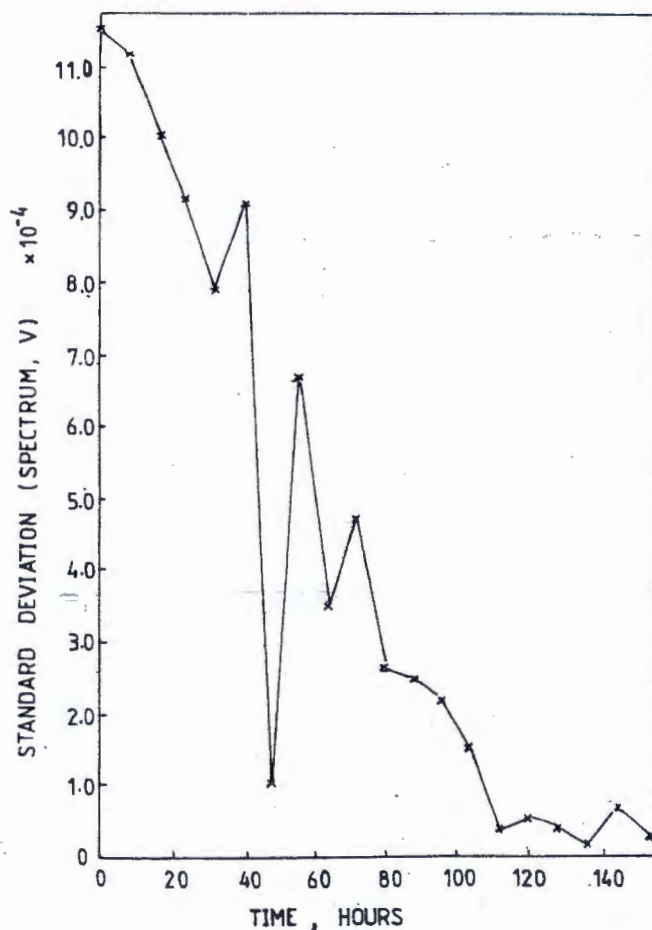
The standard deviation (spectrum) vs time curve for the specimen is shown in Fig. 2. There was a decrease of standard deviation

Fig. 2: Standard deviation vs time curve-Austenitic stainless steel (Type 316) in acid chloride environment

with respect to time up to 32 hours from the start of the experiment. Just after this time, a wide fluctuation of standard deviation curve with time could be observed up to the 80th hour from the start of the experiment. A sharp decrease of standard deviation from the 80th to 112th hour from the beginning of the experiment could again be noticed. The last 48 hours of the experiment showed very little variation of standard deviation with time.

The standard deviation (spectrum)/time curve, Fig. 2, corresponds with the spectral density curves. The correspondence is expected since the spectrum standard deviation is the average noise power within a spectrum and can be shown to be the area under a particular spectral curve.

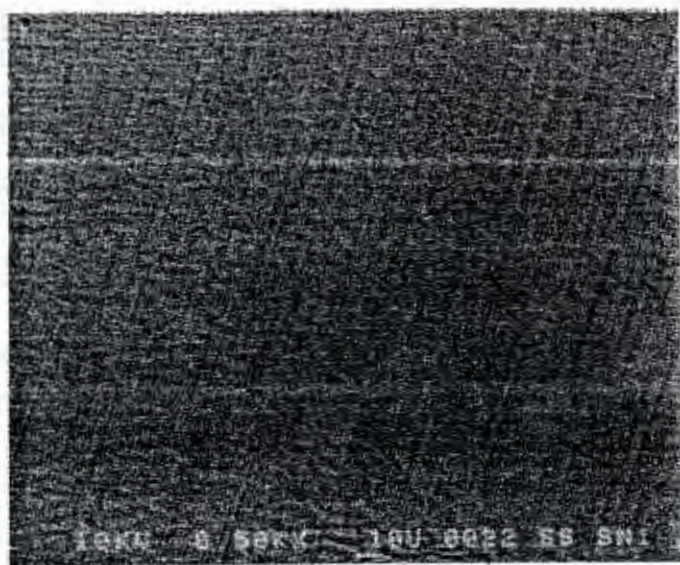
The scanning electron micrographs made from the plastics replicas of the surface of the specimen are shown in Figs. 3-5. No cracking of the surface of the specimen is discernible. However, severe pitting and general corrosion of the surface of the specimen could be clearly observed.

Fig. 3: Plastic replica of the steel specimen's surface before being immersed in acid chloride solution

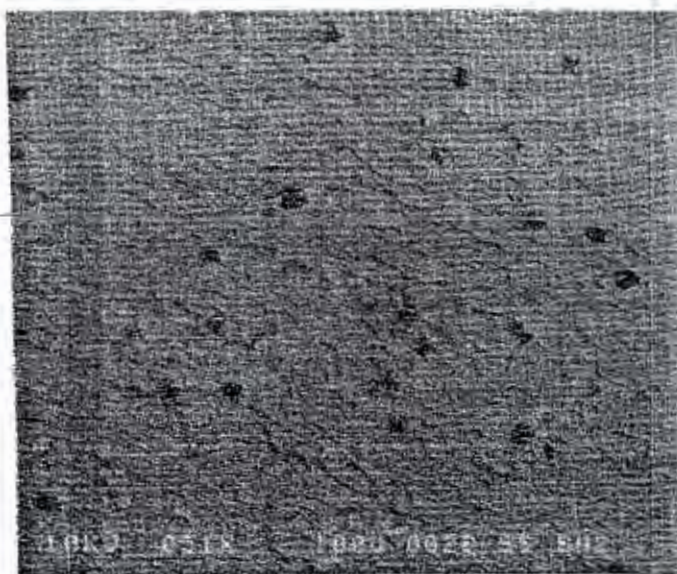
Fig. 4: Corroded surface of the steel specimen in acid chloride solution showing pitting (plastic replica)

SEM micrographs made at the end of the test also show pitting and general corrosion processes (Figs. 4 and 5). Mechanistically, the observed corrosion processes as obtained from the spectral density curves, standard deviation (spectrum) vs time curves and the SEM micrographs, seem to be consistent with film rupture/anodic dissolution mechanism.

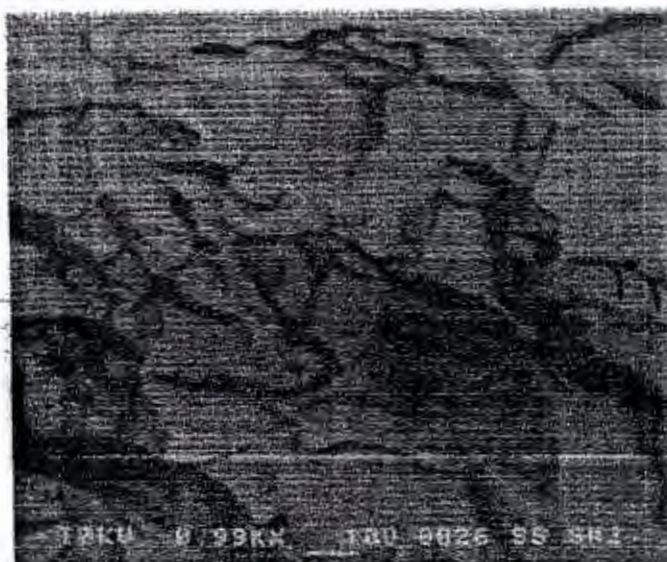
Fig. 5: Corroded surface of the steel specimen in acid chloride solution showing general corrosion interspersed with intergranular corrosion as indicated by the channels/grooves on the specimen's surface (plastic replica)

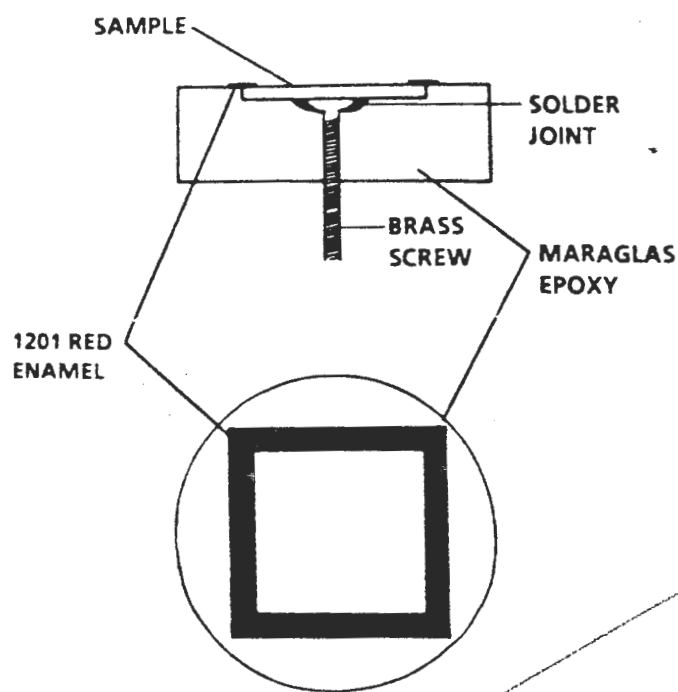
FIGURE 1. Schematic representation of a corrosion sample with the metal/epoxy mount interface coated with protective enamel.

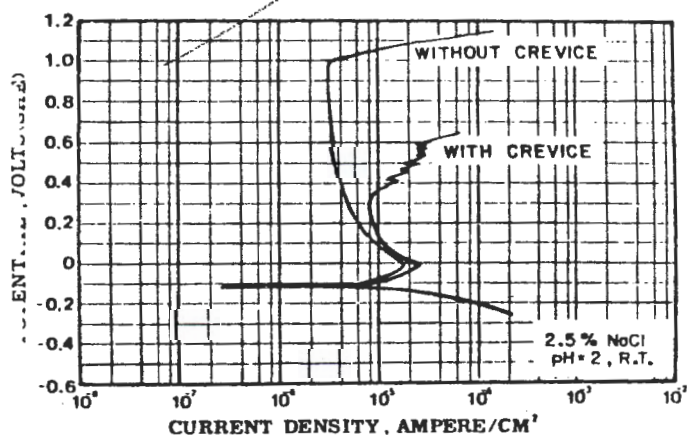
FIGURE 2. Polarization curve for AISI 316L SS (a) without and (b) with crevice corrosion (2.5% NaCl at 27 C, pH = 2, 3 V/h).

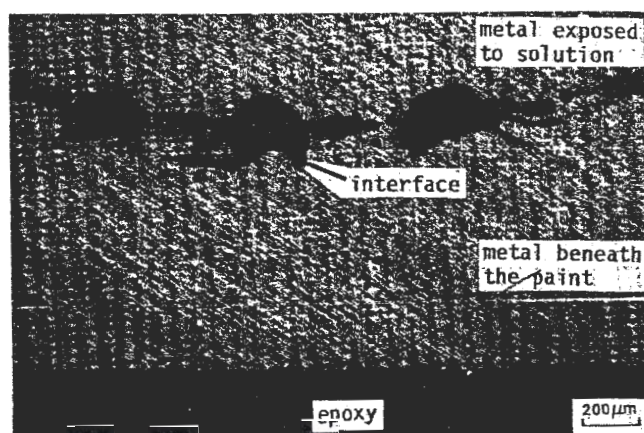
FIGURE 3. Representative appearance of crevice corrosion at the interface between the metal and the enamel for a non-prepassivated sample.

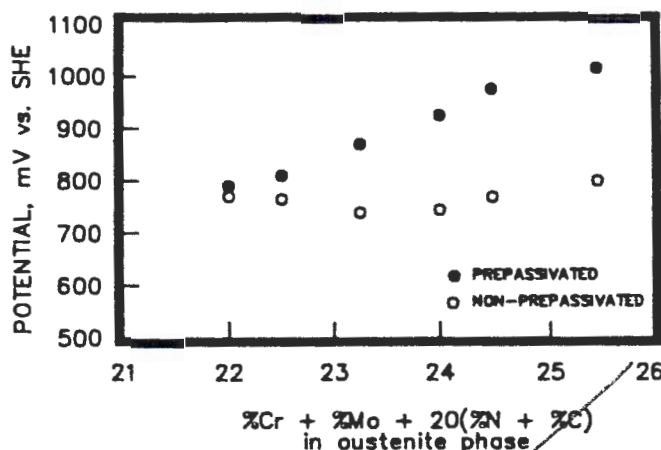
FIGURE 4. Comparison of the pitting potential determined for prepassivated surface by standard cyclic polarization and that determined for surface without prepassivation for solution-treated CF-8 alloys. All other procedure variables remain constant (1 N sulfuric acid with 0.5 M NaCl at 27 C, 3 V/h).

cal) compositions within an alloy class. By a large margin, the major compositional variable in the set of alloys depicted in Figure 4 is the nitrogen content, which varied from 0.02 to 0.17% with essentially constant Cr (20.5%), Mo (0.2%), and C (0.05%). As is obvious from the data in Figure 4, no significant effect of nitrogen would have been observed without the prepassivation treatment. For the test condition including the prepassivation treatment, the post-test surface generally revealed several pits far removed from the metal/enamel interface with no other indication of attack.

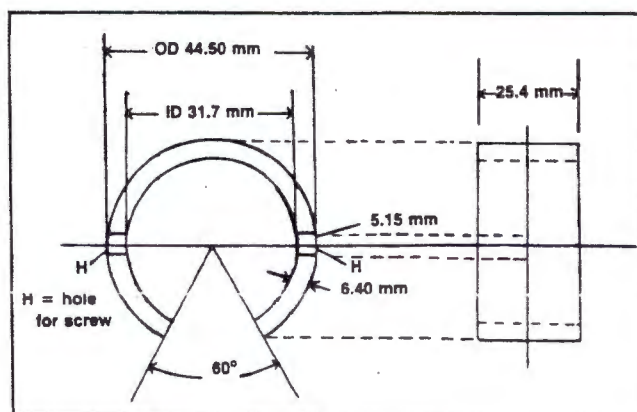
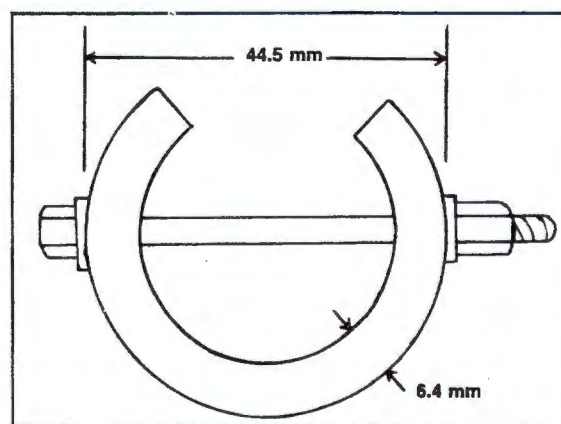
FIGURE 1. (a) Al alloy C-ring specimen preparation for stress corrosion test; (b) Al alloy C-ring specimen.

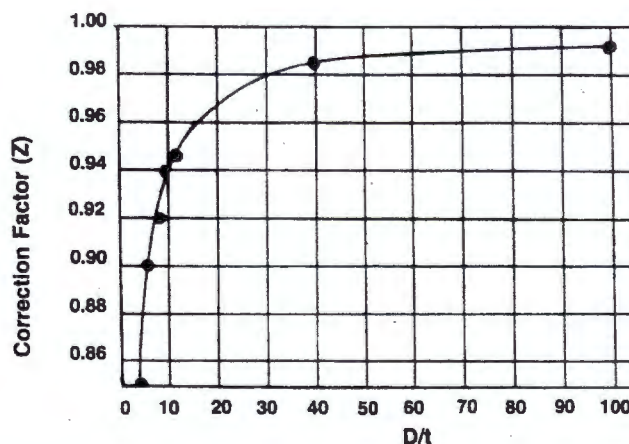
where:  $\Delta$  = change of OD, giving desired stress (mm);  $f$  = desired stress ( $\text{MN/m}^2$ ); OD = outside diameter before stressing (mm);  $t$  = wall thickness (mm);  $D$  = mean diameter ( $\text{OD} - t$ )mm;  $E$  = modulus of elasticity ( $\text{MN/m}^2$ );  $Z$  = a correction factor or a constant function of ring  $D/t$  (Figure 2); and ODf = final OD of stressed C-ring (mm).

FIGURE 2. Z correction factor used in formula by which C-ring stress is calculated.<sup>9</sup> (After Craig, et al.)

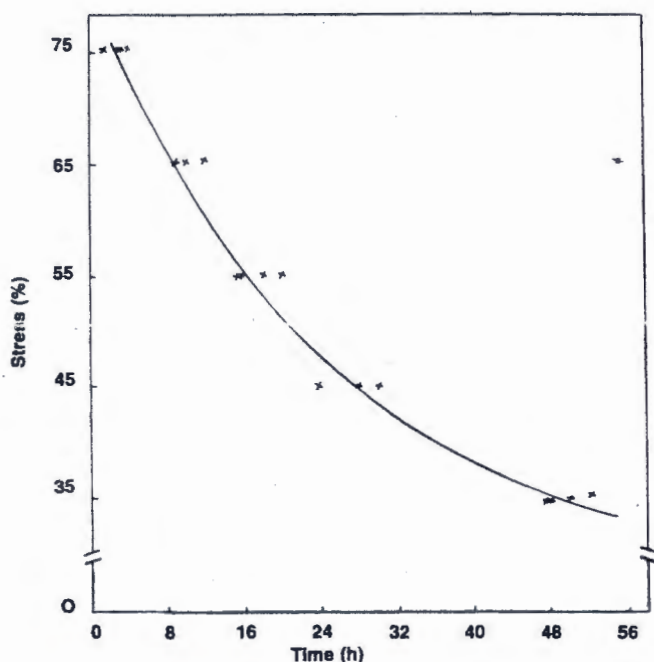
FIGURE 3. Time-to-failure vs applied stress — Al alloy.

The curve of time-to-failure (Figure 3) shows that the failure time increases with a decrease in the percentage of stress and *vice versa*. While the time-to-failure at 75% yield stress (429 MPa) was ~2 1/2 h, it took 4 h for the specimen stressed at 35% of yield stress (200 MPa) to fail.

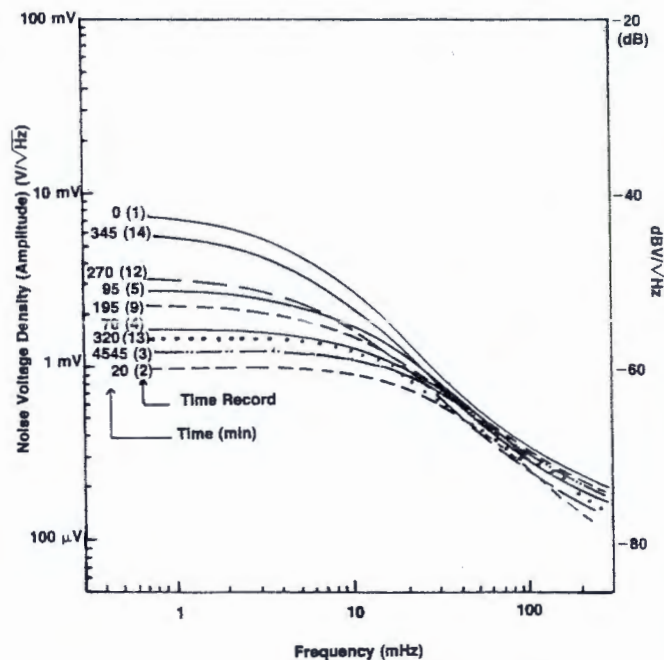
Figures 4 and 5 show the curves of the noise voltage density (amplitude) vs frequency (the spectral density curves). No failure was observed in the unstressed specimen (Figure 4). In the spectral density curves (Figure 4), the highest noise voltage density is shown at Time Record 1 and the lowest noise amplitude is shown at Time Record 2 (20 min.). The spectral curves become very close together after the frequency of 10 mHz. Although the curves of Figures 4 and 5 look similar in shape, sharing a LF noise characteristics and with almost similar corrosion reaction processes in the first 120 min. of the experiment, discernible features occurred after the 150th min. (Time Record 7). This is made clearer in the corresponding Figure 6.

FIGURE 4. Selected spectra — Al alloy, no stress.

All the spectral curves of the unstressed alloy are inversely proportional to the frequency or to some power of frequency. The noise amplitudes are distinctly separated from each other for different times at the LF ranges (0.5 to 10 mHz). The above observations indicate a LF noise, and they appear to conform with the characteristics of LF or "flicker" noise. The highest noise amplitude at Time Record 1 (0 to 20 min.) (Figure 4), with a roll-off slope of  $-17$  decibel (db)/decade may be associated with the initial growth of the passive film on the specimen's surface, as explained above. The lowest noise amplitude at Time Record 2 with a roll-off slope of  $-11$  db/decade could be associated with the subsequent passivity. The increase in the noise amplitude as shown by Time Record 3 (45 min.) to Time Record 5 (95 min. from the start of the experiment) with an average roll-off slope of  $-12$  db/decade seems to indicate film breakdown process and probably the onset of pitting. While the low-noise amplitude of Time Record 13 probably shows a repassivation process, the higher noise amplitudes of Time Records 12, 14, and 15, with roll-off slopes of  $-15$ ,  $-17$ , and  $-16$  db/decade, respectively, may be associated with increased pitting. The standard deviation (spectrum)/time curve (Figure 6), with its alternating peaks, could also be used to interpret the film breakdown and repair phenomenon of the corroding process.

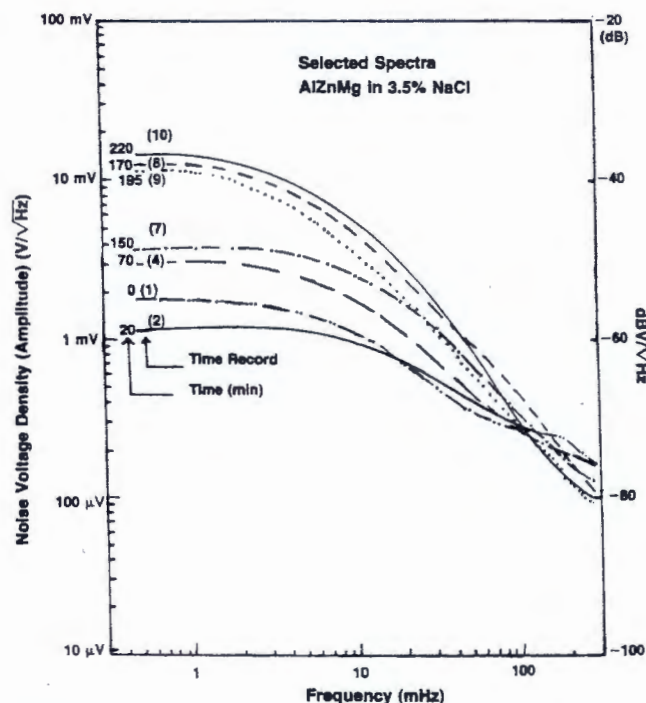
In the stressed specimens, as exemplified in Figure 5, the times of crack initiation and failure are, in most cases, those that correspond with the highest noise amplitude at the LF levels (0.1 to 1.0 mHz.). The same trend can also be observed at the higher frequencies of 10 and 100 mHz. For example, the highest noise amplitude occurred at Time Record 10 (220 min. from the start of the experiment). This was observed to be the time that the crack first became discernible. In the spectral density curves (Figures 4 and 5), the time record figures are put in brackets, while the corresponding time (min.) are written beside them.

FIGURE 5. Selected spectra — Al alloy, stress of 429 MPa.

The stressed specimens, as indicated in the curves of Figures 5 and 6, show initial similar characteristics as the unstressed specimens with respect to the corrosion processes described above. The major different corrosion reaction characteristics could be observed only during the crack initiation and propagation periods (Figure 6).

Time Records 8 through 10 have the highest noise amplitude, and they are higher than any of the time records in the unstressed specimen's spectral density curves. This could be an indication of crack growth. The chemical reactivity with fresh bared metal surface created by the crack growth and which results into active dissolution of the electrode surface might have contributed to the increased potential transients during this period and, hence, the highest noise amplitude recorded. The roll-off slope for Time Records 8 and 9 are  $-17$  and  $-20$  db/decade, respectively, while for Time Record 10 (220 min.), it is  $-22$  db/decade. The period from Time Record 8 to 10 could be associated with the crack formation and growth, although Time Record 10 is where the specimen's crack first became discernible. A roll-off slope of  $-20$  and  $-22$  db/decade could then be associated with pitting and crack growth.

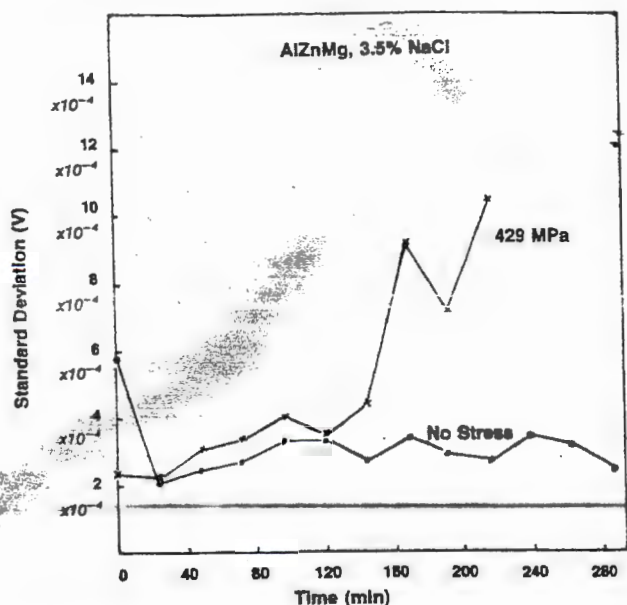
The unstressed specimen gives a standard deviation curve (Figure 6), which varies randomly with time. The first time record gives the highest peak. A zig-zag form of curve is shown after Time Record 6 (120 min.). A sharp fall of standard deviation occurs at Time Record 2 and thereafter rises with time to Time Record 5. In all of the observed stressed specimen curves, the highest peaks denote the failure time. In Figure 6, for example, the

FIGURE 6. Standard deviation vs time — Al alloys, stresses of 429 MPa and unstressed.

highest peak for specimens stressed at 75% of the yield stress (429 MPa) corresponds with a time of 3 h 36 min. The standard deviation (spectrum) vs time curves (Figure 6) gives results that can be correlated with the spectral density curves. The cracking time which is indicated by the highest standard deviation peaks are observed to correspond with the highest noise amplitude in the spectral density curves.

The standard deviation/time curves are very much related to the spectral density curves, and their variations with time correspond exactly with the spectral density curves, as indicated by the time record numbers (Figure 6). The initial high standard deviation can probably be related to the growing film on the specimen's surface and the subsequent anodic corrosion processes involving film breakdown after passivity. The immediate fall of the standard deviation curve could be associated with the film repair and the subsequent rise of the curve, with film breakdown and the onset of pitting. A further rise of the standard deviation curve with time, for example in Figure 6, may be associated with further pitting and the deepening of pits. The highest standard deviation peak is that where the cracking occurred.

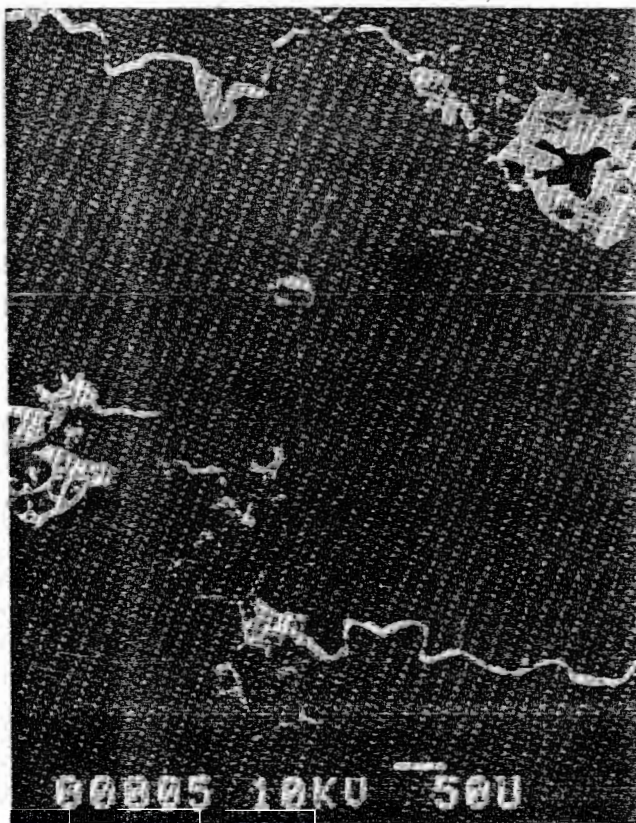
The SEM micrographs made from the stressed specimens are the negative image of the actual surface (Figures 7 and 8); hence, pits are shown as "bumps" and cracks appeared as "ridges." Pits could be seen to have developed within the first 30 min. in solution. As at 40 min. (Time Record 3), the microcracks could be observed to have initiated from pits (Figure 7). This occurrence could be correlated with the high-noise amplitude and the high standard deviation peak observed in Time Record 3. At ~3 1/2 h, crystal grains could be seen from the point of cracks and within the pits (Figure 8). This occurrence and the time corresponds with Time Record 9 (195 min.) on the spectral density curve (Figure 5).

FIGURE 7. Al alloy specimen surface after 30 min. in solution. (Negative image from plastic replica.)

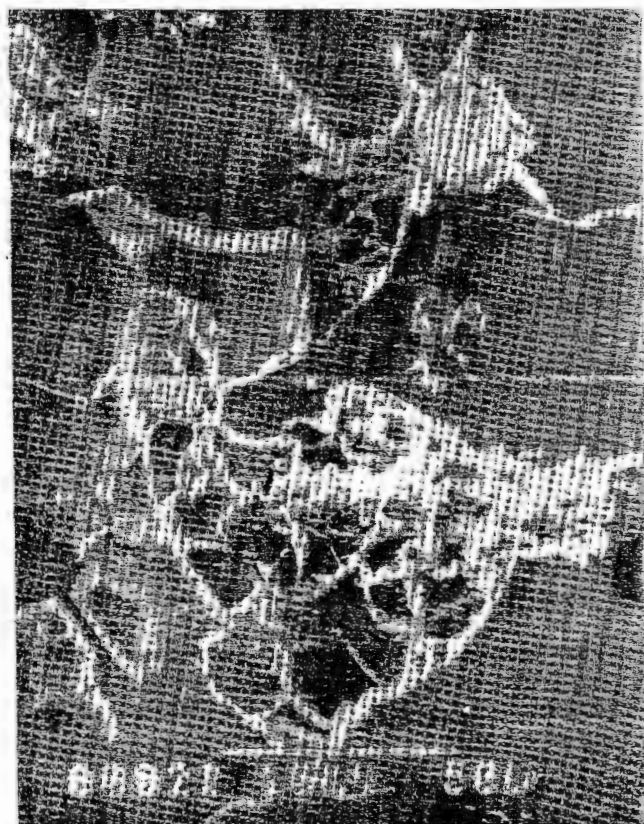
FIGURE 8. Grain crystals within pit formation and the cracked surface of the Al alloy specimen after 60 min. in solution (negative image).

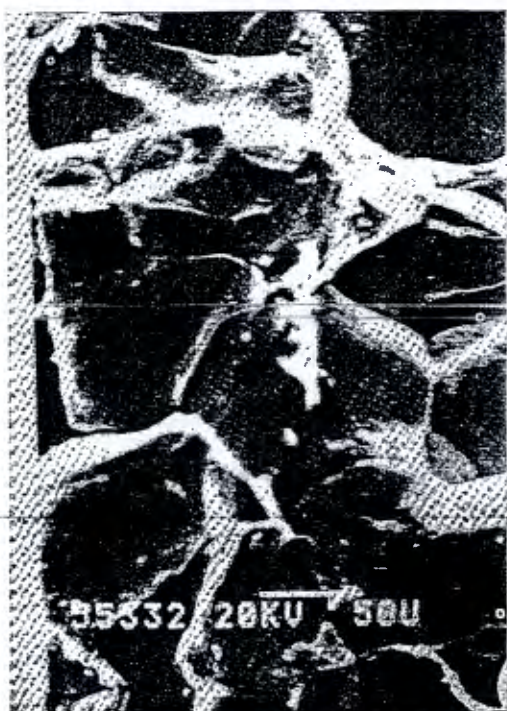
Cracking in this alloy specimen (Figure 9) could be observed to have passed through the grain boundaries and, thus, show intergranular failure which is characteristic of SCC.

FIGURE 9. Fractured surface of the Al alloy specimen (showing intergranular failure).
