NIGERIAN CORROSION ASSOCIATION

NICA/ICON/PAPR/92/8

PITTING AND CREVICE CORROSION SUSCEPTIBILITY OF SUPER AUSTENITIC STAINLESS STEELS IN SEA WATER

C.A. Loto, University of Lagos, Akoka, Lagos, Nigeria.

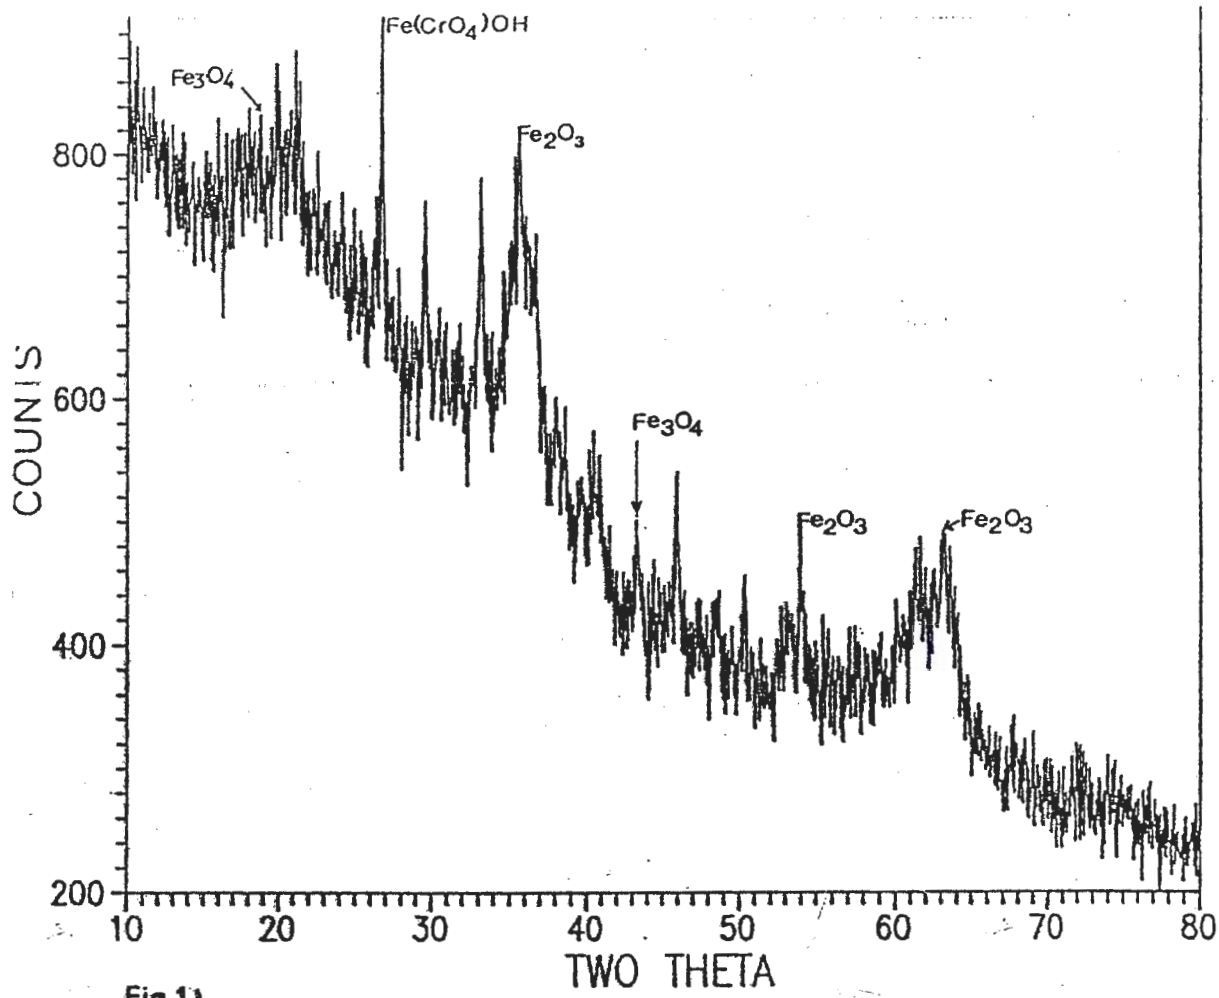
Fig 11

11. X-ray diffraction (XRD) spectroscopy analysis of the corrosion deposit from a macroscopic local corrosion attack site in the steam chamber portion of AL6XN (NO8367) alloy tube used as dummy in two test runs.

The results obtained from the x-ray diffraction analysis of the corrosion deposit from a pit located at the steam chamber's portion of one of the tubes made of AL6XN (NO8367) alloy, and the biofilm from the steam chamber and the outlet portions of the tube are presented in figures 11 - 13. The corrosion deposit consists of many phases of which the major ones are: Fe₂O₃, (Fe₃O₄) Fe(CrO₄) OH; and amorphous materials (substantial amount). Different phases were also present in the tube's steam chamber portion biofilm of which the major phases are:
