# Failure Trend of Transport Infrastructure in Developing Nations: Cases of Bridge Collapse in Nigeria

A Ede<sup>1</sup>, C Nwankwo<sup>1</sup>, S Oyebisi<sup>1</sup>, O Olofinnade<sup>1</sup>, A Okeke<sup>1</sup>  
and A Busari<sup>1</sup>

<sup>1</sup> Civil Engineering Department, Covenant University, Ota, Nigeria  
E-mail address: [anthony.ede@covenantuniversity.edu.ng](mailto:anthony.ede@covenantuniversity.edu.ng)

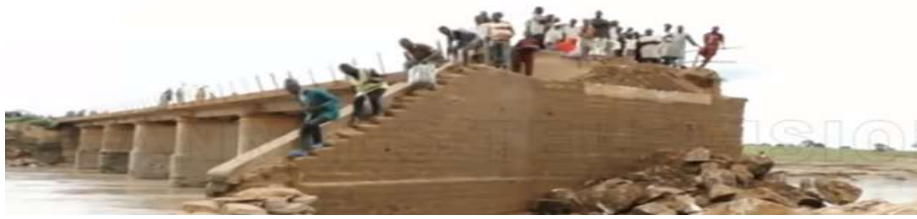
Fig. 1 Gulbim Boka Bridge

Fig. 1 showed the Gulbim Boka Bridge with the earth supporting the approach slab of at one of its ends completely washed away after a heavy rainfall in 2018.

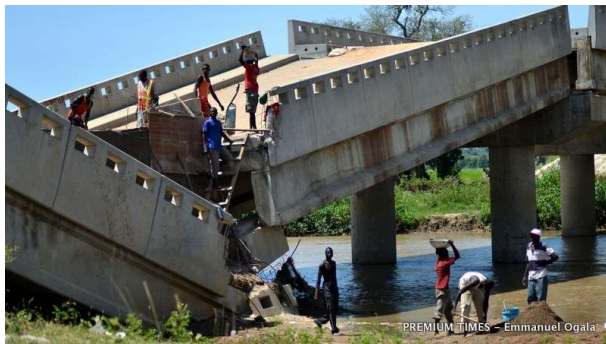
Fig. 2. Kudzum bridge

Table 3 lists seven bridges that were destroyed as a result of terrorist attacks. Fig. 2 and Fig. 3 show Kudzum and Katarko bridges respectively. Bombs were placed at strategic locations on the bridges by terrorists to render them unusable by motorists.

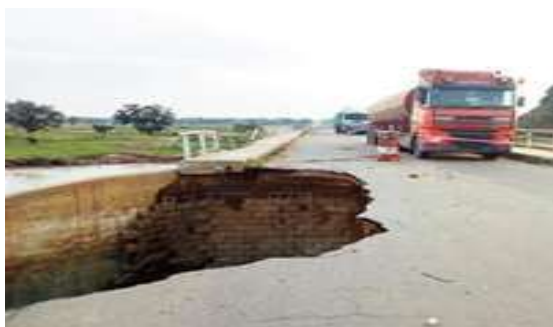
Fig. 4 Bridge along Wukari-Jalingo road  
Source. *Hunkuyi*, 2018 [25]

There is a need for developing countries to provide adequate infrastructure to accommodate their rapid growing population in their urban areas but financing, implementing and maintaining the needed infrastructure is a major challenge facing many developing countries today [61]. Available funds cater for the immediate needs of the population such as portable water, electricity, roads, sanitation, and education and not much focus is placed on maintenance of the infrastructure that is already in place [62]. Roads and bridges are constructed and adequate funds are not provided to maintain them [63]. With an increase in the rate of urbanization in the country, the focus has gradually shifted to urban centers over the years. Even though the problem of maintenance exists both in rural and urban communities, rural communities face more neglect as existing infrastructure in rural areas are left to decay by the government but in some cases are salvaged by members of the community. Bridges in Nigeria especially in the rural parts of the country have been left to decay and this has led to the partial and complete collapse of many bridges. Fig. 4 showed one of the bridges along Wukari-Jalingo road in Taraba state as at September 2018.

Significant portions of the earth filling behind the abutment was washed away by floods and no significant remedial work was done by the road maintenance agencies. The bridge deteriorated further as the back fill was exposed to the flow of the river. Fig. 4 Bridge along Wukari-Jalingo road Fig. 5 Bridge along Wukari-Jalingo road after 2 months

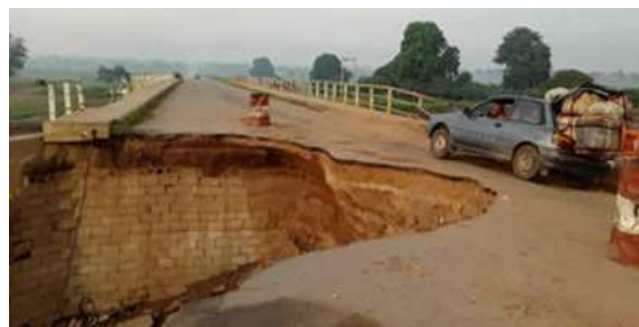
Fig. 5 Bridge along Wukari-Jalingo road after 2 months  
Source. *AIT* 2018 [24]

Source. *Hunkuyi*, 2018 [25] showed the bridge as at November 2018, after two months in a detrimental state. The lack of maintenance culture in Nigeria has been attributed to a political factors where current political administration fail to maintain existing infrastructure built by previous admirations, inexistent working policy and legislation on maintenance, lack of enlightenment by the populace on the need of maintenance and corruption [64-65]. Most bridges prior to collapse give warning signs and it is when these signs are ignored that collapse occurs [8]. In the developed world, the cheapest way to preserve such costly infrastructure is by using structural health monitoring tools to update the safe state at any time, so as to know when to intervene and save the structure from collapsing [66-68]. Irrespective of the triggering cause of bridge collapse cases in Nigeria many collapses that have happened could have been prevented if proper inspection and maintenance had taken place prior to the collapse.

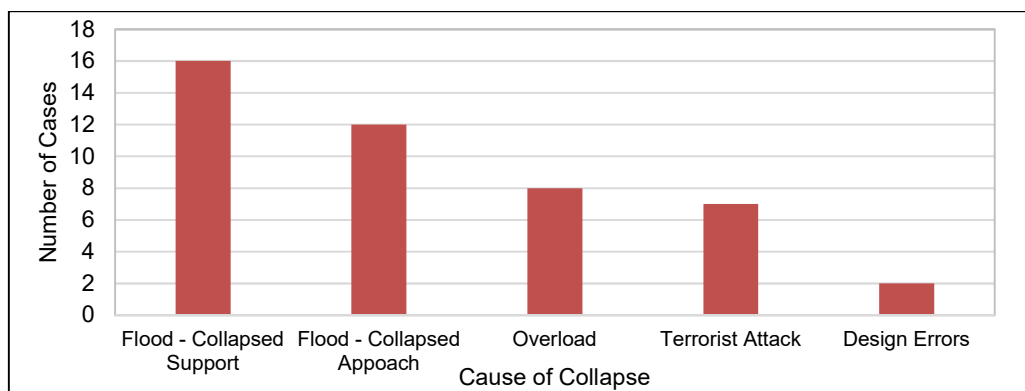
Fig. 6. Bridge collapse causes in Nigeria

Forty-five bridge collapse cases were identified, and the causes of failure are shown in the Fig. 6 below. Of the forty-five cases identified twenty-eight collapsed due to flood, eight due to overload and fatigue, seven as a result of terrorist attack and two collapsed due to faulty design and construction. The lack of proper bridge inspection and maintenance was also identified as the root cause of failure of many bridges in Nigeria. Fig. 7 showed the trend of the identified bridge collapse cases from 2010 – 2018.

Flood can be immediately identified as the prevalent cause of collapse in Nigeria. Through the years, flood has been the major cause of bridge collapse in Nigeria except for 2014 where bridges collapsed mainly because of terrorist attacks. A study on Tatabu bridge collapse in Niger state revealed a significant increase of the stream flow from 2015 to 2017 due to increased rainfall and change of land use. Flood water reached heights far above the bridge approach at about 1.7 meters. This increase, coupled the high water velocity and pressure during the flood because of the meandering nature of the river caused the bridge to collapse [69]. Many rivers in Nigeria do not have proper river training works that properly guide the river during floods. Collapse due to overload is seen to be constant over the years.
