# Fire Emergency Safety Preparedness in the College of Leadership Development Studies Building in Covenant University, Ota, Nigeria

Department of Architecture, Covenant University, Ota, 112212, Ogun State, Nigeria

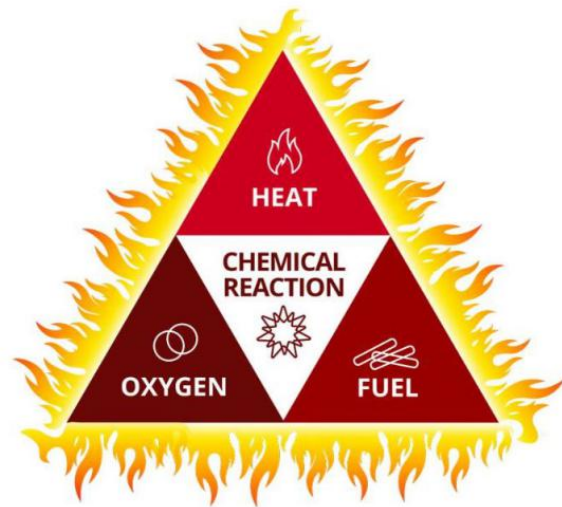
Fire is the phenomenon of combustion caused by the oxidation of a fuel source at high temperature [12]. It is a chemical process that is accompanied with the release of energy and the production of heat and light. This can be illustrated using the fire triad which consists of oxygen, heat and fuel as shown in Figure 1. Fire cannot occur if any of these three components are absent.

Figure 1. The Fire Triad

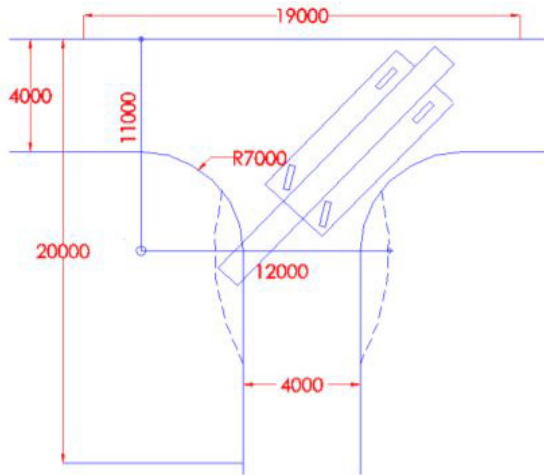
Hopper [41] explained that in the aspect of site planning, the use of space around the building should be such that it can allow for a fire vehicle to intervene by being able to move around the building if need be, during a fire outbreak. Spaces around the building must make it practical for rescue and external firefighting operations to be mounted. This is achieved by providing an access way such that the site is accessible to firefighting appliances. Access ways should be designed with a width of at least 4 m through its full distance. The material should be made of either perforated slabs, metallic materials or paved to bear the 30 tonnes stationary load of a fire vehicle. The access way should enable fire vehicles to enter, manoeuvre and extend equipment such as ladders and pumps, turntables and hydraulic platforms. The outer turning radius of the access road for the fire vehicle should be at least 7 m and comply with the other requirements shown in Figure. 2.

Figure 2. Turning Radius for a Fire Vehicle

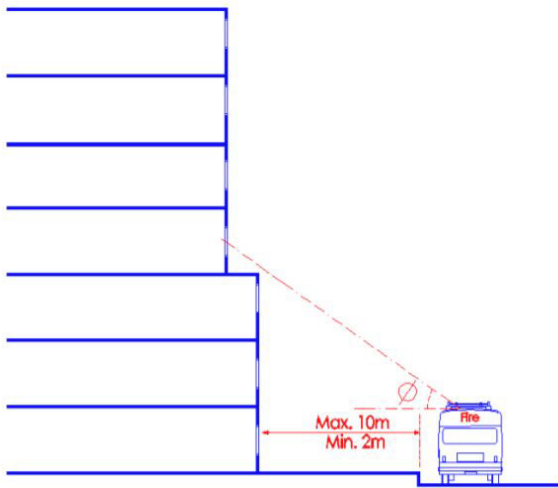
The requirements in Figure 3 are for buildings with a minimum habitable height of 10 m and a maximum horizontal height of 10 m between the fire vehicle and the building as shown in Figure 3.

Figure 3. Required Distance between a Fire Vehicle and a Building

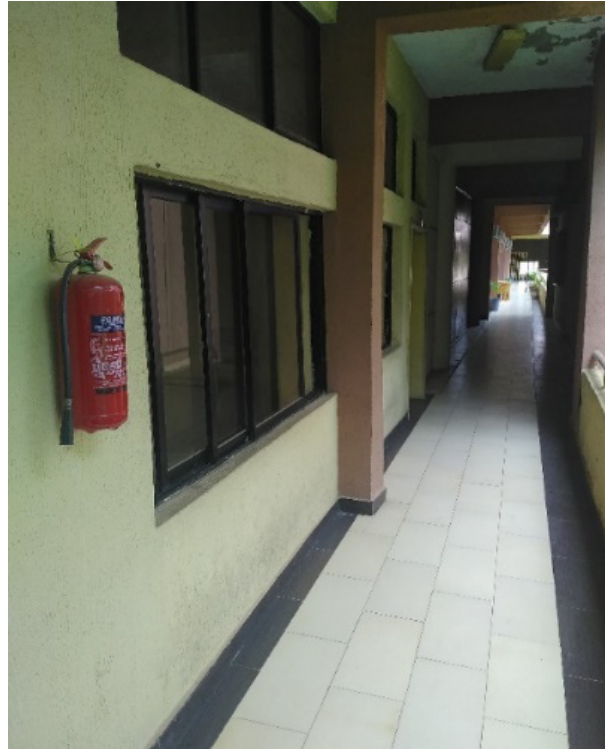
**Figure 5.** Fire Extinguisher hung along a corridor

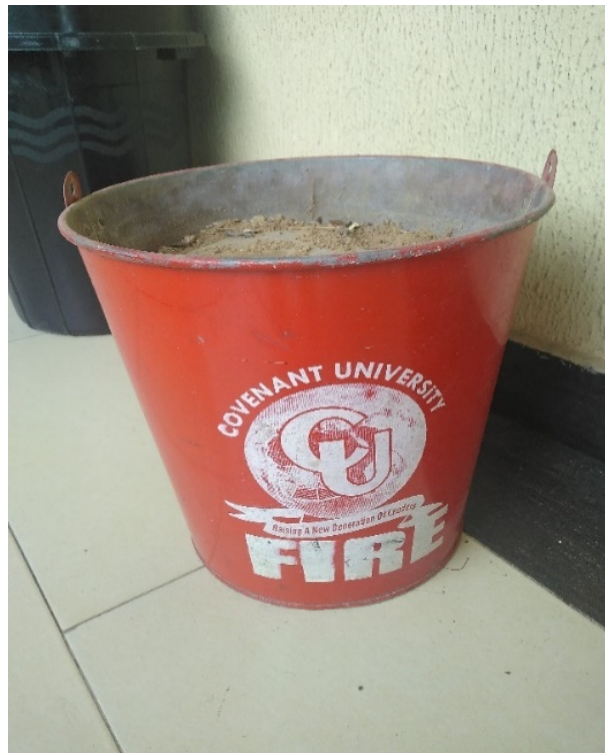
**Figure 6.** Fire bucket positioned along a corridor

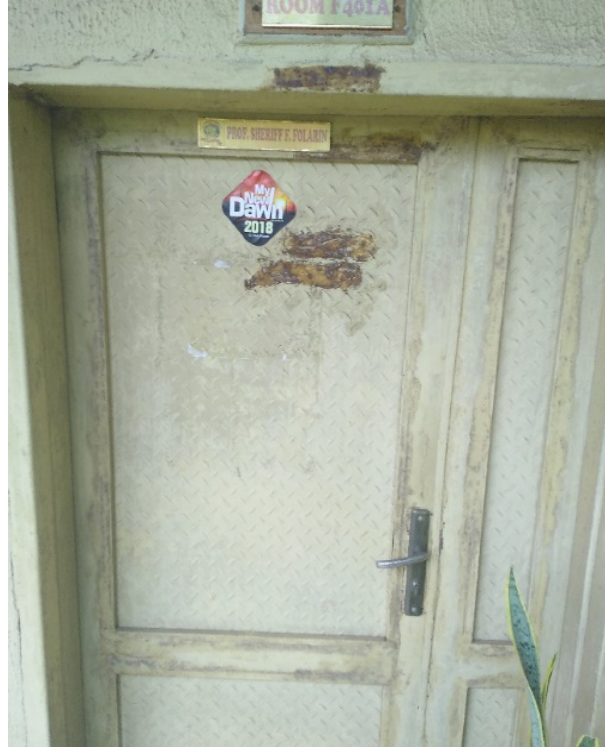
Nevertheless, measures such as dampers, fire doors, fire signage and muster points were found not to be provided for. The fire walls are sandcrete block walls of between 150 mm and 225 mm thick, rendered on both sides. The fire floors are reinforced concrete slabs finished with tiles,

while their underneath in upper floors are screeded with sand/cement plaster. Figure 7 shows an example of a non-fire resistant door used in the building, while Figure 8 are examples of fire resistant walls and suspended floor, viewed from a corridor in the building.

**Figure 7.** Non-Fire Resistant Door

Based on the outcome of the study, the following recommendations are made in order to enhance the fire safety level in the college building: the building should be retrofitted with active and passive firefighting and protection measures found to be missing; all active firefighting devices should be checked regularly to ensure they are in good working order at all times; regular fire safety workshops and seminars should be carried out in the institution for the benefit of the university community; and regular fire drills should also be conducted in the building from time to time to help improve users awareness level on basic fire emergency safety protocols.

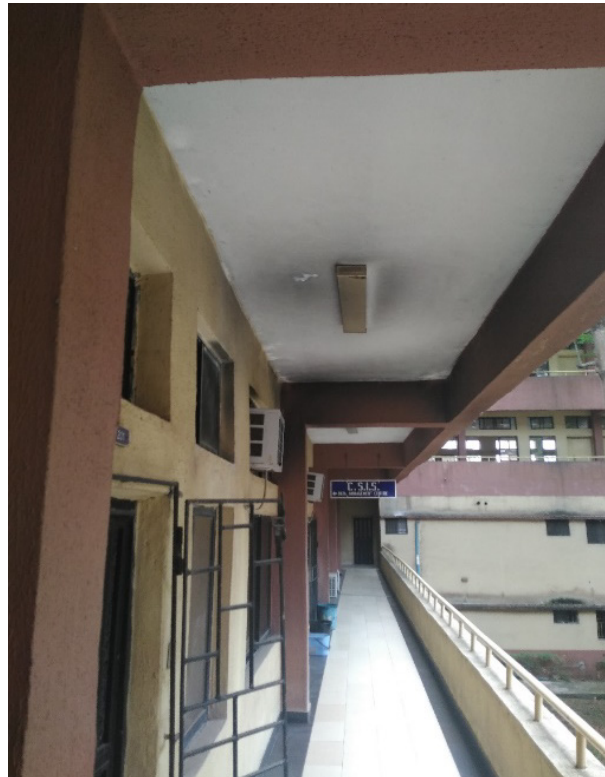
**Figure 8.** Fire Resistant Walls and Floors

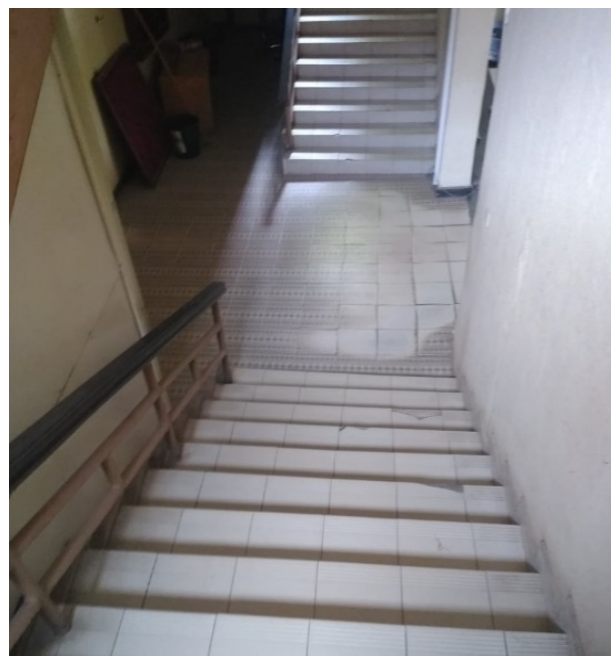
Escape routes, general movement corridors and staircases are also generally considered adequate and reliable as their provisions conform with standard fire emergency safety requirements. Widths of general movement spaces are largely 1.5 m and above. Staircases have an effective minimum width of 1.8 m and provided with handrails for safety and support purposes as shown in Figure 9.

Figure 9. Staircase Flight Lobby

The escape routes sizes are adequate for mass movement in case of emergency. Their floor surfaces are finished with vitrified tiles. The floors are hard, non-slippery and considered safe to use in line with universal design requirements highlighted by Sholanke *et al.* [36]. Though fire signage which helps users to find their way towards exits in case of emergency were not provided in the building, nevertheless, the movement and escape routes are generally free from obstacles that can hinder mass movement. Based on the general findings on the escape routes, they are adjudged reliable. According to Kironji [45], the primary function of escape routes is to guide people to a point of relative safety within the shortest possible time, which the escape routes conform with.

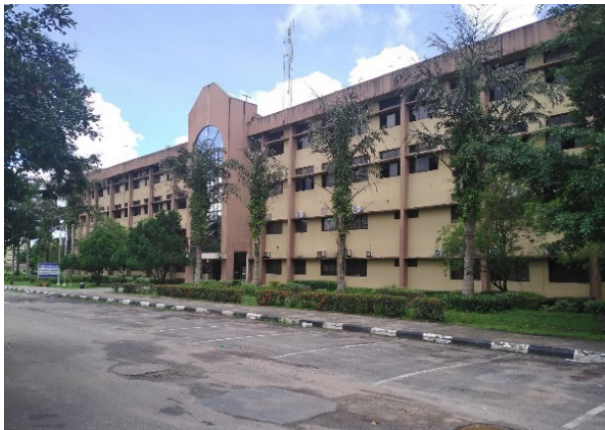
Site planning for fire protection requires that fire apparatus such as trucks, ladders, pumps and tankers have unobstructed access to reach a building. The building has adequate space around it to accommodate mass pedestrian movements and fire apparatus, including fire vehicles in case of a fire emergency, as shown in Figure 10 and Figure 11.

**Figure 10.** Front view of the Building with Adequate Vehicular Manoeuvring Space

turning space is available within the car park areas for fire trucks to manoeuvre and turn around, as shown in Figures 10 and 11. Hopper [40] reported that drive-way layout in such a building should have a cul-de-sac or t-turn on one end of an access way for fire vehicles. From the findings on the planning of the site, the site planning conforms with fire safety standards and adjudged a reliable passive fire emergency safety measure for the building. However, it was observed that no specific point was designated as a muster point for the building in line with standard practice. Such points are usually located at a safe distance outside public buildings where people can gather for a roll-call to ascertain that everyone in the building is safely out of the building, in the event of an emergency such as a fire outbreak.

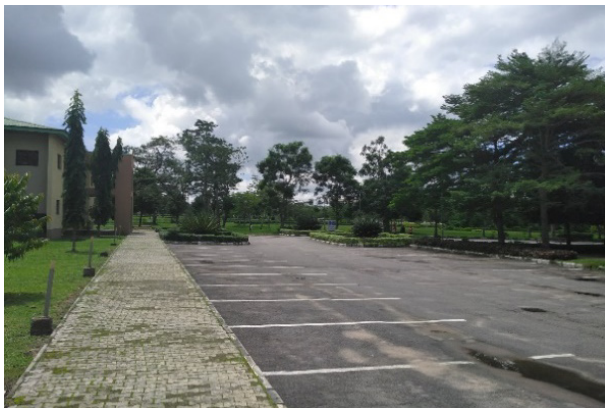
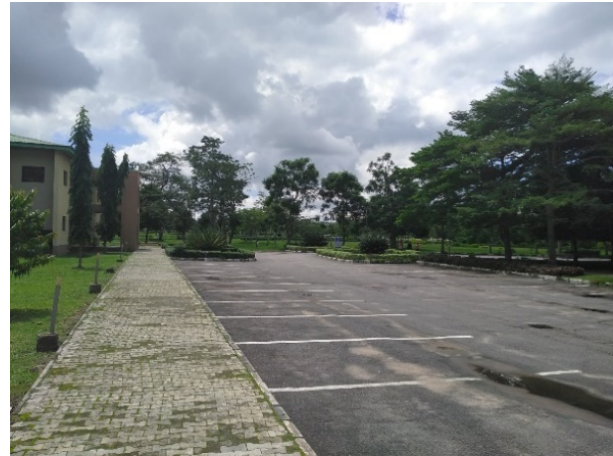
**Figure 11.** Side view of the Building with Adequate Vehicular Manoeuvring
