## CIVIL & ENVIRONMENTAL ENGINEERING | RESEARCH ARTICLE

# Early deterioration assessment of selected reinforcement in different host environments, case study: Lagos State, Nigeria

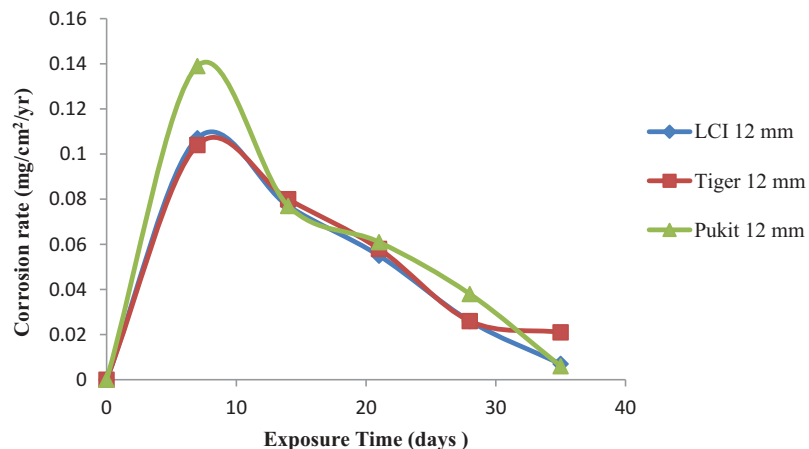
**Figure 1. Plot of corrosion rate against exposure time of LCI, Tiger TMT and Pulkit 12-mm-diameter reinforcement in freshwater.**

Figures 1, 2 and 3 show the variation in the corrosion rate of the three brands of reinforcement materials of Tiger TMT, LCI and Pulkit of diameters of 12, 16 and 20 mm immersed in freshwater for a period of 35 days of exposure. It was clearly shown that the corrosion resistance of the Tiger TMT reinforcement materials of 12 mm is drastically high from 7th day with the value of 0.014 mg/cm<sup>2</sup>/year and 28th day of exposure with 0.026 mg/cm<sup>2</sup>/year, respectively. It was noted that oxidation at the anode of the sample is relatively high due to the loss of electrons to the environment and then used up at the cathode. Tiger TMT material of 16 mm displayed high corrosion resistance from 7th to 14th days of exposure with the values of 0.014 and 0.012 mg/cm<sup>2</sup>/year, while the Tiger TMT material of 20 mm equally displayed high corrosion resistance on the 21st day of exposure with the values of 0.012 mg/cm<sup>2</sup>/year. It is evident that the Tiger TMT reinforcement material has high corrosion resistance in the freshwater because of its high anti-corrosive properties.

The plots of Figures 1–12 showed that the Tiger TMT material has a high value of corrosion resistance in freshwater, NaCl (1.0 M) and Lagoon, while LCI showed good chemical and mechanical properties in the 1.0 M of KCl solution. From the experimental analysis, it was concluded that Tiger TMT of 20-mm diameter recorded low corrosion rates of 0.008 mg/cm<sup>2</sup>/year on the 28th day of exposure in the Lagoon environments. Pulkit-reinforced material of 12, 16 and 20 mm diameters displayed high corrosion rates throughout the media for the period of 35 days of exposure due to the oxidation taken place at the sites and loss of electrons to the environment.

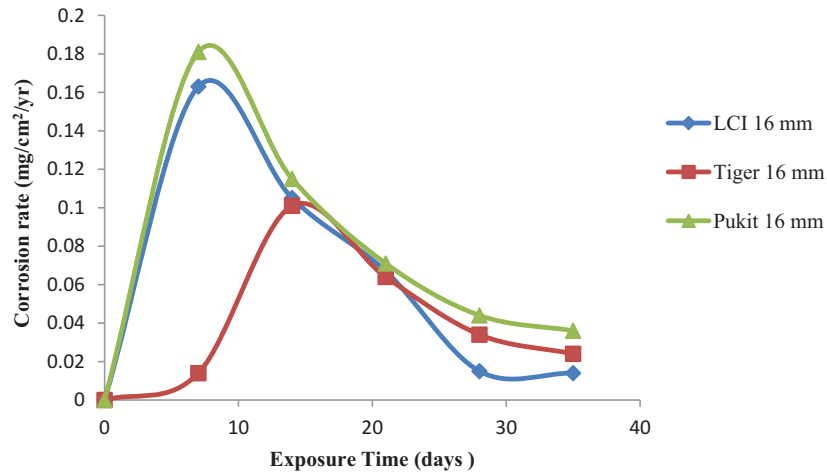
**Figure 2. Plot of corrosion rate against exposure time of LCI, Tiger TMT and Pulkit 16-mm-diameter reinforcement in freshwater.**

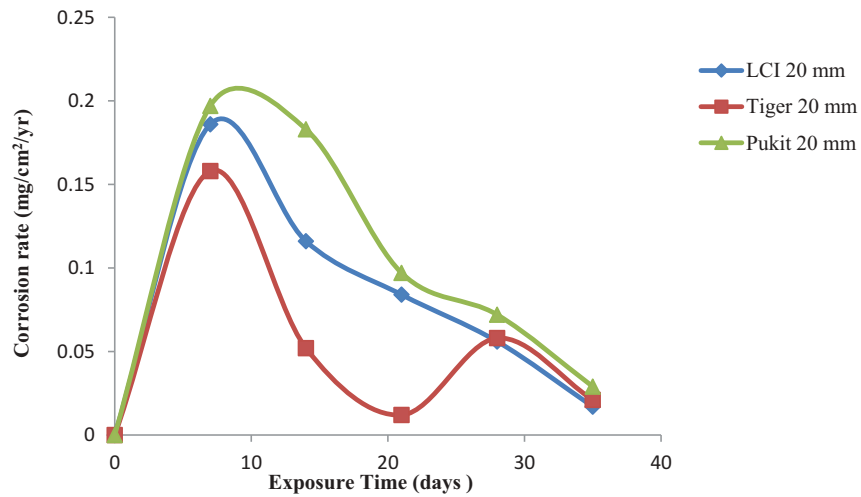
**Figure 3. Plot of corrosion rate against exposure time of LCI, Tiger TMT and Pulkit 20-mm-diameter reinforcement in freshwater.**

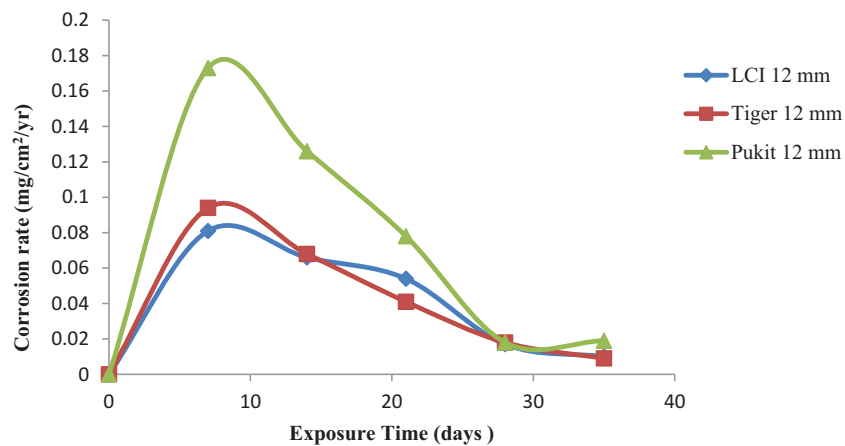
**Figure 4. Plot of corrosion rate against exposure time of LCI, Tiger TMT and Pulkit 12-mm-diameter reinforcement in 1.0 M NaCl.**

Figures 4, 5 and 6 show the variation in the corrosion rate of the three brands of reinforcement materials of Tiger TMT, LCI and Pulkit of diameters of 12, 16 and 20 mm, respectively, immersed in NaCl medium for a period of 35 days of exposure. Tiger TMT material of 12 and 16 mm displayed high resistance to corrosion on the 35th day of exposure with a value of 0.09 mg/cm<sup>2</sup>/year and the latter with the value of 0.017 mg/cm<sup>2</sup>/year, respectively, while the LCI 20-mm diameter recorded corrosion resistance from 7th to 21st days of exposure with the values of 0.159 and 0.056 mg/cm<sup>2</sup>/

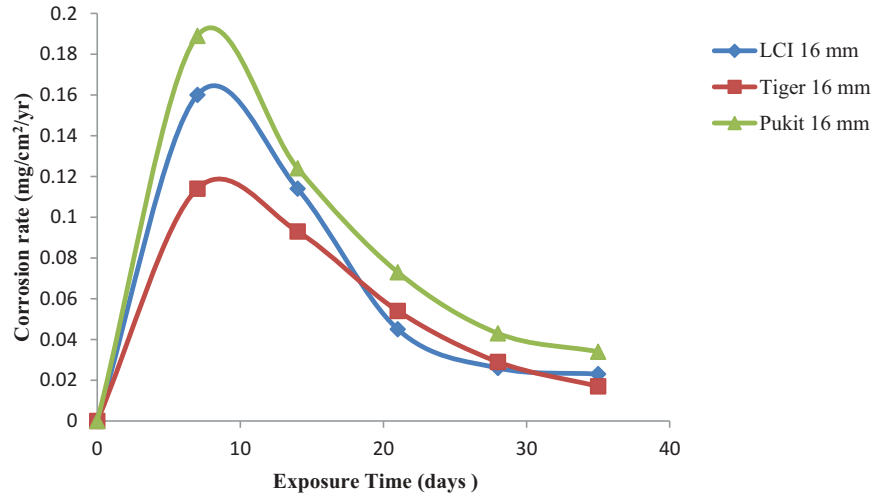
Figure 5. Plot of corrosion rate against exposure time of LCI, Tiger TMT and Pulkit 16-mm-diameter reinforcement in 1.0 M NaCl.

year, respectively. The Pulkit of 16 mm material on the 7th day of exposure recorded 0.189 mg/cm<sup>2</sup>/year as the high-corroded material compared to others.

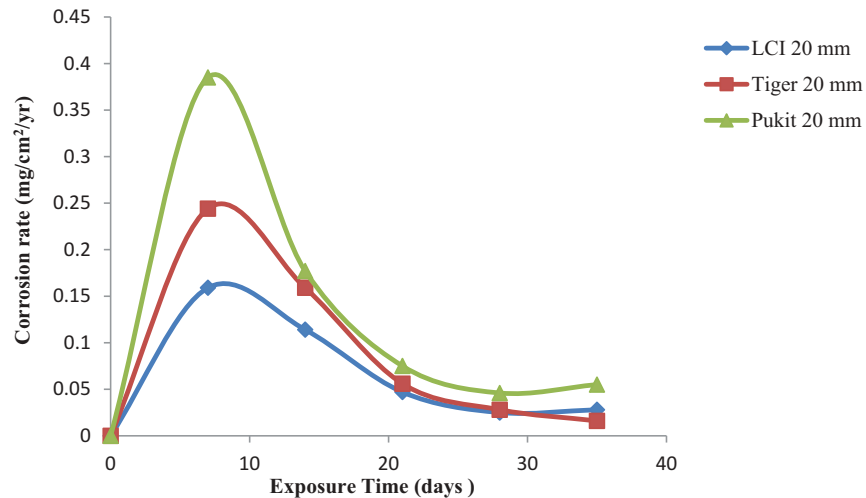
Figure 6. Plot of corrosion rate against exposure time of LCI, Tiger TMT and Pulkit 20-mm-diameter reinforcement in 1.0 M NaCl.

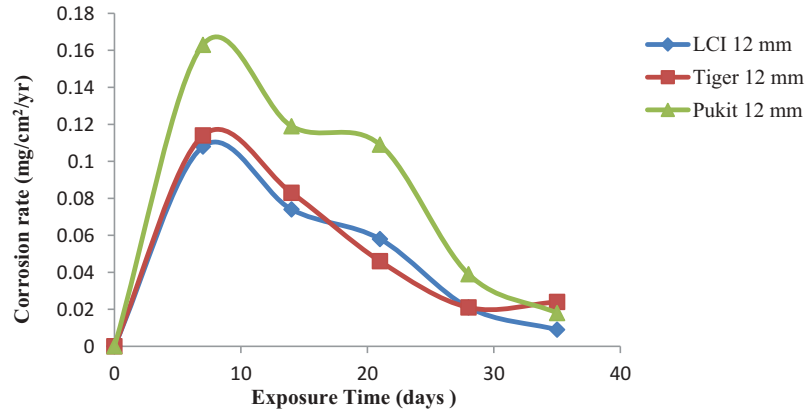
**Figure 7. Plot of corrosion rate against exposure time of LCI, Tiger TMT and Pulkit 12-mm-diameter reinforcement in 1.0 M KCl.**

Figures 7, 8 and 9 show the variation in the corrosion rate of the three brands of reinforcement materials of Tiger TMT, LCI and Pulkit of diameters of 12, 16 and 20 mm, respectively, immersed in 1.0 M of KCl medium for a period of 35 days of exposure. Contrary to the results shown in Figures 1–6, LCI materials displayed high resistance to corrosion in 1.0 M of KCl medium from 14th to 35th days of exposure with the values of 0.0112 and 0.008 mg/cm<sup>2</sup>/year, and LCI 20 mm also displayed low corrosion rate from 7th to 35th days with the values of 0.186 and 0.033 mg/cm<sup>2</sup>/year, while Tiger TMT material of 12 mm proved to be more resistant to corrosion from 21st to 28th days of exposure with the rates of 0.046 and 0.021 mg/cm<sup>2</sup>/year, respectively.

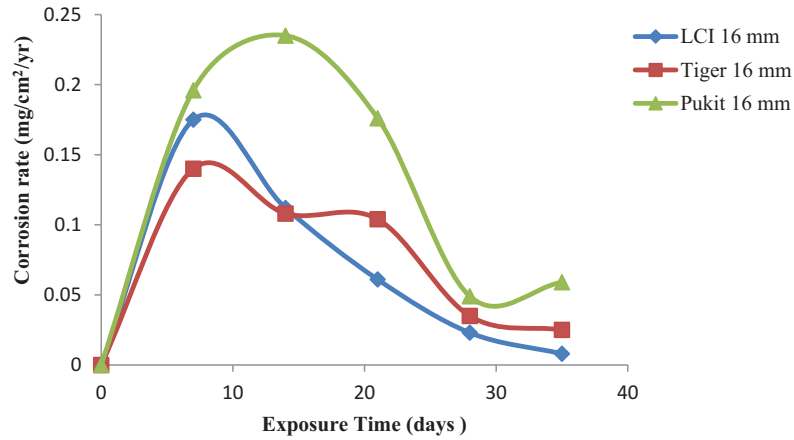
**Figure 8. Plot of corrosion rate against exposure time of LCI, Tiger TMT and Pulkit 16-mm-diameter reinforcement in 1.0 M KCl.**

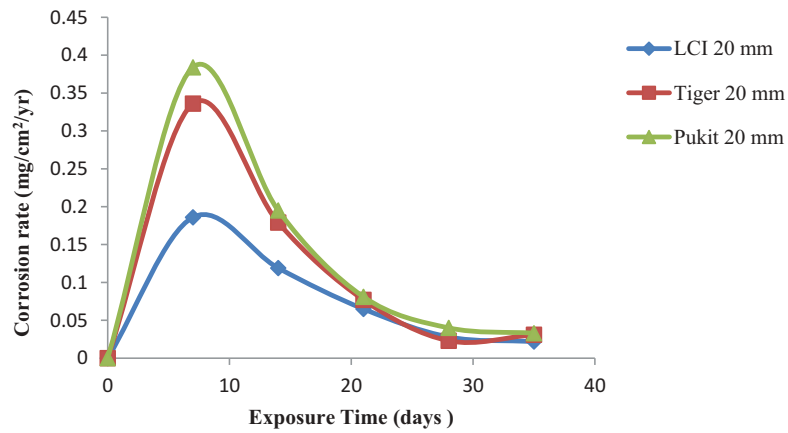
**Figure 9. Plot of corrosion rate against exposure time of LCI, Tiger TMT and Pulkit 20-mm-diameter reinforcement in 1.0 M KCl.**

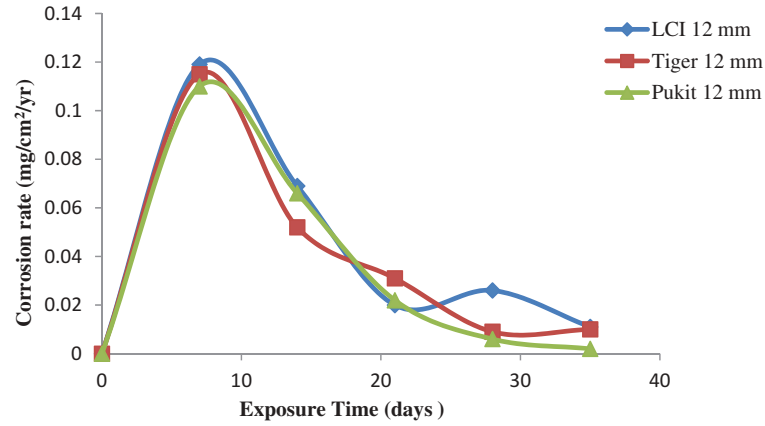
Figure 10. Plot of corrosion rate against exposure time of LCI, Tiger TMT and Pulkit 12-mm-diameter reinforcement in Lagoon.

Figures 10, 11 and 12 show the variation in the corrosion rates of the three brands of reinforcement materials of Tiger TMT, LCI and Pulkit of diameters of 12, 16 and 20 mm, respectively,

immersed in the Lagoon medium for a period of 35 days of exposure. Tiger TMT 16 and 20 mm showed high corrosion resistance on the 14th day with the value of 0.014 mg/cm<sup>2</sup>/year while later on the 28th day recorded 0.008 mg/cm<sup>2</sup>/year in the Lagoon environment, and Pulkit material displayed the least with more corrosion than others.

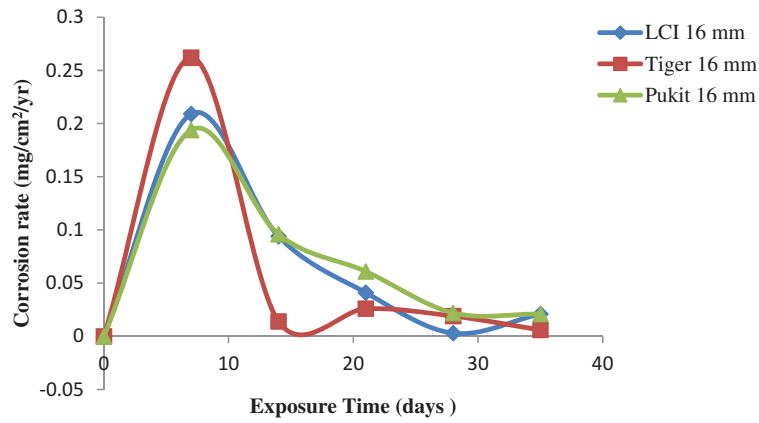
Figure 11. Plot of corrosion rate against exposure time of LCI, Tiger TMT and Pulkit 16-mm-diameter reinforcement in Lagoon.

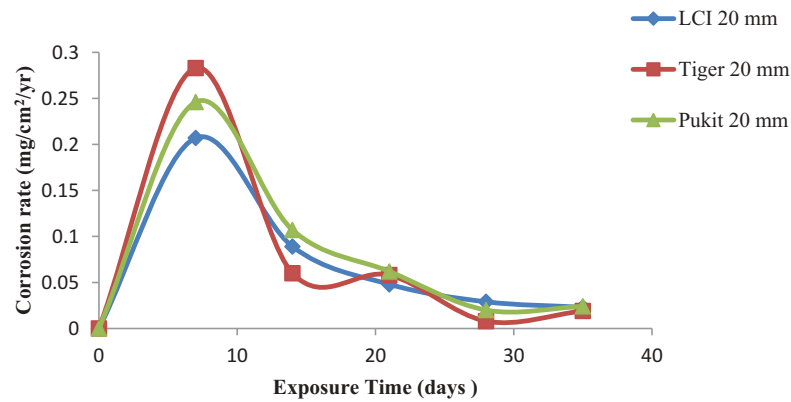
Figure 12. Plot of corrosion rate against exposure time of LCI, Tiger TMT and Pulkit 20-mm-diameter reinforcement in 1.0 M Lagoon.
