A review of the mineralogical and geotechnical properties of some residual soils in relation to the problems of road failures: A case study of Nigeria

To cite this article: R O Sani *et al* 2021 *IOP Conf. Ser.: Mater. Sci. Eng.* **1036** 012071

R O Sani¹, O M Olofinnade¹, I I Akinwumi¹ and O D Afolayan¹

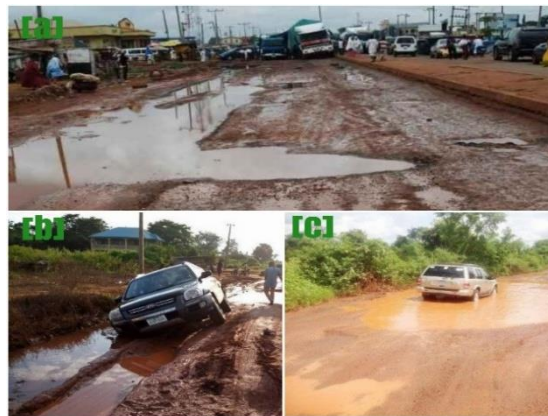
Figure 1. (a) Kaduna – Abuja road (North Central Nigeria), (b) Otukpa-Otukpo Markurdi, (North Central Nigeria), (c) Enugu – Awka - Onitsha road (Eastern Nigeria)
