JOURNAL OF ENGINEERING RESEARCH

**ASSESSING THE SAFETY OF DRINKING WATER SOURCES IN ADO-ODO/OTA
LOCAL GOVERNMENT AREA, OGUN STATE, NIGERIA**

E.O. LONGE, D.O. OMOLE** and C.S. MGBACHI***

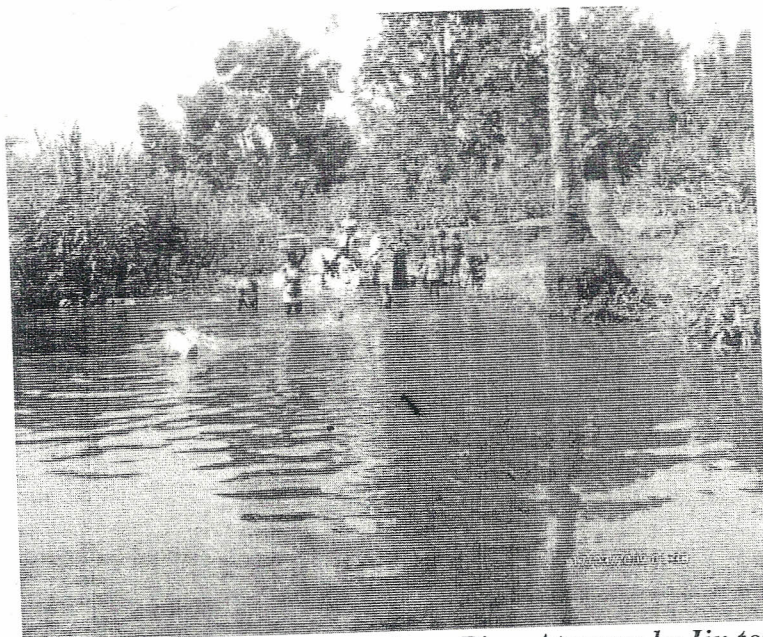
Figure 2: Fetching of water from River Atuwara by Iju town residents
