EFFECT OF CONSTRUCTING HIGH-RISE BUILDINGS WITHOUT A GEOPHYSICAL SURVEY

Adagunodo T. A.^{1*}, Sunmonu L. A.¹, and Oladejo O. P.²

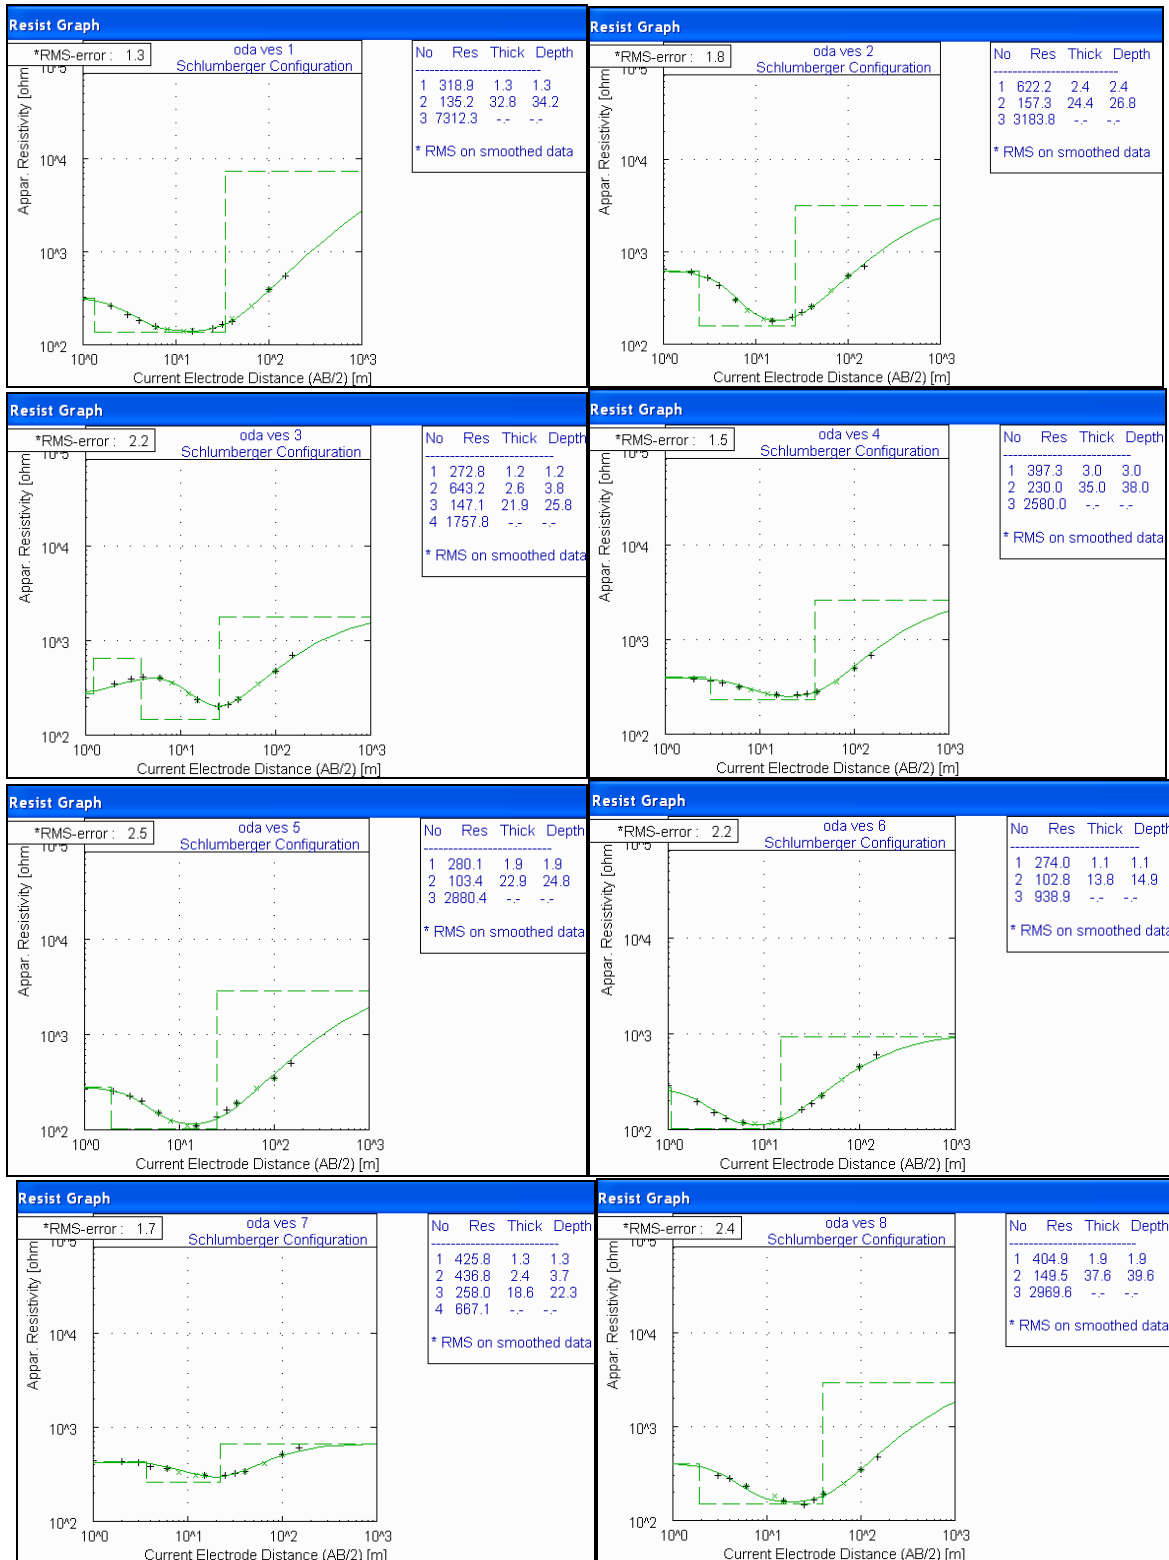
Figure 3: The model curves for VES 1 to VES 8.

The resistivity sounding curves of the 8 VES stations (figure 3) obtained from the survey area consist of three and four geoelectric layers. Six VES curves (VES 1, 2, 4, 5, 6, and 8) showed H-type (i.e. 3-layer earth model) while the remaining two VES curves (VES 3 and 7) showed KH-type (i.e. 4-layer earth model). The curves were characterized according to their signatures, which mirror the layering of the subsurface. The resistivity of the topsoil ranged between 272.8 Ωm and 622.2 Ωm with an average value of 374.5 Ωm , the thickness of the topsoil ranged between 1.1 m and 3.0 m with an average value of 1.7625 m, the resistivity of the weathered layer ranged between 102.8 Ωm and 258 Ωm with an average value of 160.4125 Ωm , the thickness of the weathered layer ranged between 13.8 m and 37.6 m with an average value of 25.875 m, the overburden thickness of the survey area ranged between 14.9 m and 39.6 m with an average value

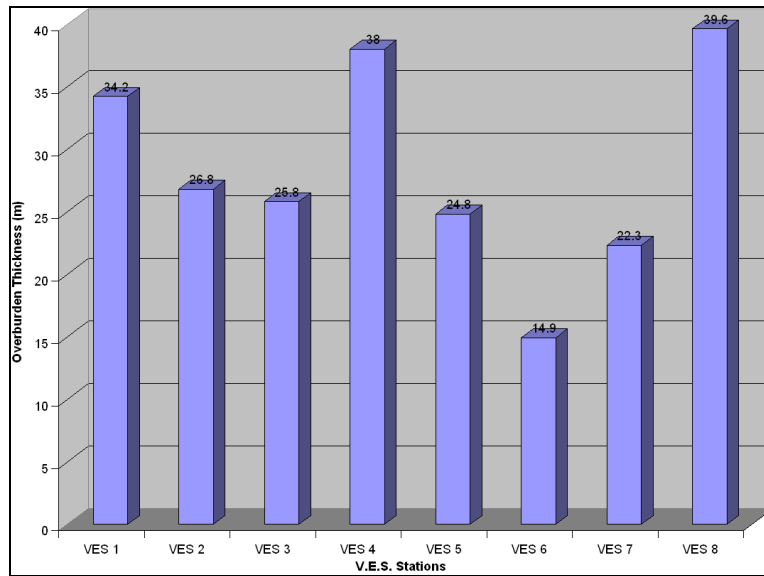
Figure 5: Distribution of the overburden thickness in the study area.

Overburden thickness interpretation with respect to subsurface competency for the construction of high-rise building in the study area is as follow: figure 4 shows that only the Southern part of the building is underlain with thin overburden while the remaining parts are relatively thick. According to Sunmonu *et al.* (2012), who rated overburden greater than 15 m (about 50 ft) as thick (table 4), it could be seen from figure 5 that except VES 6 that has the value of 14.9 m (approx. 15 m), other VES stations are greater than 15 m. This overburden is relatively thick for a high-rise building without an artificial basement before the foundation is laid.

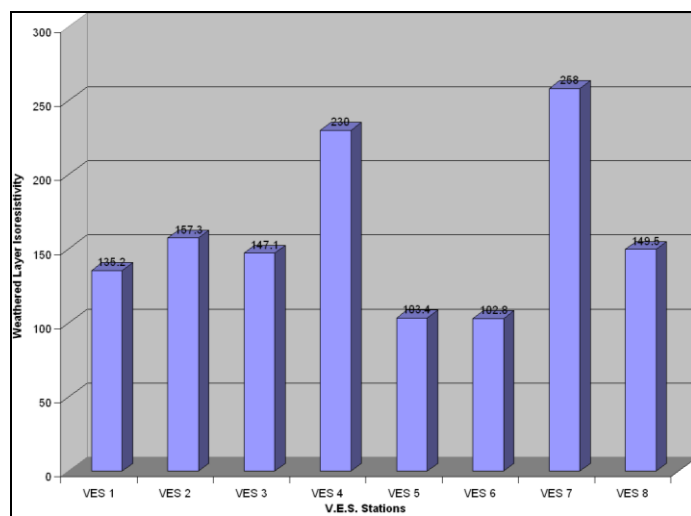
Figure 7: Distribution of the weathered layer iso-resistivity in the study area.

However, the weathered layer iso-resistivity interpretation with respect to subsurface competency for the construction of high-rise building in the study area is as follow: the resistivity varied between 102.8 Ωm and 258 Ωm with an average value of 160.4125 Ωm . The 3-D weathered layer iso-resistivity map (figure 6) was produced from the interpreted VES data. Also, the distribution of the weathered layer iso-resistivity was produced in figure 7. From figure 6 and figure 7, none of the weathered layer resistivity falls within the zone of optimum weathering and good groundwater potential i.e. resistivity ranging from 21 Ωm and 100 Ωm . The closest resistivities are that of VES 5 and VES 6 which are 103.4 Ωm and 102.8 Ωm respectively. These 2 VES stations fall under the medium conditions and medium potential for groundwater as reported by Sunmonu *et al.* (2012). This was done in order to know the characteristics of weathered layer in the study area, whether it will permit the transport of water from subsurface to the supporting walls of the building or not. The result showed that the resistivities of the weathered layer's value constitute little and medium weathering processes with poor potential for groundwater (table 5). Therefore, water cannot be transported from the subsurface to the supporting walls of the building.
