## Corrosion of Aluminium Alloy in White Mangrove Wood Ash Solution

C.A. Loto.

Department of Mechanical Engineering, University of Lagos, Akoka, Lagos, Nigeria.

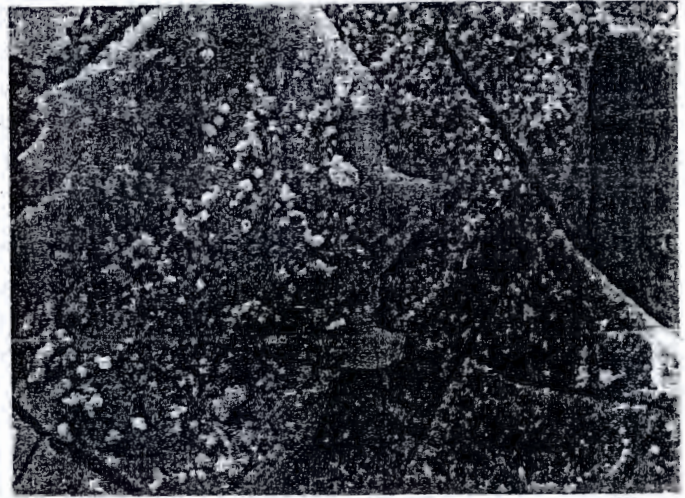
Figure 3. S.E.M. micrograph of the test aluminium alloy's surface before immersion in test environment.

The scanning electron micrographs made before and after immersion are presented in Fig. 3-7, shows that the corrosion deposits could probably be oxide layers. Clear are the salts' crystals from the predominant sodium, potassium, calcium and magnesium. Fig 7 shows the pitting surface of the test aluminum alloy specimen, which occurred from the reacting species (e.g.  $\text{Cl}^-$  and  $\text{SO}_4^{2-}$ ) while penetrating the specimen's protective film. The evidence presented above shows a lack of corrosion resistance of the aluminum alloy in the given environment.

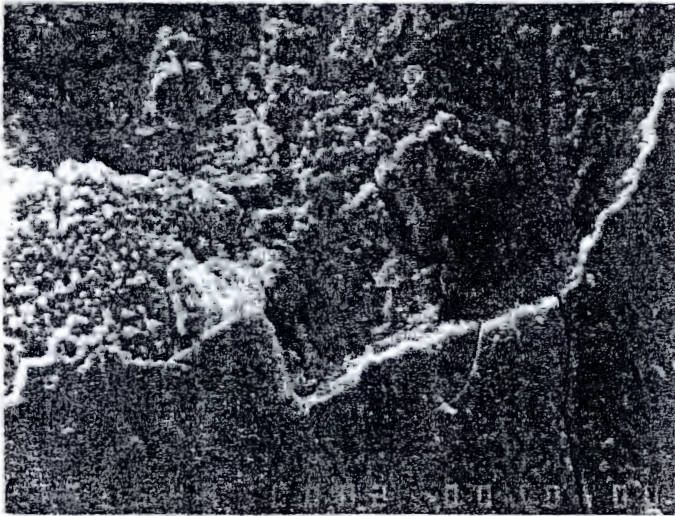
Figure 4. S.E.M. micrograph of the test aluminium alloy's surface after immersion in test environment showing hard brittle corrosion deposits and oxide layers.

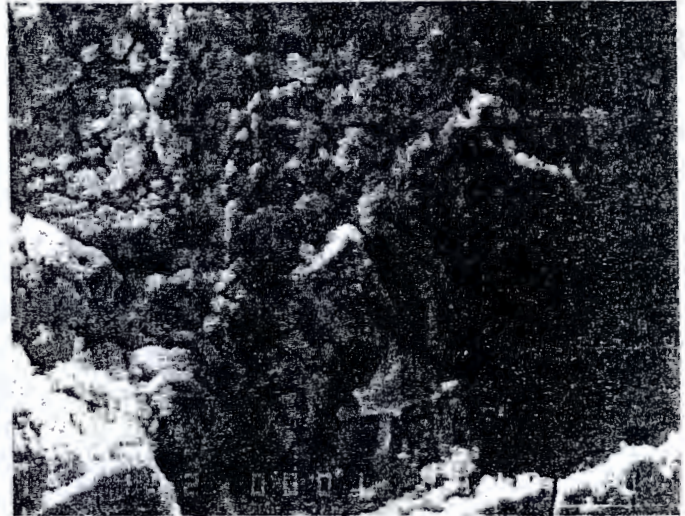
Figure 5. Surface of the test aluminium alloy after immersion showing further corrosion deposits and cracked oxide layers.

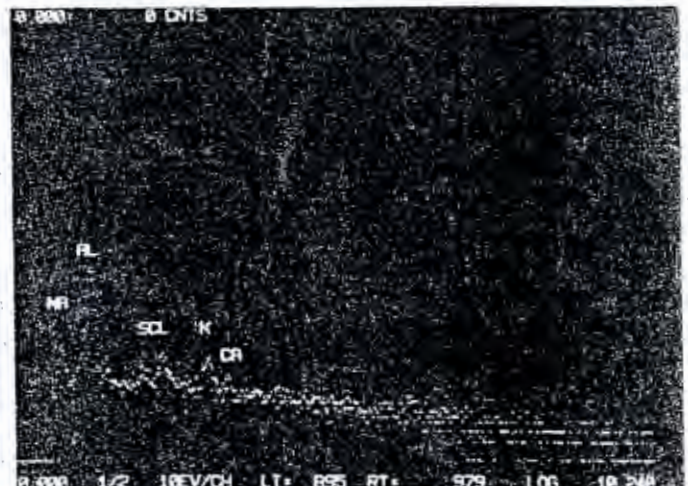
Figure 7. S.E.M. micrograph of the test aluminium alloy surface after immersion showing extensive pitting of the specimen's surface located underneath the corrosion deposits.
