Quality characteristics of concrete poles manufactured in the Ibadan metropolis, southwest Nigeria

In Nigeria, power is transmitted by overhead transmission lines fixed on wooden or concrete poles. Often times these poles collapse under excessive loads occasioned by storm and accidents. This project work is to determine the quality characteristics of concrete electric poles used to carry overhead conductors in the Ibadan metropolis of Nigeria. Samples of broken concrete poles were collected from various sites within Ibadan metropolis. Core, permeability, cube and tensile tests were carried out on samples of stumbled poles and fresh concrete mix collected from companies producing poles. This was to check the conformance of the poles to the standard set by the regulatory authority. The test results showed that all the samples on which the core and permeability tests were carried out fell short of the required standard of 37,000KN/m. For the core test, only one sample had the average values of 46,200KN/m and 50,400KN/m² at 7days and 28days respectively which exceeded the standard minimum value. The results showed that the manufacturers did not use the right ratio of materials, the mo

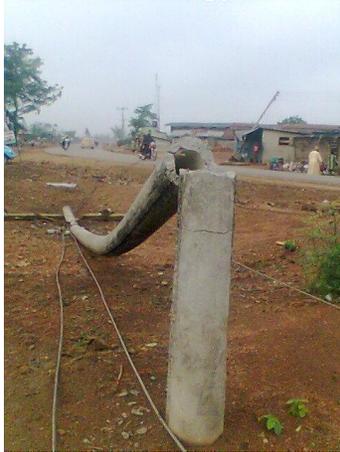
Plate 1: Fracture at 1,200 mm

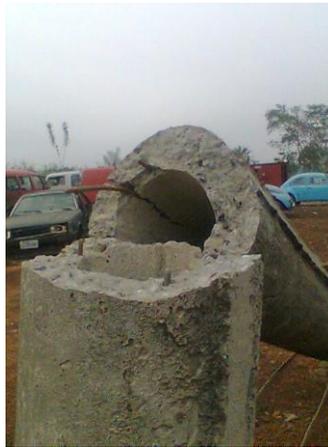
Plate 2 Clean fracture at 900mm

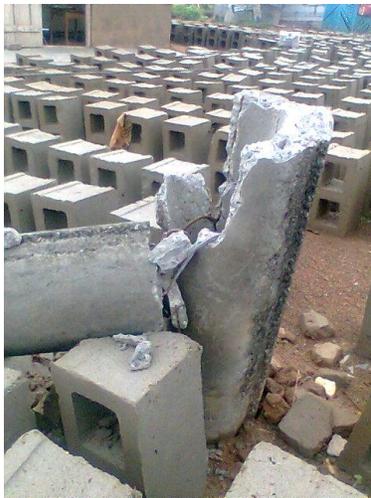
Plate 3 A fracture and a tear

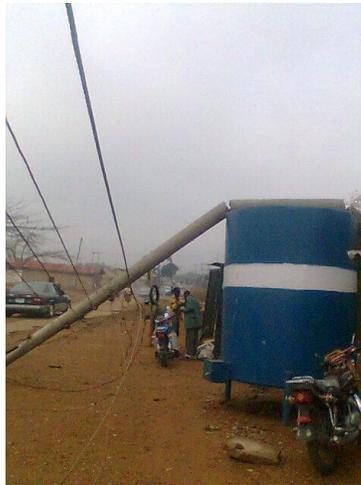
Plate 4 Multiple fracture

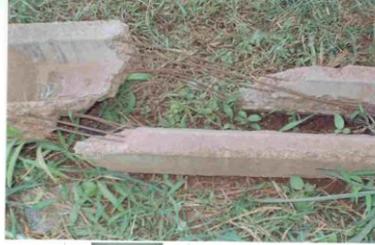
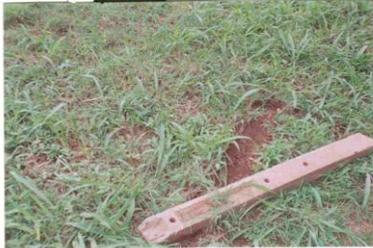
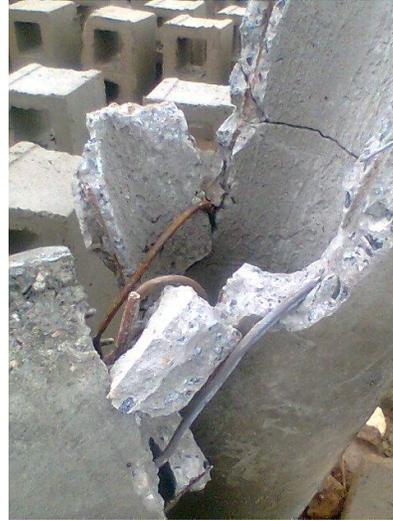
Plate 5: Stumbled Pole wires unbroken Plate 6: Stumbled Pole
