Subsurface Geophysical Investigation and Physiochemical/Microbial Analysis of Groundwater Contaminant in Ota, Southwestern Nigeria

Abstract Geoelectrical imaging of the subsurface to investigate groundwater contaminants in a sedimentary environment like Ota, South-western Nigeria was carried out. The 2 – Dimensional electrical resistivity survey method for the subsurface imaging was done by engaging the Wenner array configuration using PASI Resistivity Meter in the surface measurement. The vertical electrical sounding (VES) was also done using the Schlumberger array configuration to determine the depth to the aquifer layer. The DIPRO software and the WIN-Resist application software were used for the interpretation of the 2 – D resistivity data and VES data respectively. Both Hydrochemical and Microbial analyses were done to test for the presence of heavy metals and the estimation of Total Aerobic Bacteria (TAB). From the VES results the depth to the aquifer lies around 20.1m (60.33ft.) of resistivity of 34.1 Ω -m and the 2–D results showed the resistivities as 28.0 Ω -m and 47.0 Ω -m respectively showing that the study area has groundwater potential. For the hydrochemical analysis

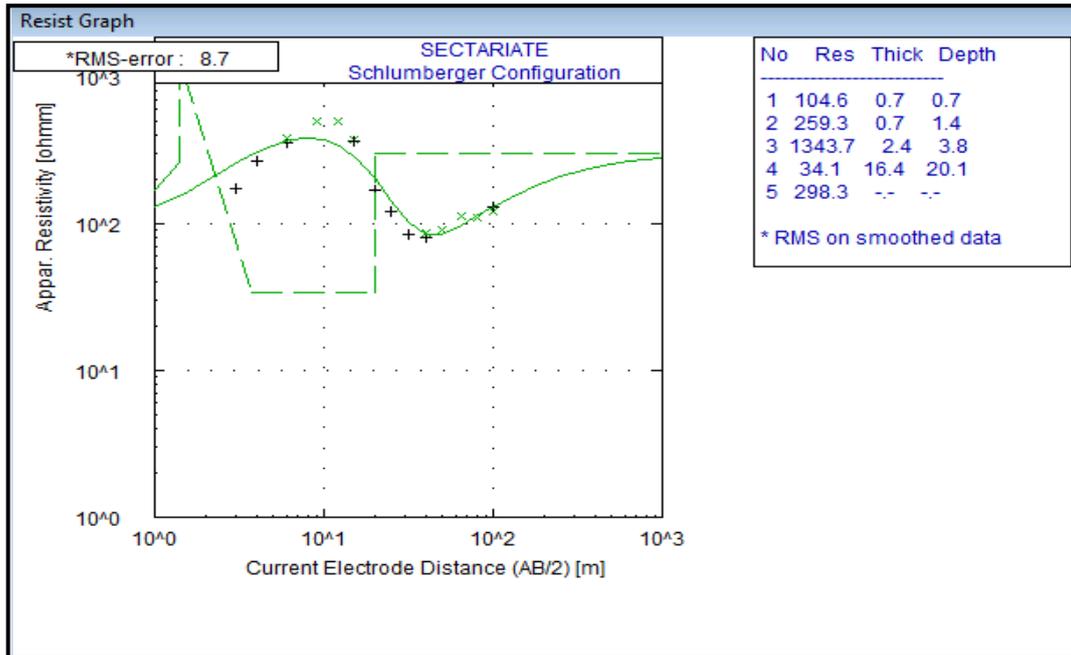
Figure 1. Vertical Electrical Sounding (VES) Survey

From Figure 1, the total depth gives 20.1m (60.33ft.) of resistivity of 34.1 Ω -m and the 2 – D results showed the resistivities as 28.0 Ω -m and 47.0 Ω -m respectively (Figure 3 and Figure 4) showing that the study area has groundwater potential. Here the resistivity from the VES reading lies in between the resistivities gotten from the 2 – D results. From the study it can be seen that the depth to the aquifer is not too

From the VES results the depth to the aquifer lies around 20.1m (60.33ft.) of resistivity of 34.1 Ω -m and the 2 – D results showed the resistivities as 28.0 Ω -m and 47.0 Ω -m respectively showing that the study area has groundwater potential. For the hydrochemical analysis on heavy metals, the result lies within World Health Organization (WHO) standard for drinking water. But for the microbial analysis, total aerobic plate count of 2.3×10^6 for drinking water is high and above WHO standard specification for drinking water. The presence of coliform at count of 2.4×10^4 and isolation of *Escherichia Colipoint* to faecal contamination of sample is suspected. This could be from underground seepage or direct contamination of storage tanks and pipes. The presence of *Staphylococcus aureus* is also suspected.

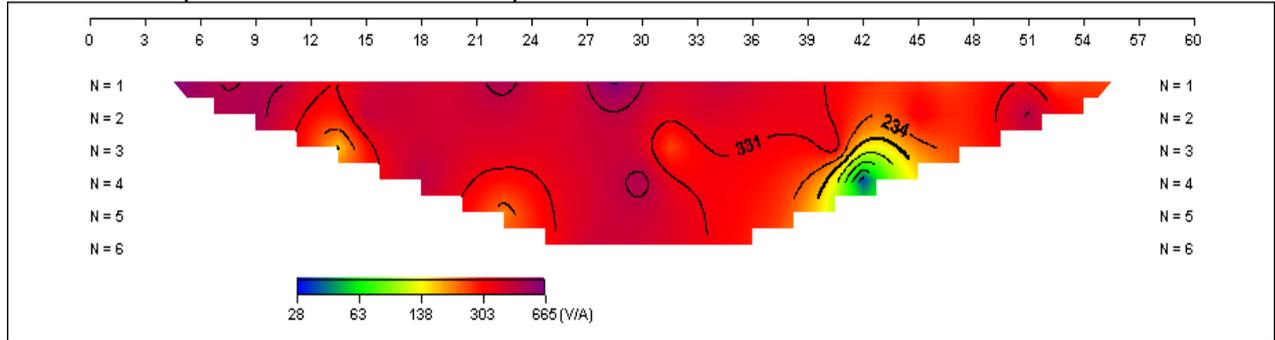
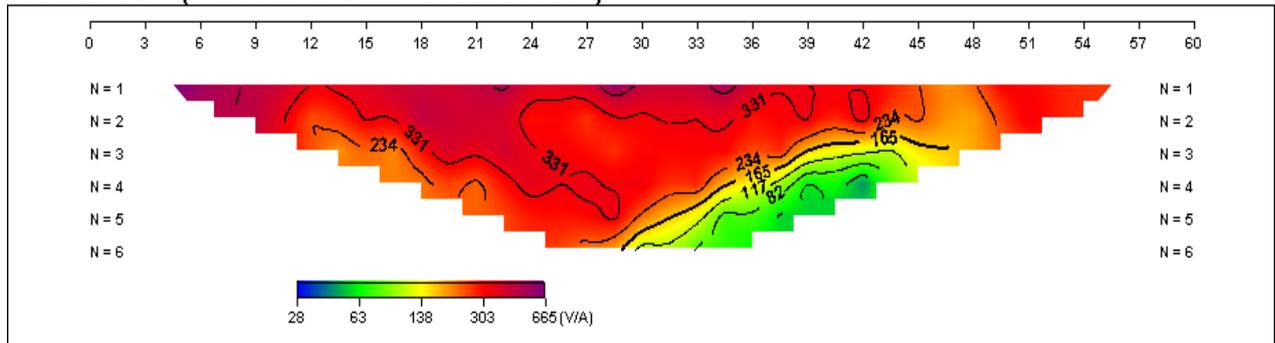
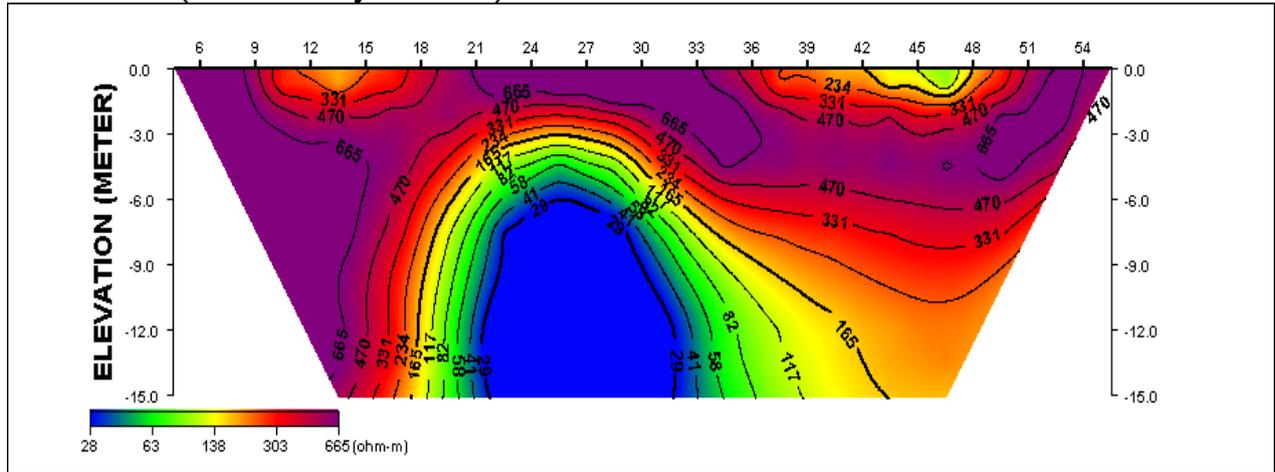
Figure 3. 2 – D Resistivity Survey (Traverse 1)

TRAVERSE 1 (Field Data Pseudosection)

TRAVERSE 1 (Theoretical Data Pseudosection)

TRAVERSE 1 (2-D Resistivity Structure)

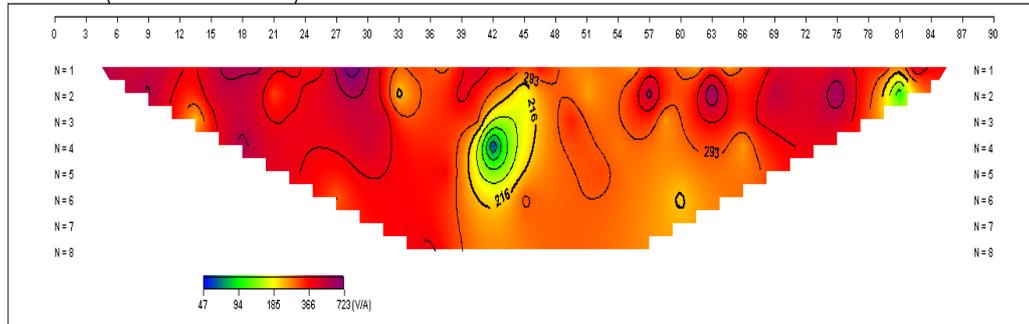
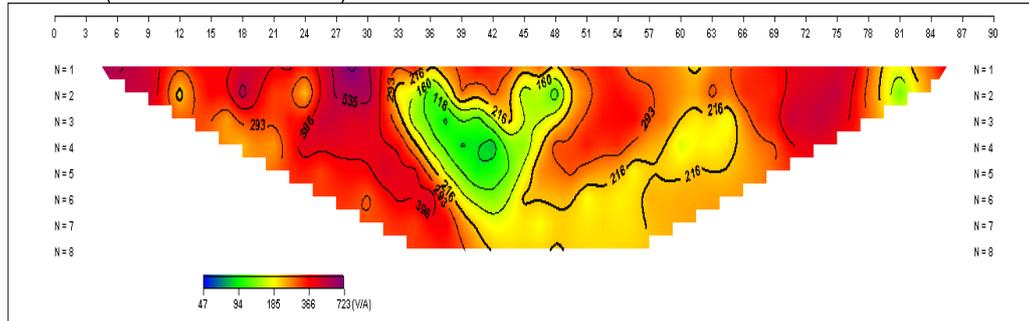
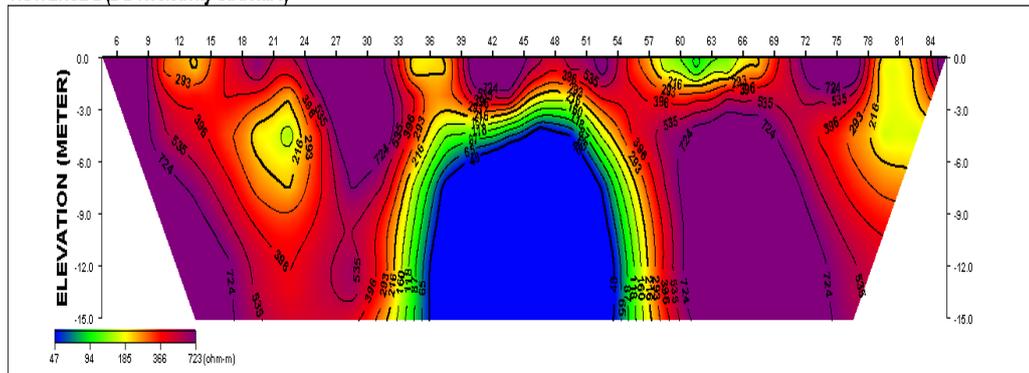
Figure 4. 2 – D Resistivity Survey (Traverse 2)

TRAVERSE 2 (Field Data Pseudosection)

TRAVERSE 2 (Theoretical Data Pseudosection)

TRAVERSE 2 (2-D Resistivity Structure)

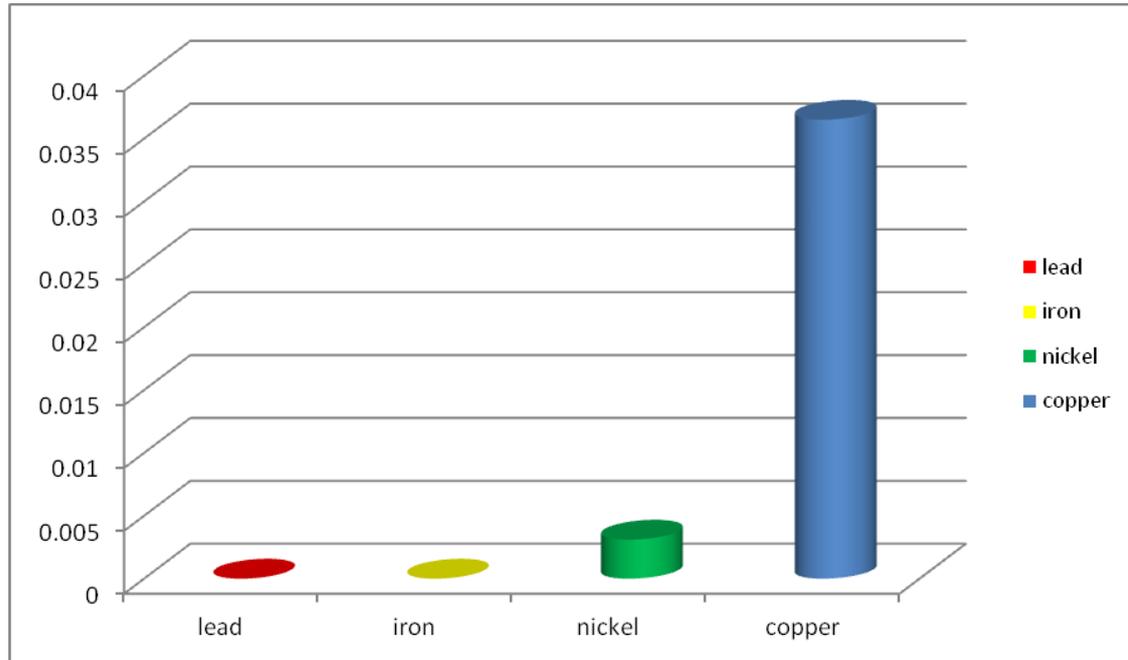
Figure 5. Chart Showing Level of Heavy Metals in Samples

It was observed that for all the water samples that was tested for the concentrations of heavy metals, all were within the WHO standard for drinking water. We therefore, advice that the authority in charge of water management in Ota,
