MAINTENANCE CHALLENGES OF MULTI-OWNER MULTI-STOREY RESIDENTIAL BUILDINGS IN LAGOS, NIGERIA

Folorunso, Clement Oluwole (PhD) Department of Architecture

Arc. Oladunni Izobo-Martins, Albert B. Adeboye (PhD) & Egidairo Aduwo (PhD)

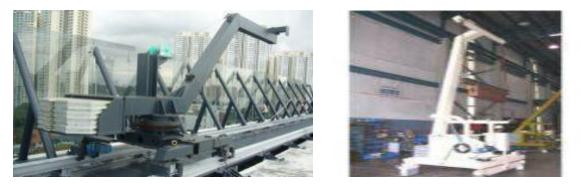
Figure 2a&b: Motorized Trolley

• **Motorised Trolley:** this is a mechanically powered travelling suspension rigs. It can travel on concrete runways and parapet walls. It contains hydraulic cylinder, arm rotation and telescoping. It has a galvanised finish and comes in various colours.

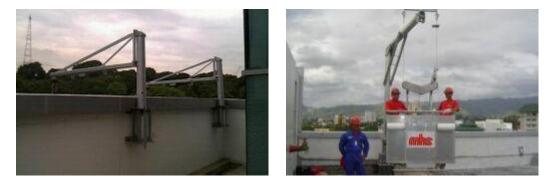
Figure 3a&b: Rigging system

• **Rigging** System: it requires a permanent installation of the sockets or the pedestals into the building's roof slab or reinforced concrete slab for usage. It requires planning and integration at the design stage. The design and installation of the sockets or pedestals depends on the cradle length of the gondola-cable car. It requires one (1) or two (2) davit arms- small cranes- for effective operation. A mono winch cradle requires one davit while double winch cradles operate on two davit arms which connect all the sockets within a monolithic roof by manual transfer. The size and weight of the davit arm is of importance to effective usage and prevention of accident.

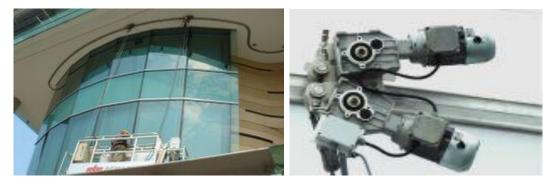
Figure 4a&b: Monorail system

• **Monorail System:** This provides access to building facade through the running of a single track that runs along the exterior facade with compliance to the shape of the building. Smooth running trolleys mounted on the monorail track allows a suspended gondola to move along the building horizontally or at inclined angle without inhibition. Control can be manipulated manually or electrically along the monorail tracks. For a climbing monorail, a high performance climbing trolley runs along the inclined monorail to suspend and traverse a gondola cradle. It is capable of climbing any slope vertically with a load of 500kg.

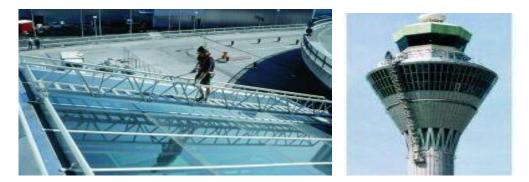
Figure 6a&b: Ladder and gantry system

• Ladder and Gantry Systems: These are purpose built systems that can take any shape of the architecture of the building or surfaces that requires maintenance. It is usually fabricated with aluminium alloy, stainless and galvanised steel. There are various types of ladders such as telescopic, curved and rotating ladders. They are built with girders to prevent failure. Gantries are specially built for maintaining atrium, skylights and exteriors of towers with safety devices.
