Challenges Affecting the Development and Optimal Use of Tall Buildings in Nigeria

Anthony Nkem Ede,

Department of Civil Engineering, Covenant University, Ota- Nigeria.

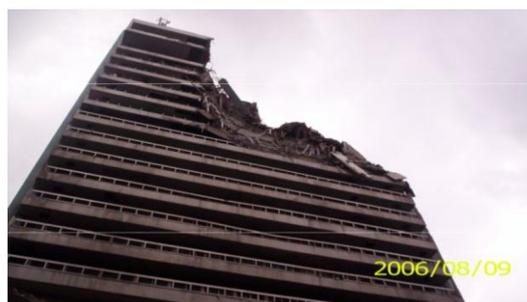
Figure 3: The Nigerian Industrial Development Bank (NIDB) building upon collapse. Source: [11]

It is important to know that the 3 most feared hazards of tall buildings world-wide, i.e., fire, terroristic attaches and building collapse are rife in Nigeria, affecting the high rise and low rise alike. Nitel building, the Nigerian tallest building suffered a serious fire outbreak in 1983, killing 5 people. It took 72 hours to put off the fire because of lack of water hydrants and adequate water supply. The 32 storey building lacked adequate aeration and ventilation and has only two stairways provided. Nigerian Industrial Development Bank (NIDB) building shown in Fig. 3 is another example of high-rise building that suffered fires disaster in Nigeria. In its case, it experienced three fire outbreaks, the third being the last and it led to its eventual collapse in 2006 due to the weakening of the structural members.
